Regional Beach Management Plan 2017: Littlehampton to Brighton Marina

Report – ENVIMSE100035/R-01

Final Report, July 2017

Main Report

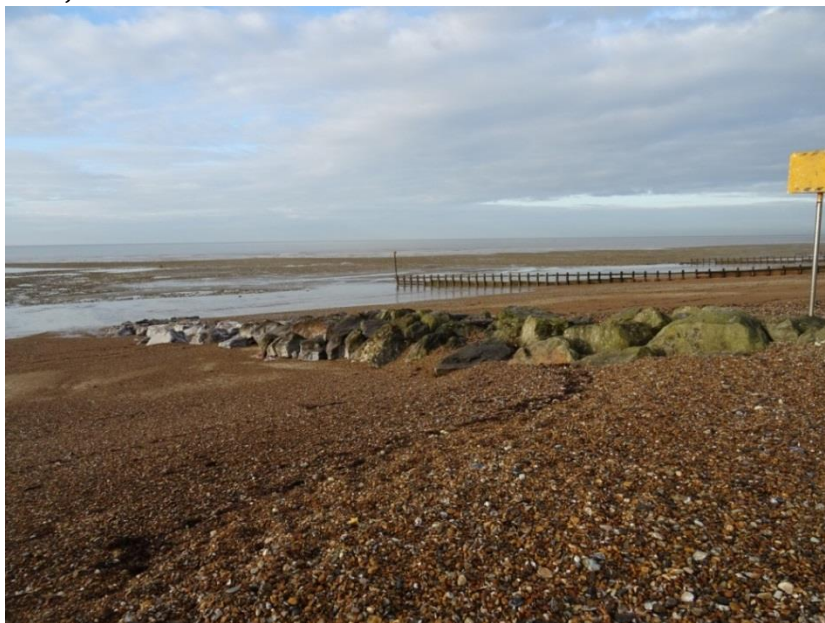
FIGURE 1-6 ROCK GROUYNE TO THE SOUTH OF SEA ROAD

The defences protect the village of Rustington and consist of a concrete vertical wall (+4.9-5.2 mOD) extending from the harbour to Littlehampton Skate Park. A concrete recurve wall at +5.8 mOD extends for 275m. A timber vertical wall at an elevation of +6.3 mOD extends from opposite Marama Gardens to the beach shelter at the end of Sea Road. A concrete promenade extends for the majority of the frontage, extending from the harbour to in front of the RAF Nursing Home just west of Broadmark Lane.

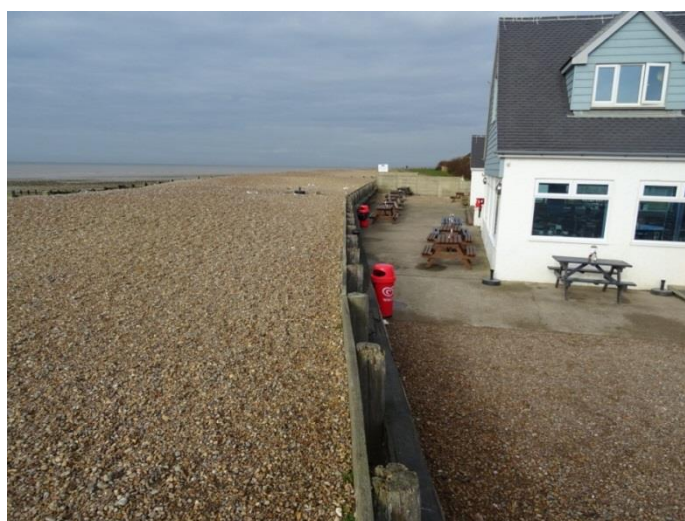
FIGURE 1-7 TIMBER BREASTWORK IN FRONT OF THE BLUE BIRD CAFÉ, FERRING

There are two short sections of hard defence at Ferring; a 200 m timber wall at +5.7 mOD fronting the Blue Bird Café, (Figure 1-7) and a short concrete wall (+6.7 mOD) and promenade that extends for 80 m behind Arundel Court. A total of 135 timber groynes and 10 rock groynes hold sediment along Ferring (Mott MacDonald 2016a). The spacing and orientation vary across the whole frontage. Responsibility of these groynes is shared between Arun DC, Adur & Worthing BC and the Environment Agency (Mott MacDonald, 2016a). Nine outfalls are present, with the majority consisting of concrete casing or a timber frame with supporting piles.

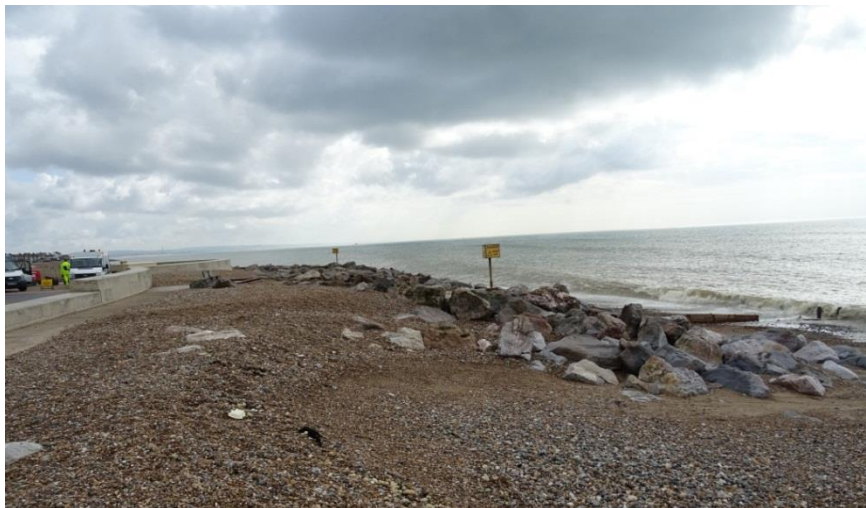
FIGURE 1-8 SPLASH POINT, WORTHING

Between West parade and Splash Point, there is an intermittent wall at (+5.5- +6.6 mOD) with several access points that run along the promenade. Splash Point is a vertical sea wall (+6 mOD) protected by a rock revetment, this was constructed in the 1990s. Splash Point to Ham road has a concrete promenade that is protected at each end with a rock revetment and sea wall at varying heights (+5.5 mOD to +6.3 mOD). Beyond Ham Road the majority of the frontage is protected by a groyned beach, with intermittent splash walls in places.

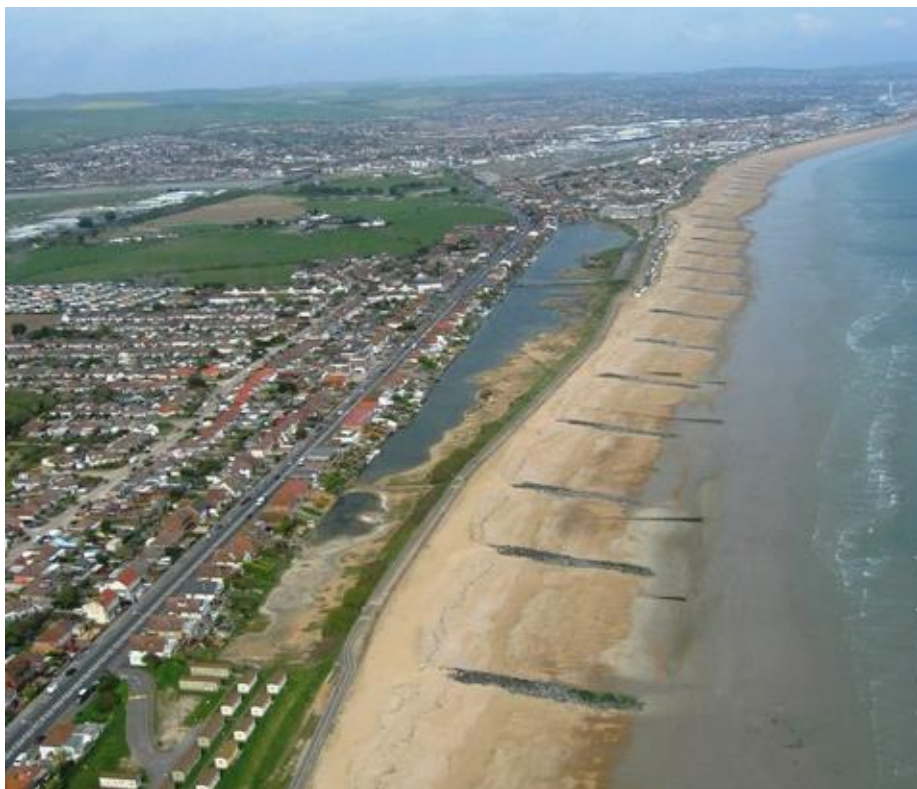
FIGURE 1-9 LANCING ROCK GROYNES AND WIDE WATER LAGOON

There are a variety of defences at Lancing, the first of which is a timber wall, stretching from Lancing Beach Green to the middle of Widewater lagoon (Figure 1-9). This timber wall is built at a level of +5.5 mOD between the Beach Green and the sailing club, where it increases in height to +6.7 mOD. There is a short section of recurved concrete sea wall fronting the Widewater Lagoon at a level of +5.6 mOD. Prior to the construction of this sea wall, there was a 600 m breach of the barrier beach in 1908.

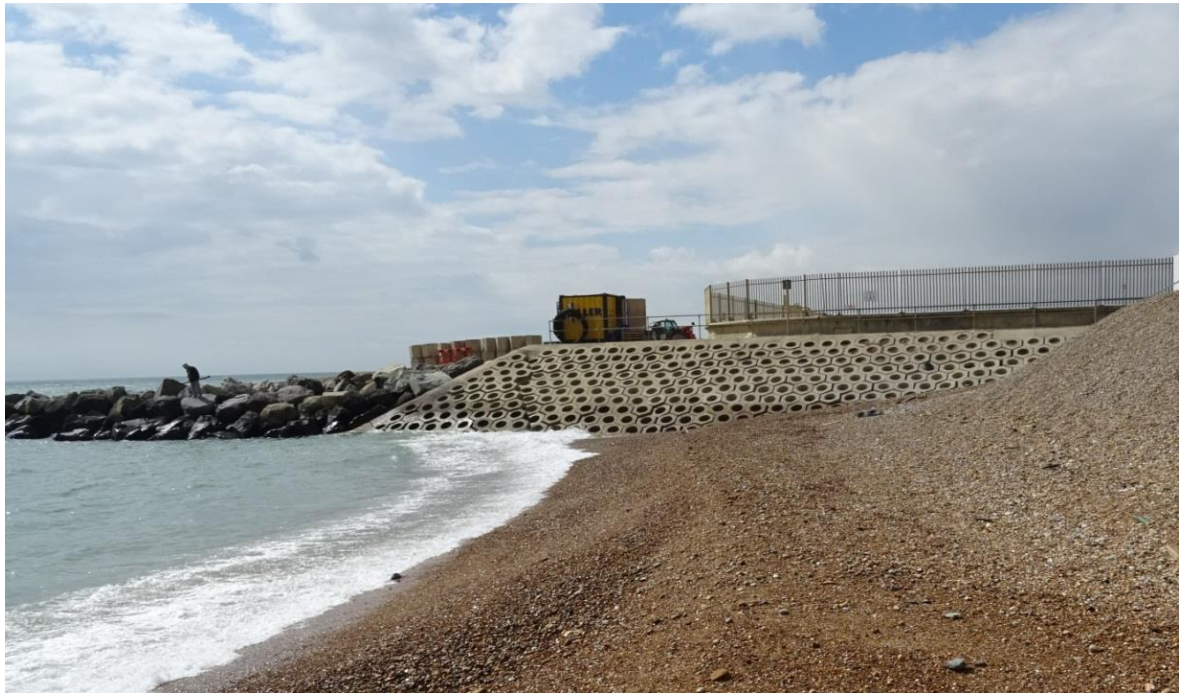
FIGURE 1-10 SEABEES ALONGSIDE SHINGLE BEACH AND ROCK GROUYNE, EAST OF HARBOUR ENTRANCE, SOUTHWICK

Southwick beach extends from Shoreham Harbour arm to the Hove lagoon. The beach consists of shingle and sand with a sand foreshore, and has a slope gradient of 1 in 9. Within the harbour arm beach there is a rock revetment which is built to a level of +4.5 mOD with a slope of approximately 1 in 7 to 1 in 10, which flattens towards the beach toe, although steeper in parts with a slope of 1 in 5.5. To the east of the harbour arm there are two rock groynes 250 m apart. The sea wall is made of concrete sea bees, designed to help dissipate wave energy (Figure 1-10).

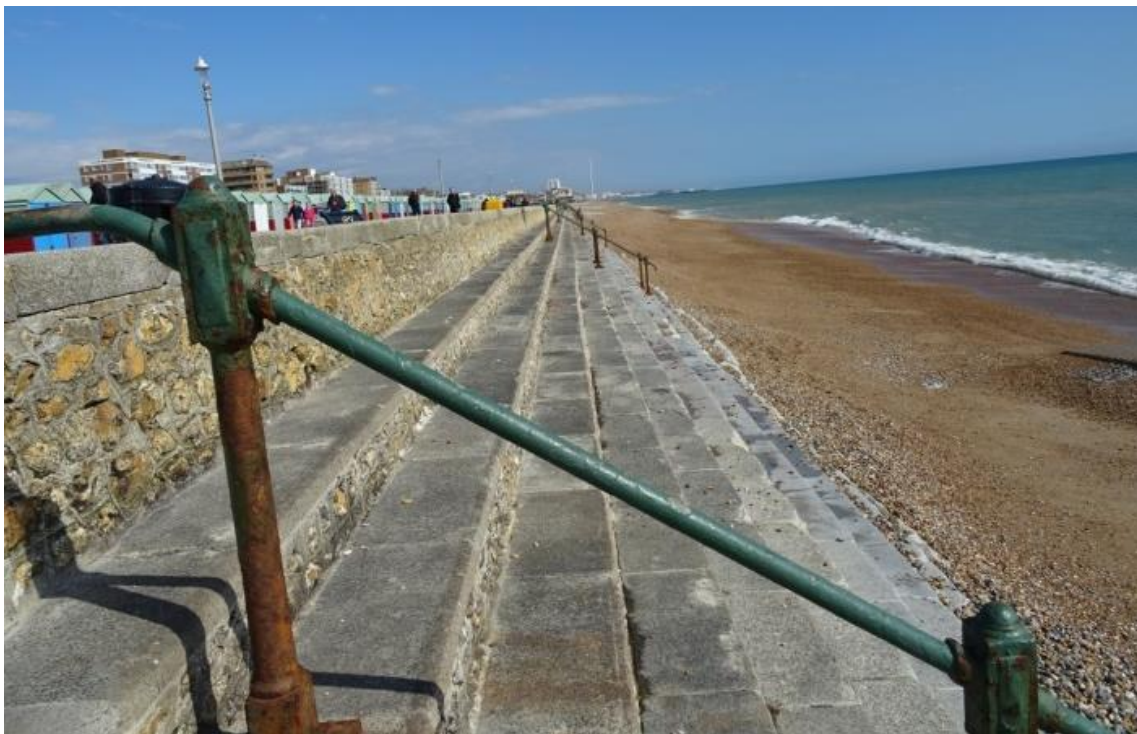
FIGURE 1-11- STEPPED REVETMENT, HOVE

Starting in the west, at Hove, there is a 120m stretch of coast in front of the Lagoon which is undefended. To the east of the Lagoon is vertical sea wall stretches for 200m which changes to a stepped revetment and vertical wall at +6.5mOD which runs east for 300m (Figure 1-11). A series of vertical walls between the tennis courts and Brighton Marina ranging in height from +6.6mOD to +8.0mOD rising from west to east. Between Meeting Place Café and the Brighton Marina there is a high retaining wall which does offer some protection against flooding. Small shops and cafes built into the arches have historically been flooded. There are eight outfalls between the Pier and the marina, two of which act as controlling structures.

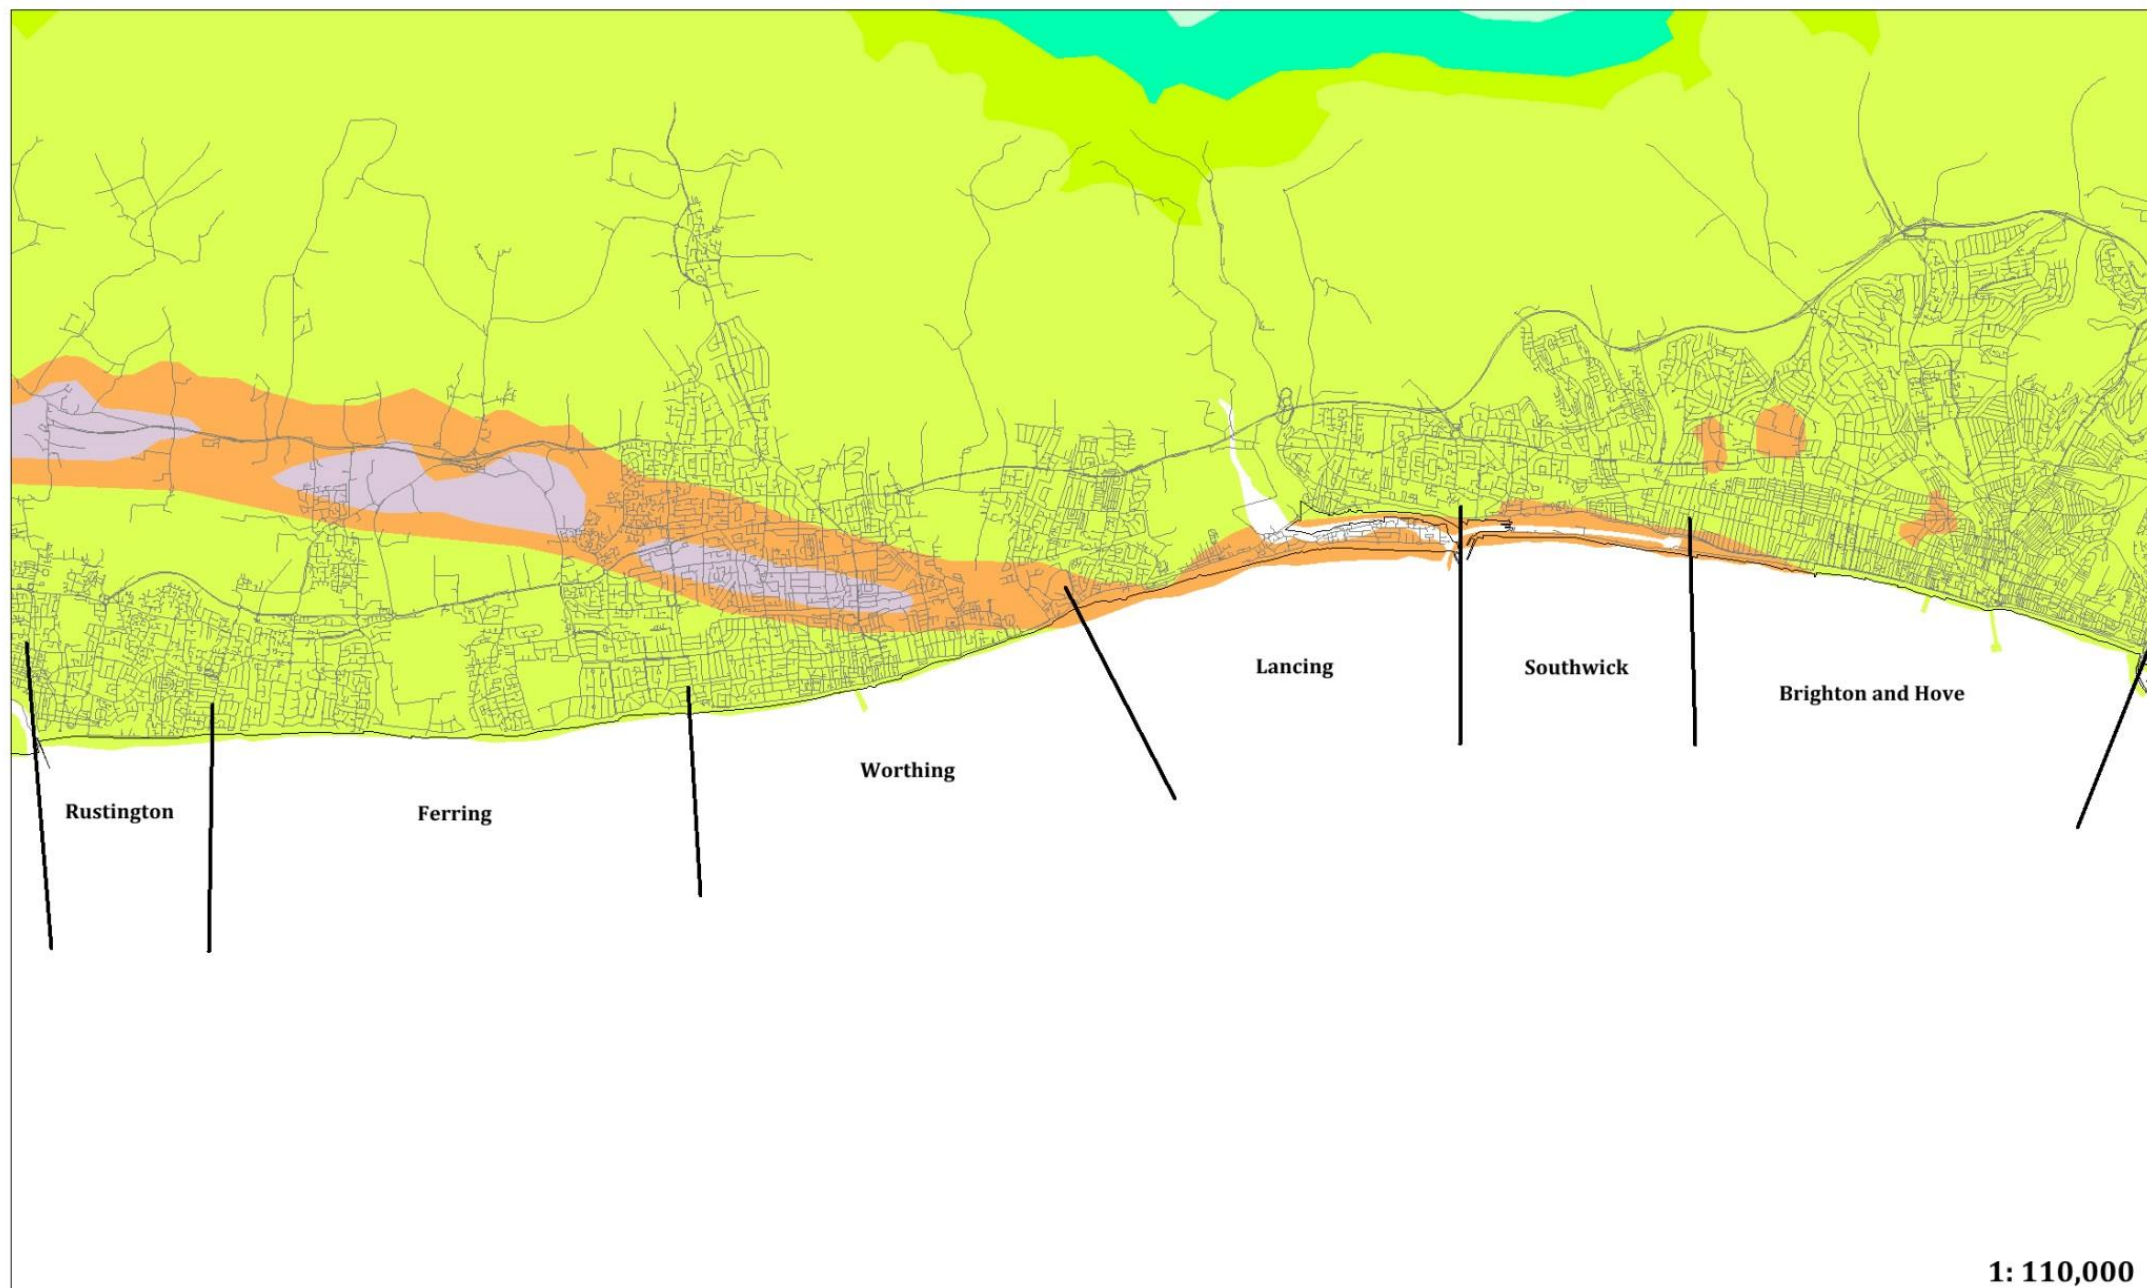
FIGURE 1-13 GEOLOGY - BEDROCK

The Littlehampton to Rustington, Rustington to Ferring, Worthing and Brighton and Hove units are underlain by Chalk bedrock; a band of clay stretches through the centre of the study area extending from Lancing to Southwick (Figure 1-13).

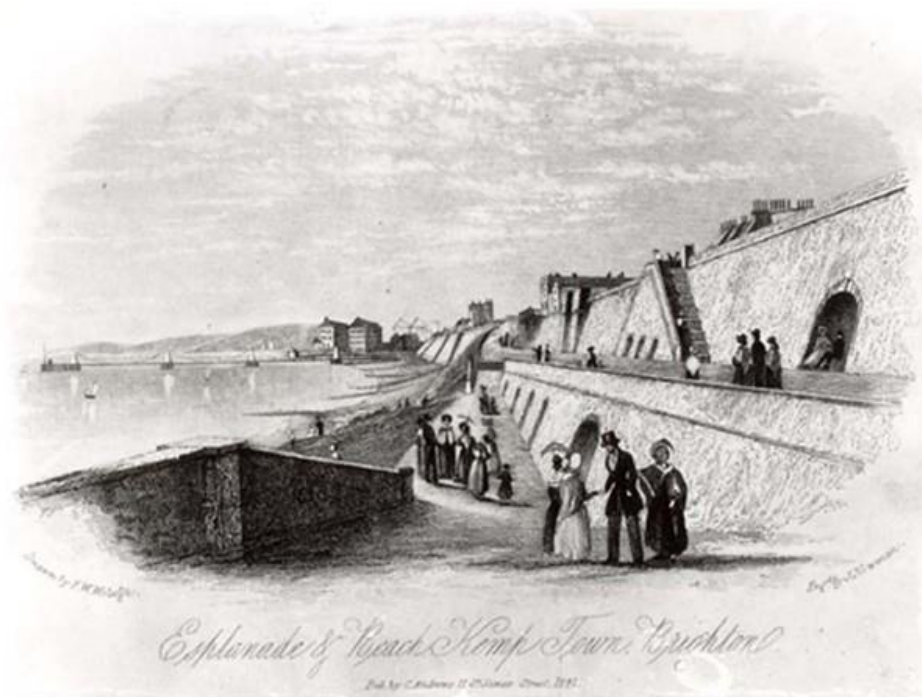
FIGURE 1-16 BRIGHTON NEW SEA WALL, KEMP TOWN 1830'S

As part of the construction of the Chain Pier in 1822-1823 a short section of a masonry sea wall was built in front of the cliffs. A concrete sea wall was constructed in 1830 – 1833 along the face of the East Cliff from the Old Steine to Royal Crescent. The defence was backfilled with rubble to the height of half that of the cliffs. Further works extended the sea wall up to Kemp Town by 1838.

Prior to the beach defences being built the sea reached the base of the cliffs at Kemp Town during high tide. The first sea wall, a simple flint structure, was built to protect against this in 1795. This was extended in 1809.

Around this time, a similar structure protected the frontage between Black Lion Street and Ship Street. This wall has been extended several times; in 1821 to West Street, in 1825-27 to East Street, in 1853 to the West Battery (in front of the Grand Hotel), and to the Brunswick Town sea-wall at the Hove boundary in 1894.

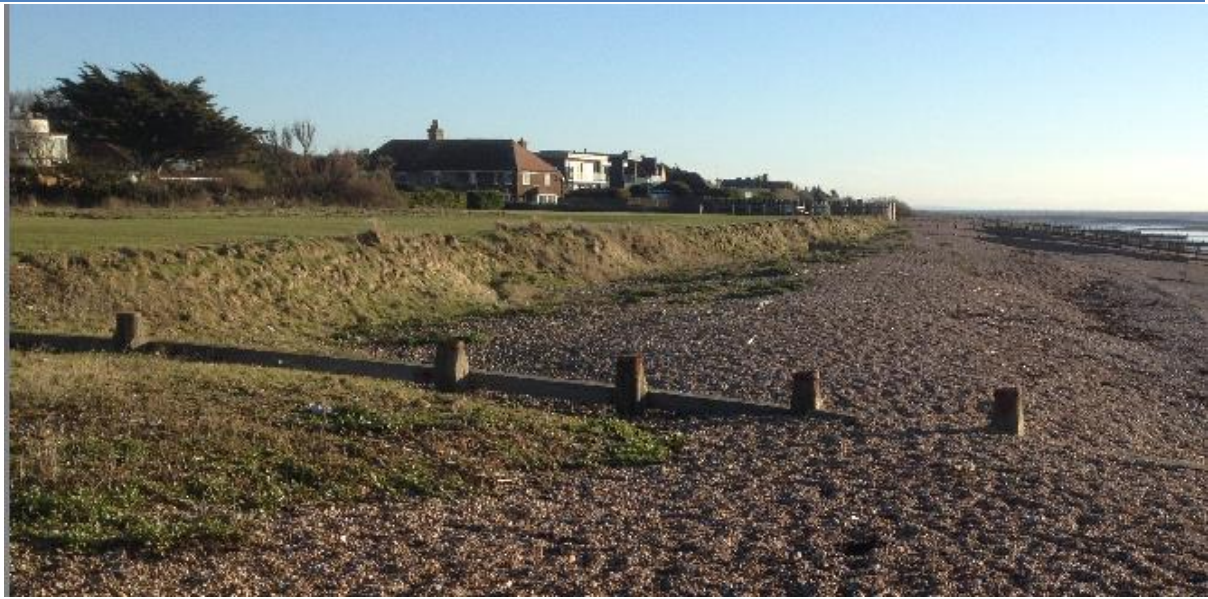
FIGURE 2-1 WOODEN GROYNES AND SHINGLE BEACH FRONTING RISING GROUND, LOOKING TOWARDS FERRING FROM RUSTINGTON

Damage to slopes and cliffs, property on top of the slopes and cliffs and damage to property through loss of beach are all reduced by the presence of a shingle beach (Figure 2-1). There is a cliff present West of Brighton however the properties are set back, therefore between Littlehampton and Brighton no properties are at risk of being lost to the sea (Appendix C).

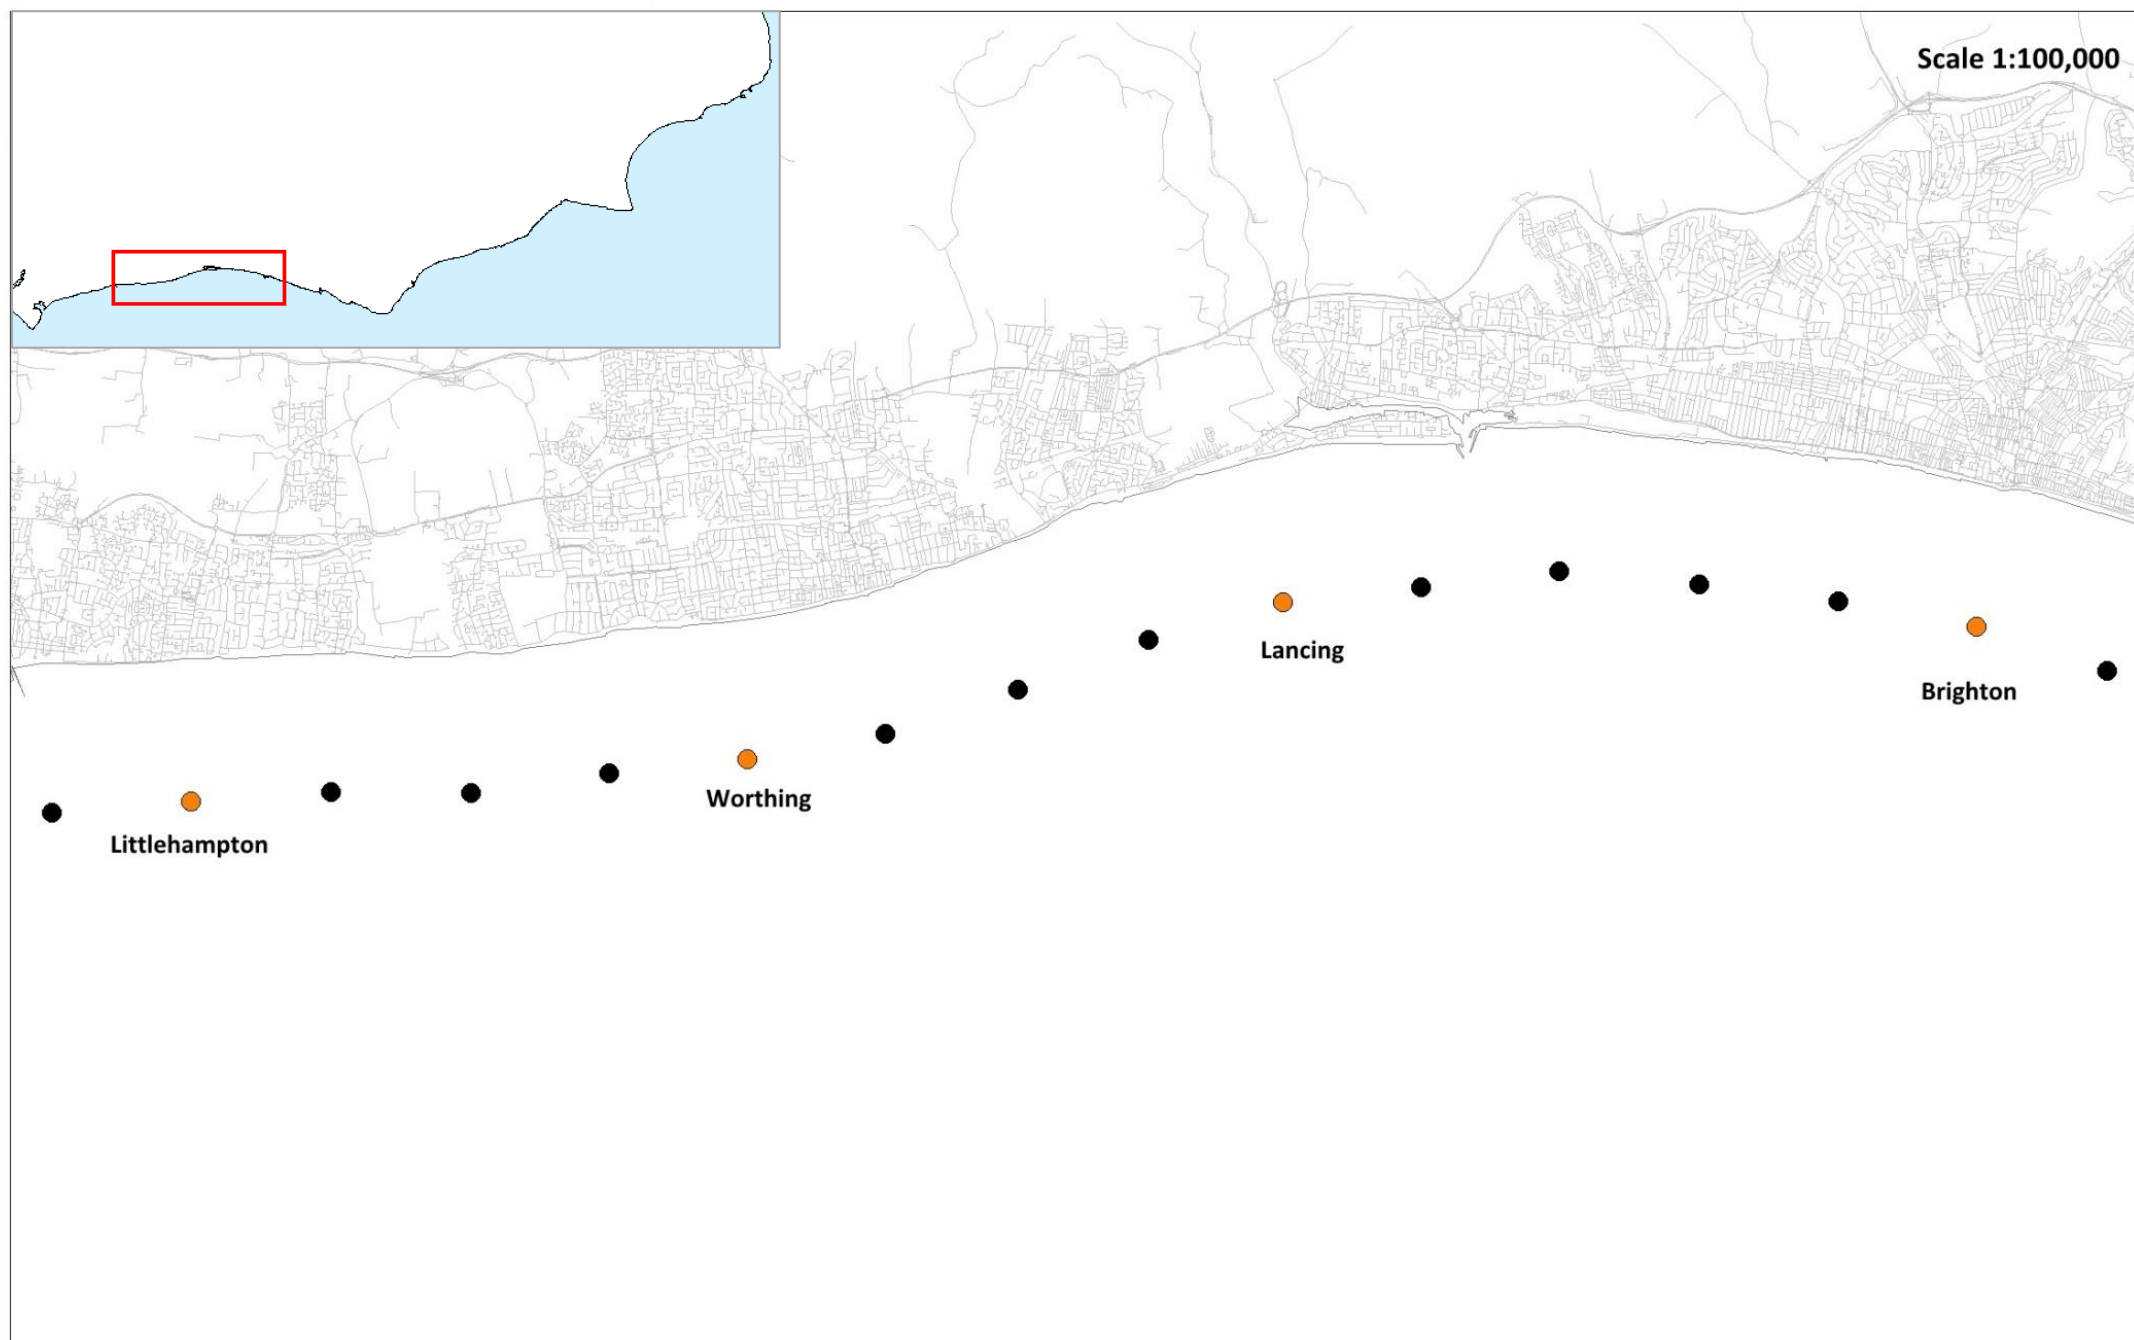
FIGURE 3-1 LOCATION OF EXTREME WATER LEVELS (EWL) AND EXAMPLE POINTS

Extreme water levels increase from east to west along the frontage with a typical difference of at least 360mm between Littlehampton and Brighton Marina.

Extreme water levels were taken from the Coastal Flood Boundary (CFB) conditions for UK mainland and islands report (Environment Agency, 2011). They are shown for four locations along the study area in Table 3-1and Figure 3-1.

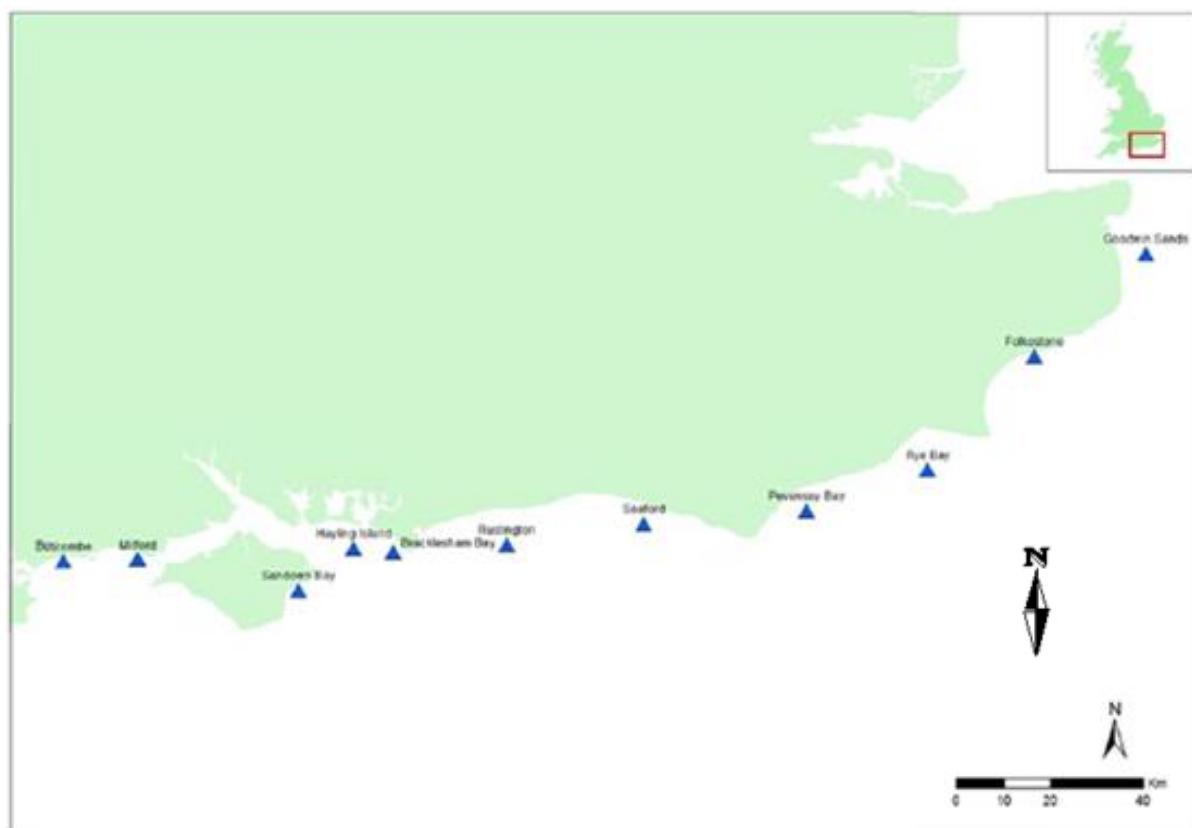
FIGURE 3-2 LOCATION OF WAVE BUOYS ON THE SOUTH EAST COAST

As part of the Regional Coastal Monitoring Project a network of wave buoys has been deployed around the coast since 2003.

Directional WaveRider buoys applicable to this study are Rustington and Seaford. Rustington has been operational since 15th July 2003 to the present day and Seaford was deployed on the 22nd January 2008. Both buoys are located along the 10m CD contour and a summary of collected data is presented in the following wave roses (Figure 3-3).

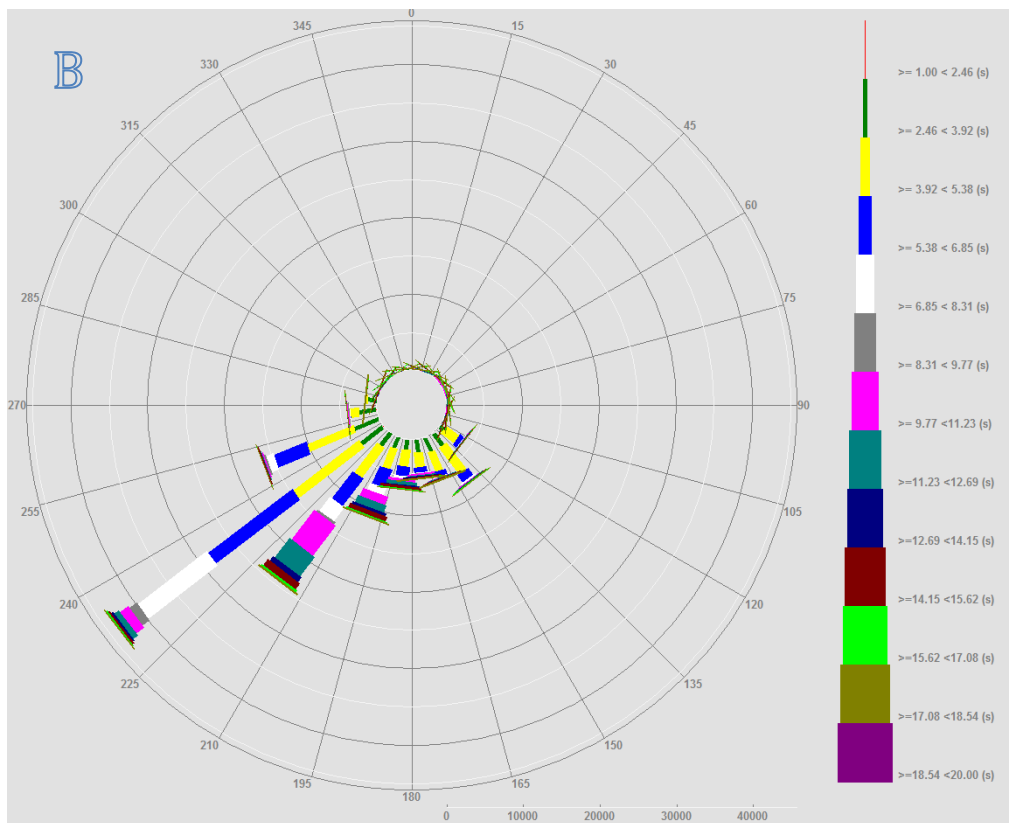
FIGURE 3-3 OFFSHORE WAVE HEIGHT (H_s) 01/01/2007 TO 01/01/2017 A: RUSTINGTON WAVE ROSE B: SEAFORD WAVE ROSE

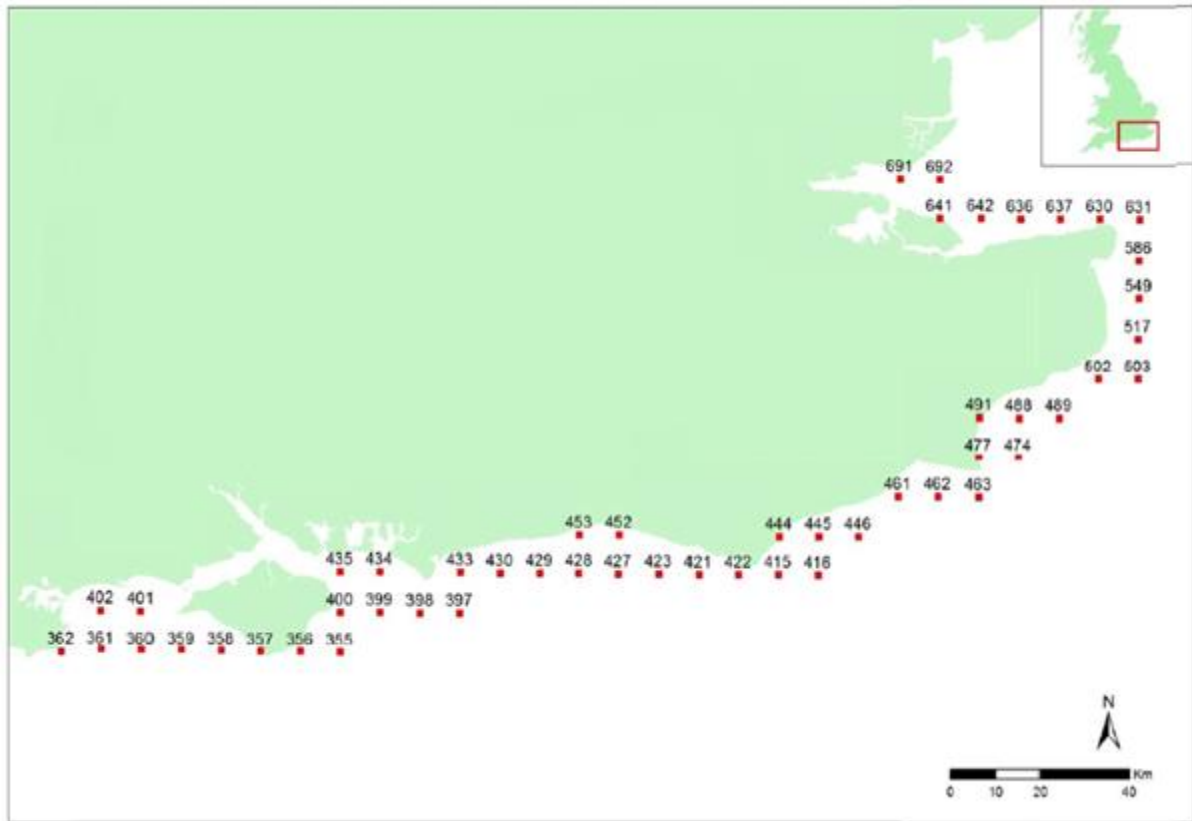
FIGURE 3-4 LOCATION OF MET OFFICE HINDCAST POINTS

Using thirty-three years of Met Office Hindcast data for 52 nearshore locations at ~5km intervals (Figure 3-4) the Joint Return Probability for Beach Management study (Mason, 2014) calculated extreme return periods for each of these points.

Significant wave height return periods for Met Office points M0429, M0430, M0452 and M0453 are included for reference in Table 3-2.

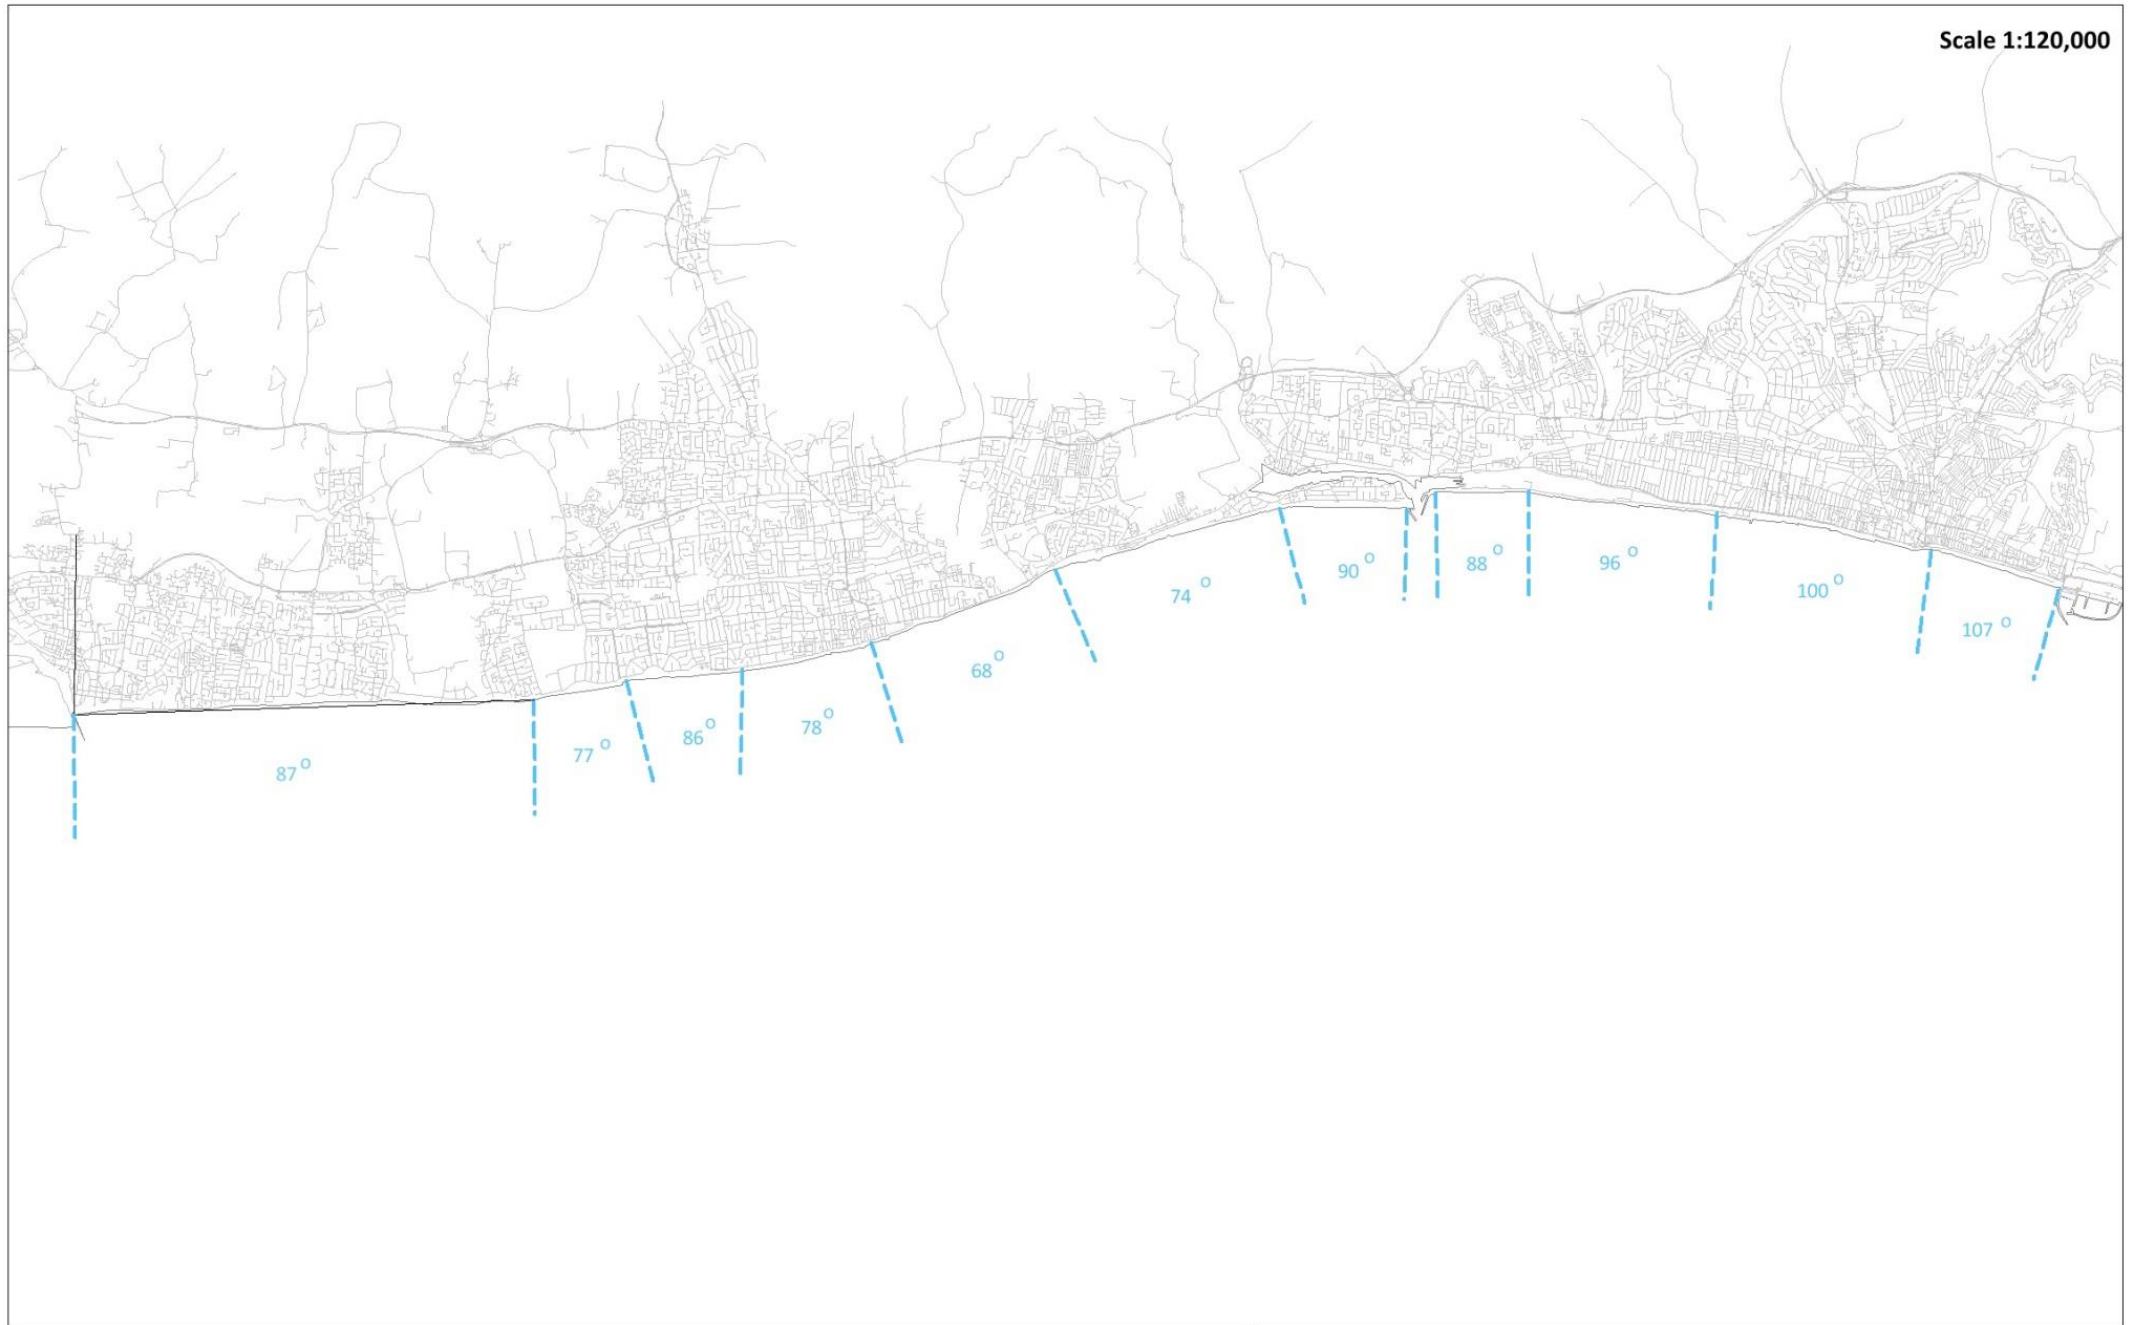
FIGURE 3-8 COASTAL ORIENTATION MAP (BEARING FROM DUE NORTH)
 © Crown copyright and database rights 2017 Ordnance Survey 100019614.
 Additional overlain information is copyright to Canterbury City Council

Orientation is one of the factors which affect the rate of longshore transport as the dominant waves approaching from the south west tend to strike the coast at a more acute angle which promotes west to east drift. Conversely, waves from the east strike the coast closer to perpendicular which reduces the amount of material that is transported back in a westerly direction.

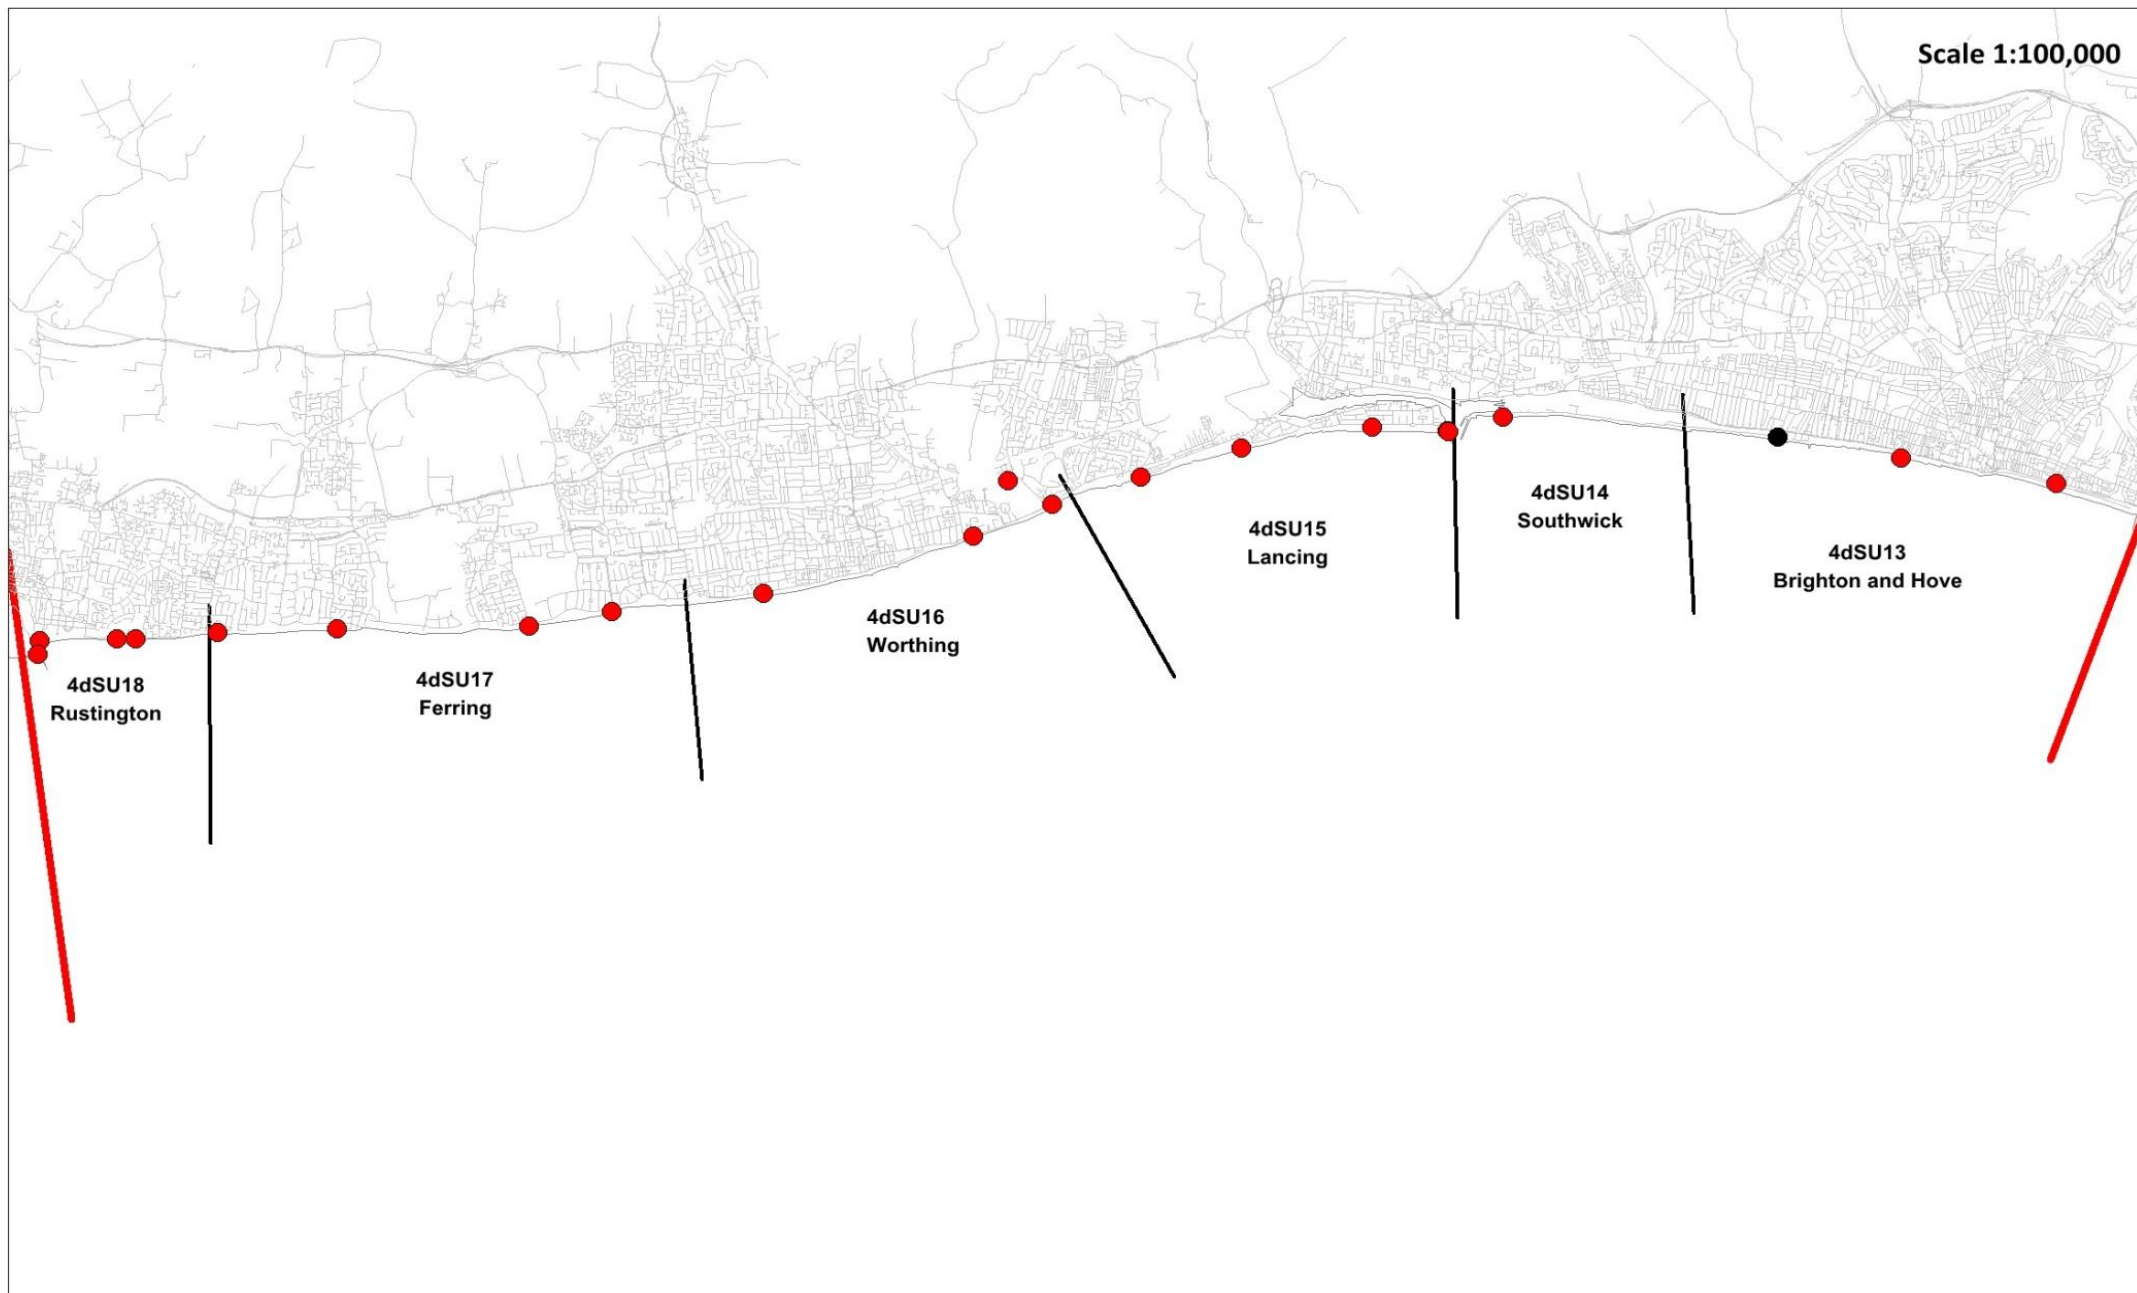
FIGURE 4-1 SURVEY CONTROL PINS LOCATION MAP

The elevations of the beaches between Littlehampton and Brighton Marina have been surveyed using a number of techniques since the RCMP project began. ABMS Photogrammetry was used between 2001 and 2006 at a contact scale of 1:5,000 and 1:3,000, ATV GPS survey and profiles were undertaken between 2007 and 2011, and since 2012 ATV-mounted mobile laser scanning has point clouds of all the beaches. This data is then processed to provide a 3-D model of all the beaches and profile data are extracted.
