Regional Beach Management Plan 2017: Littlehampton to Brighton Marina

Report – ENVIMSE100035/R-01

Final Report, July 2017

Main Report

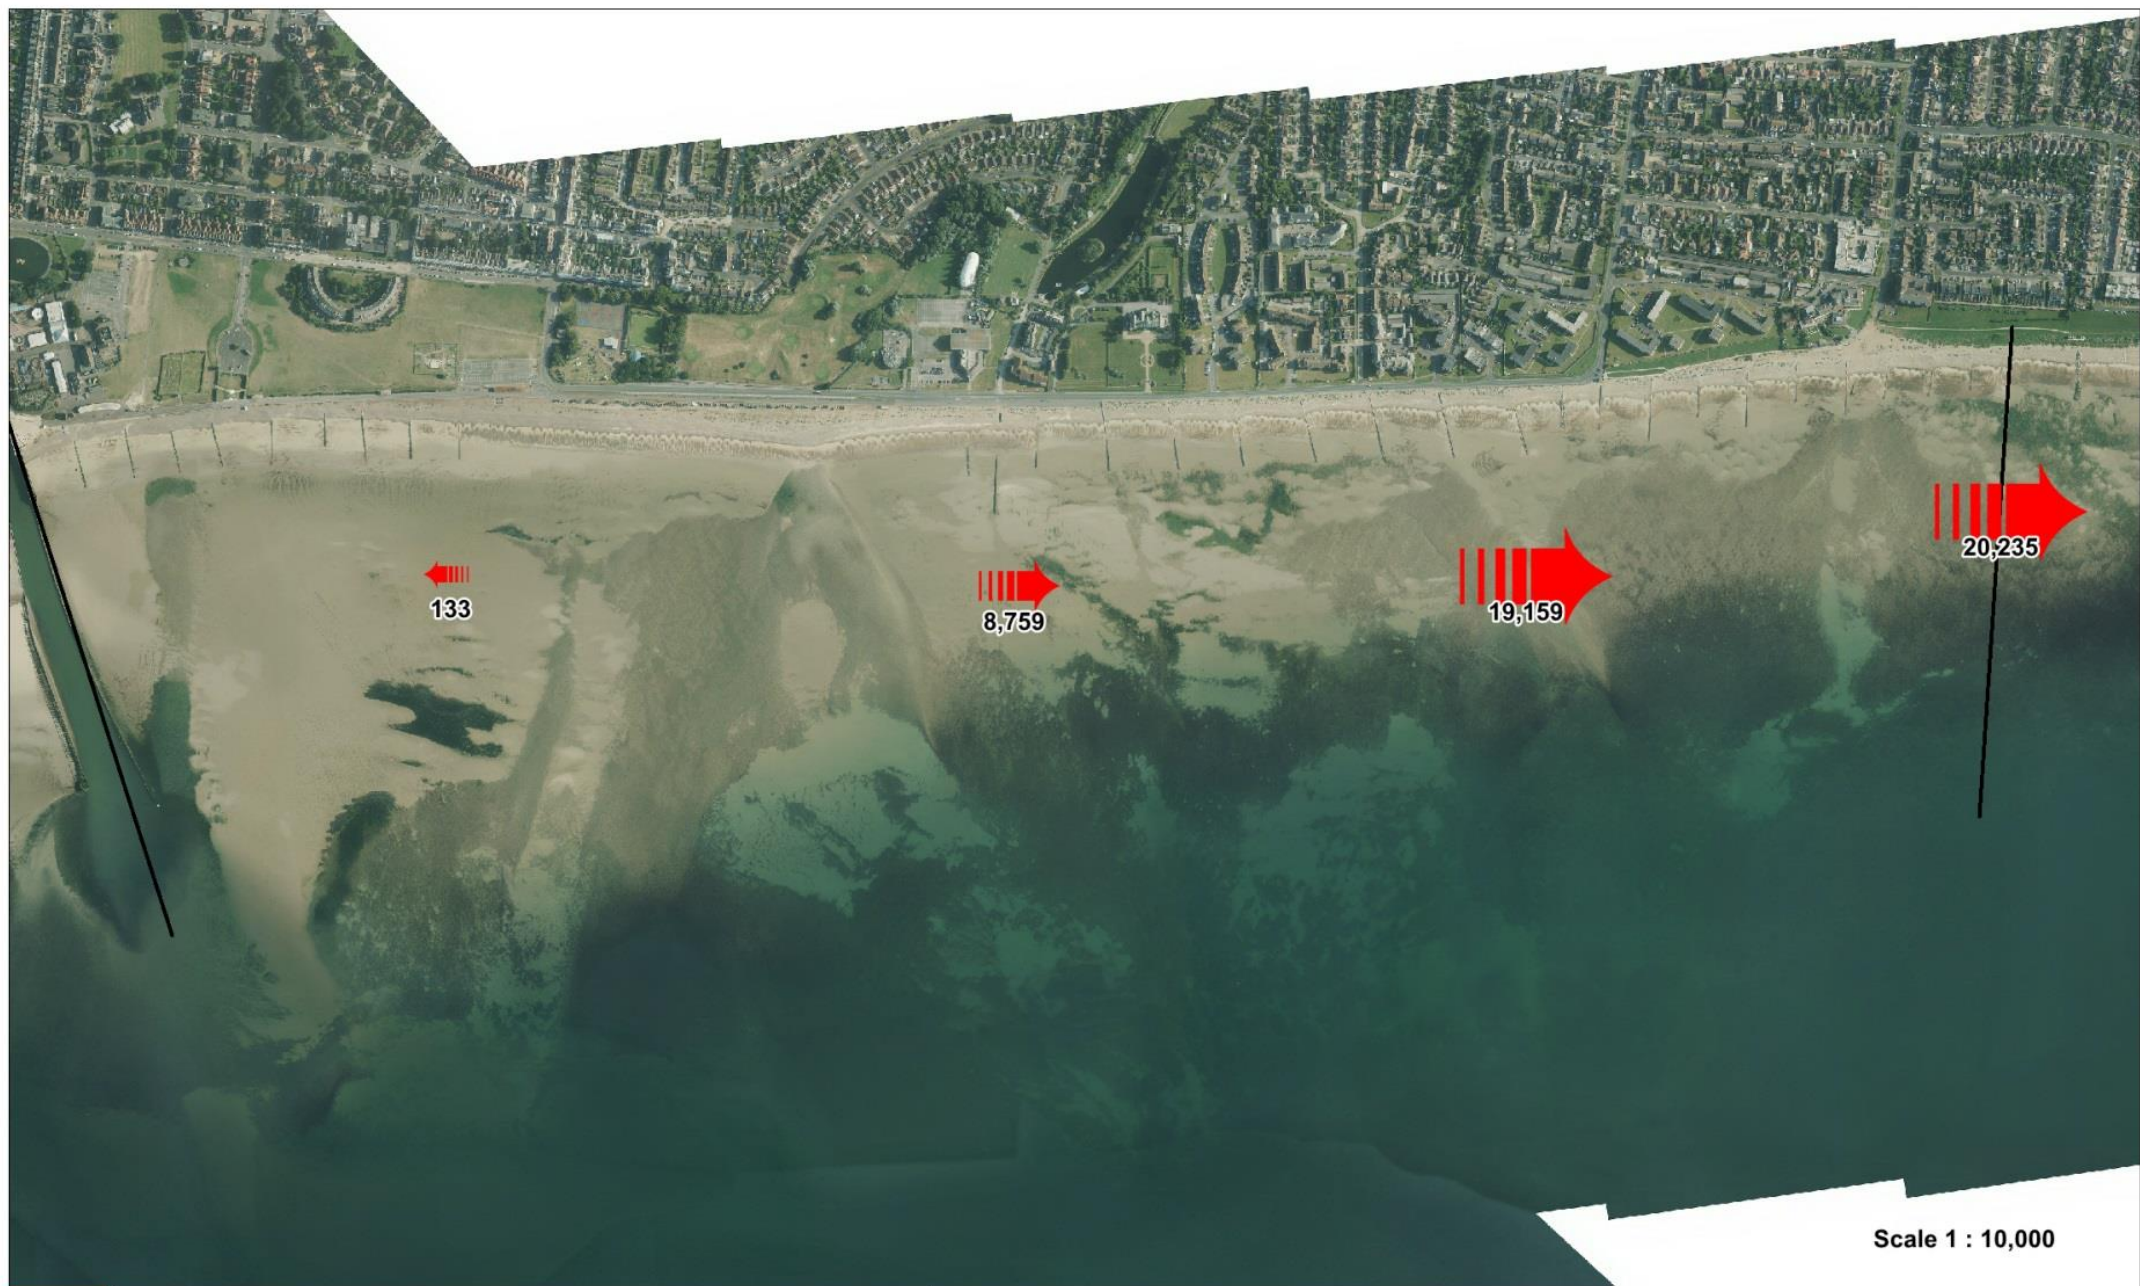
FIGURE 5-3 SEDIMENT TRANSPORT – LITTLEHAMPTON
TO RUSTINGTON

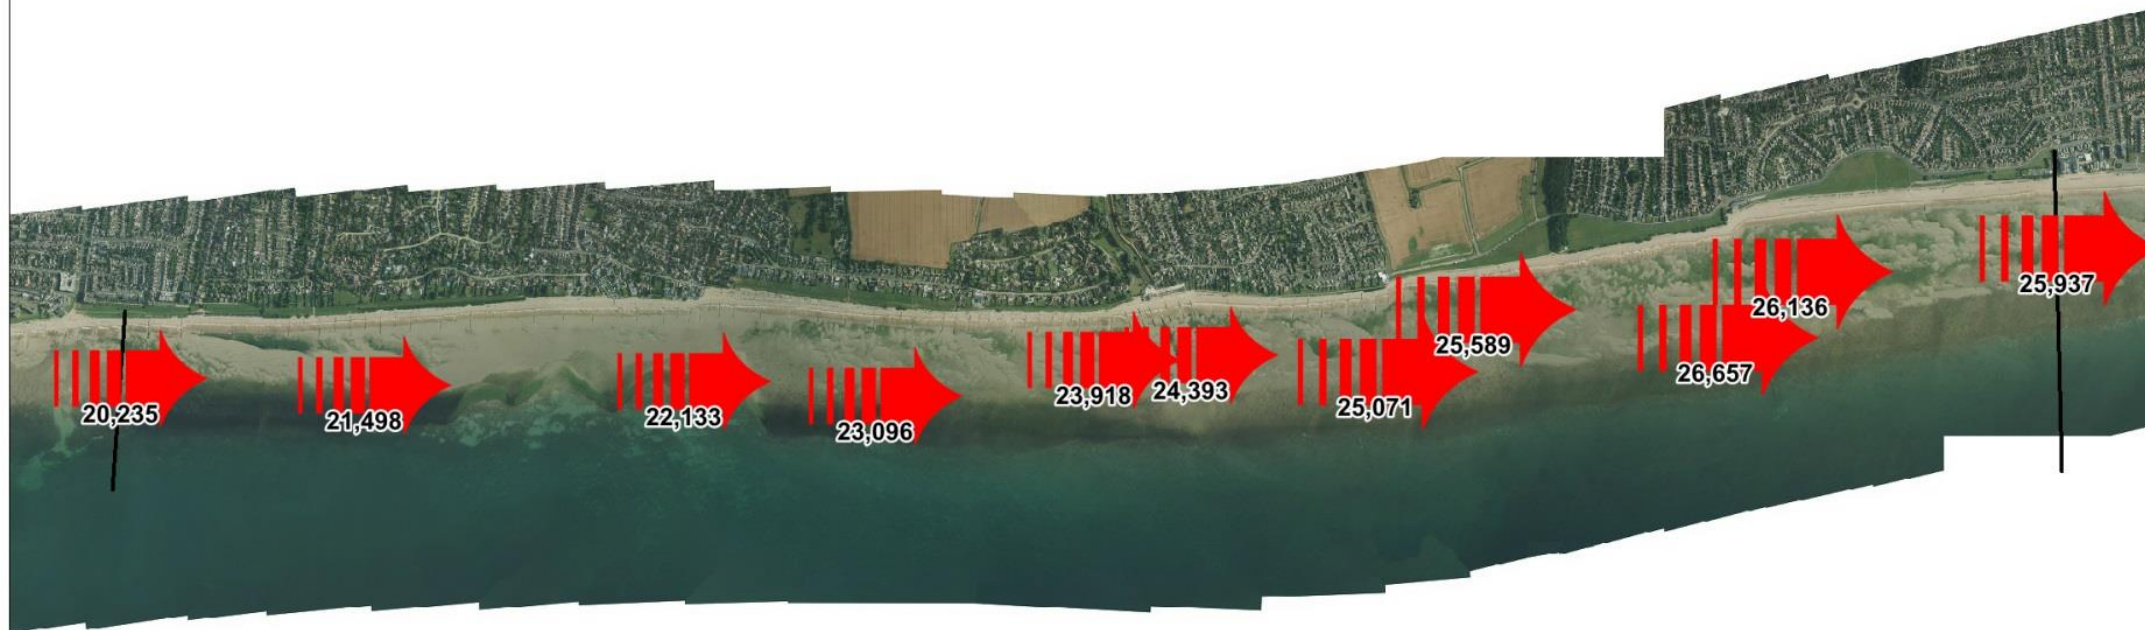
FIGURE 5-4 SEDIMENT TRANSPORT – RUSTINGTON
TO FERRING

Estimated annual sediment transport in cubic meters.

This stretch is a gravel beach with a vegetated backshore and sandy foreshore. The predominant drift direction is west to east and the net transport increases eastwards, progressing from 20,235m³ up to 26,657m³ (Figure 5-4).

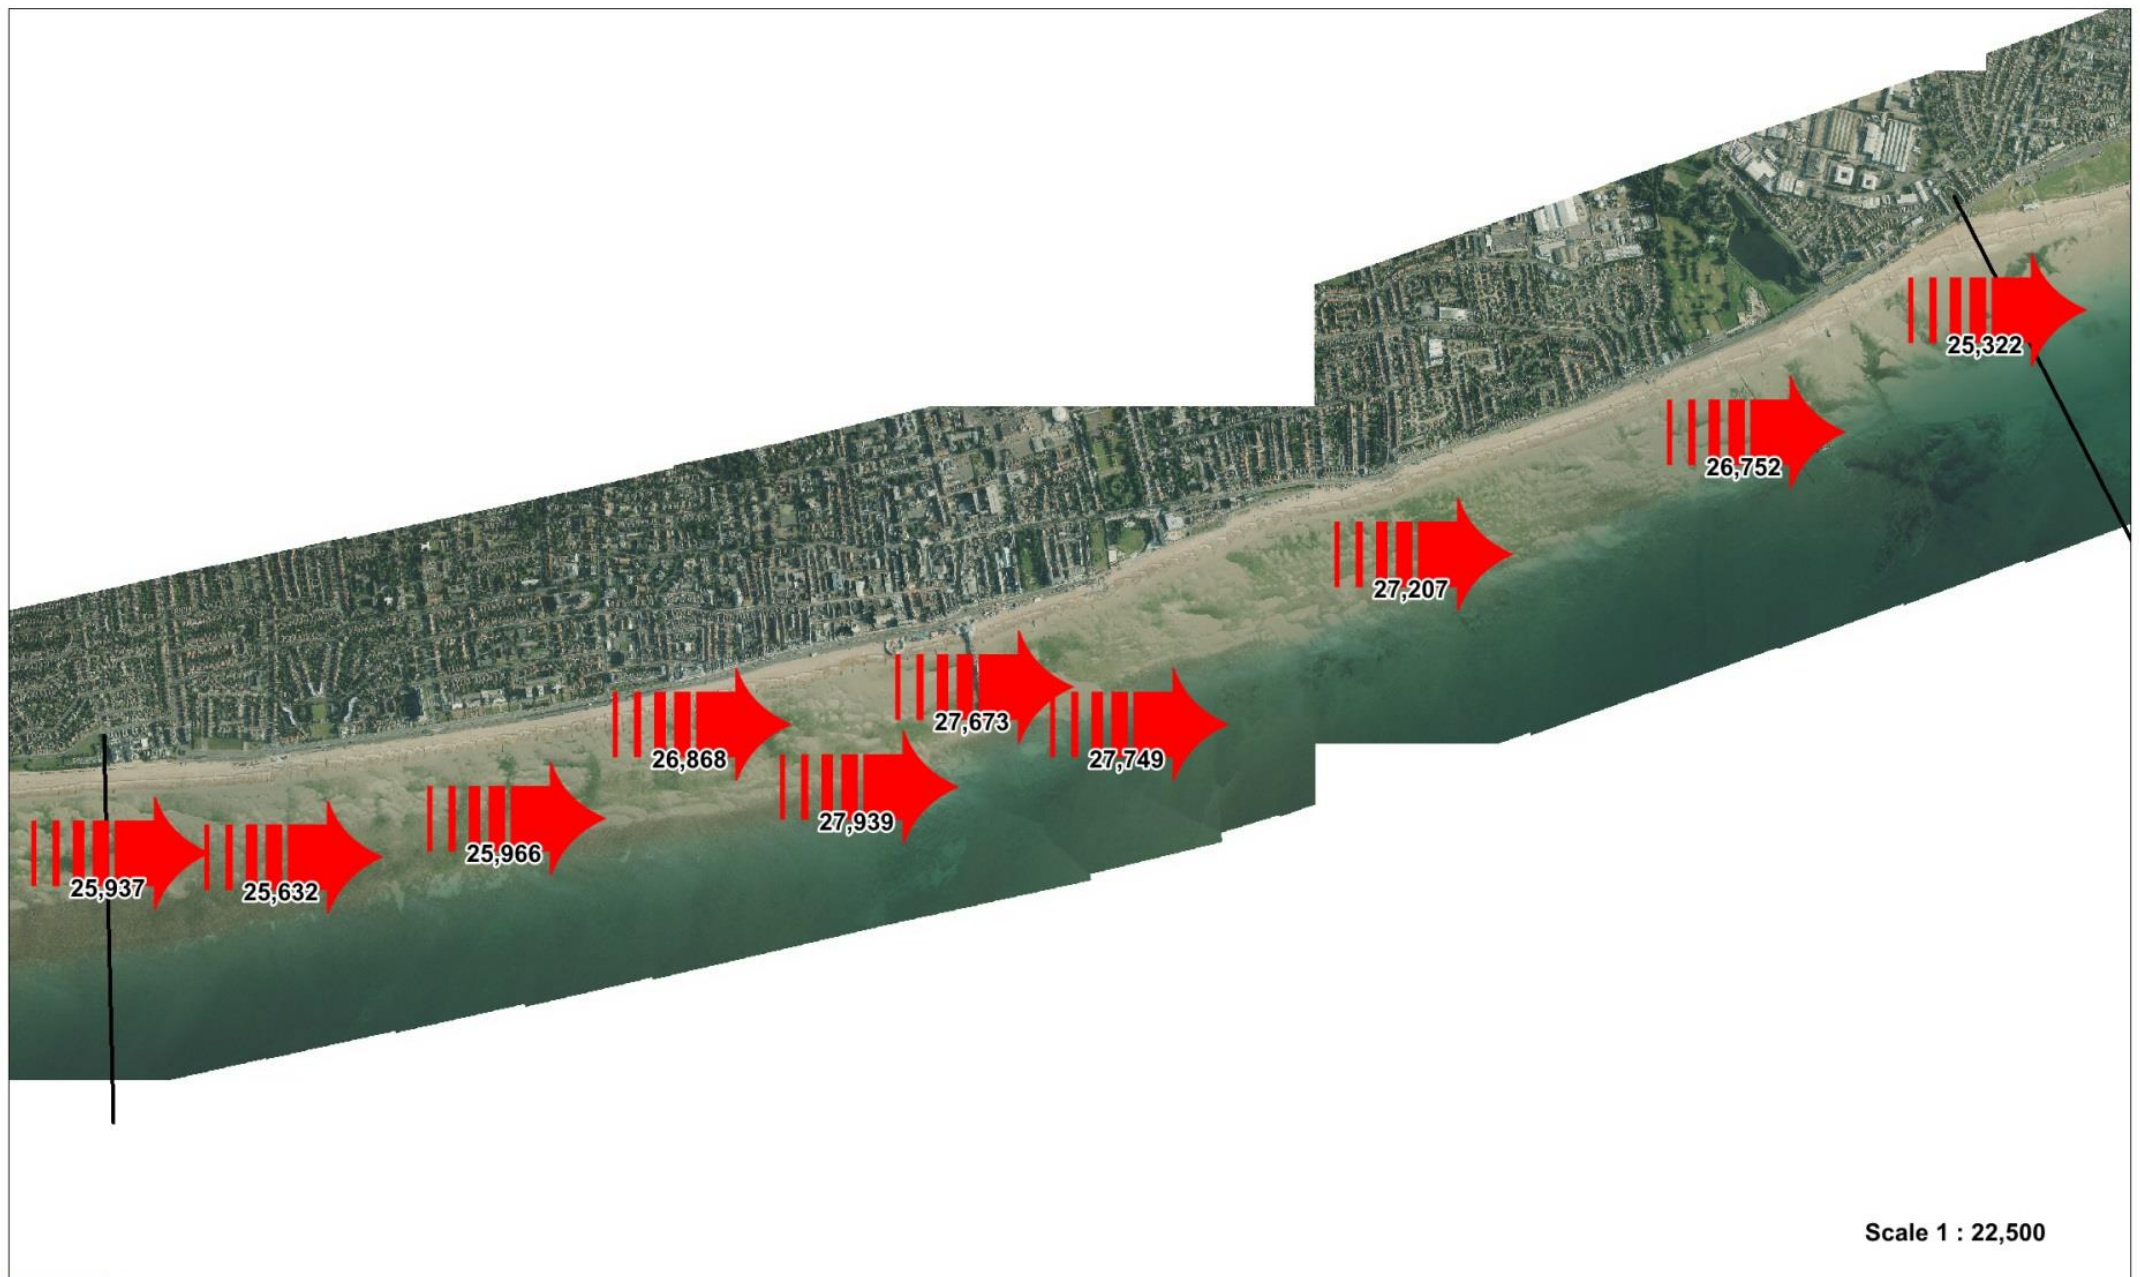
FIGURE 5-5 SEDIMENT TRANSPORT – WORTHING

Estimated annual sediment transport in cubic meters.

Worthing unit is a shingle beach with a sandy foreshore. The predominant drift direction is west to east and net sediment transport increases towards the eastern end of the unit. The transport rates are between 25,322m³ and 27,939m³ (Figure 5-5).

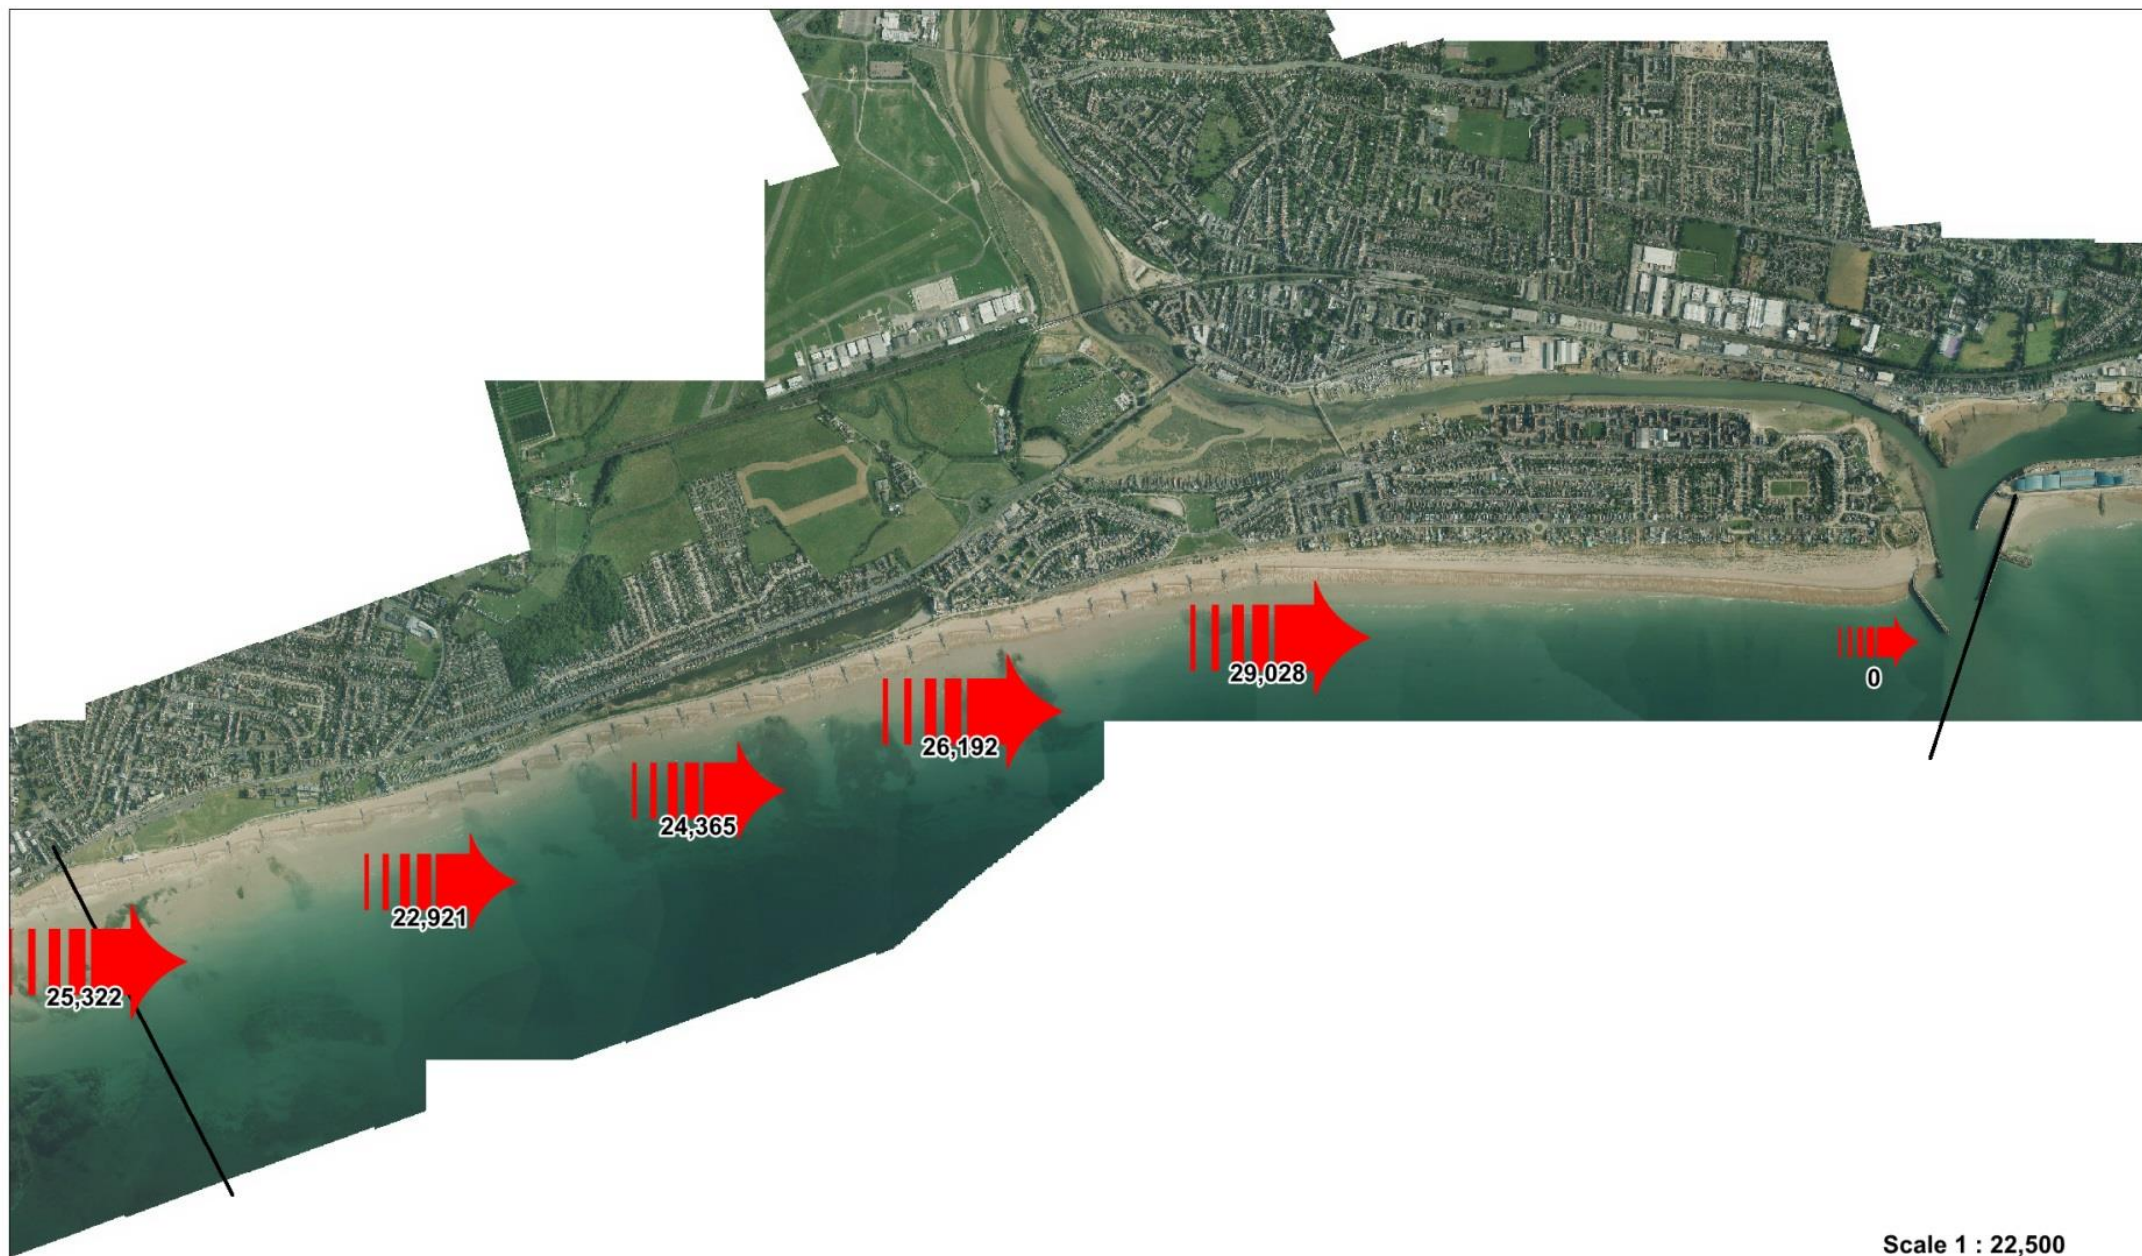
FIGURE 5-6 SEDIMENT TRANSPORT – LANCING

Estimated annual sediment transport in cubic meters.

Lancing is a gravel beach with a sandy foreshore. The predominant drift direction is west to east and sediment transport levels through the unit are high, peaking at just less than 30,000m³ – the highest within the study area (Figure 5-6). Approximately 25,000m³ is transported into Lancing from Worthing per year and as no material naturally bypasses the harbour arm, which acts as a terminal groyne, the unit continues to gain year or year. The total volume graph displays the As Surveyed beach volumes which does not discount the ~13,700m³ bypassed annually around Shoreham Harbour.

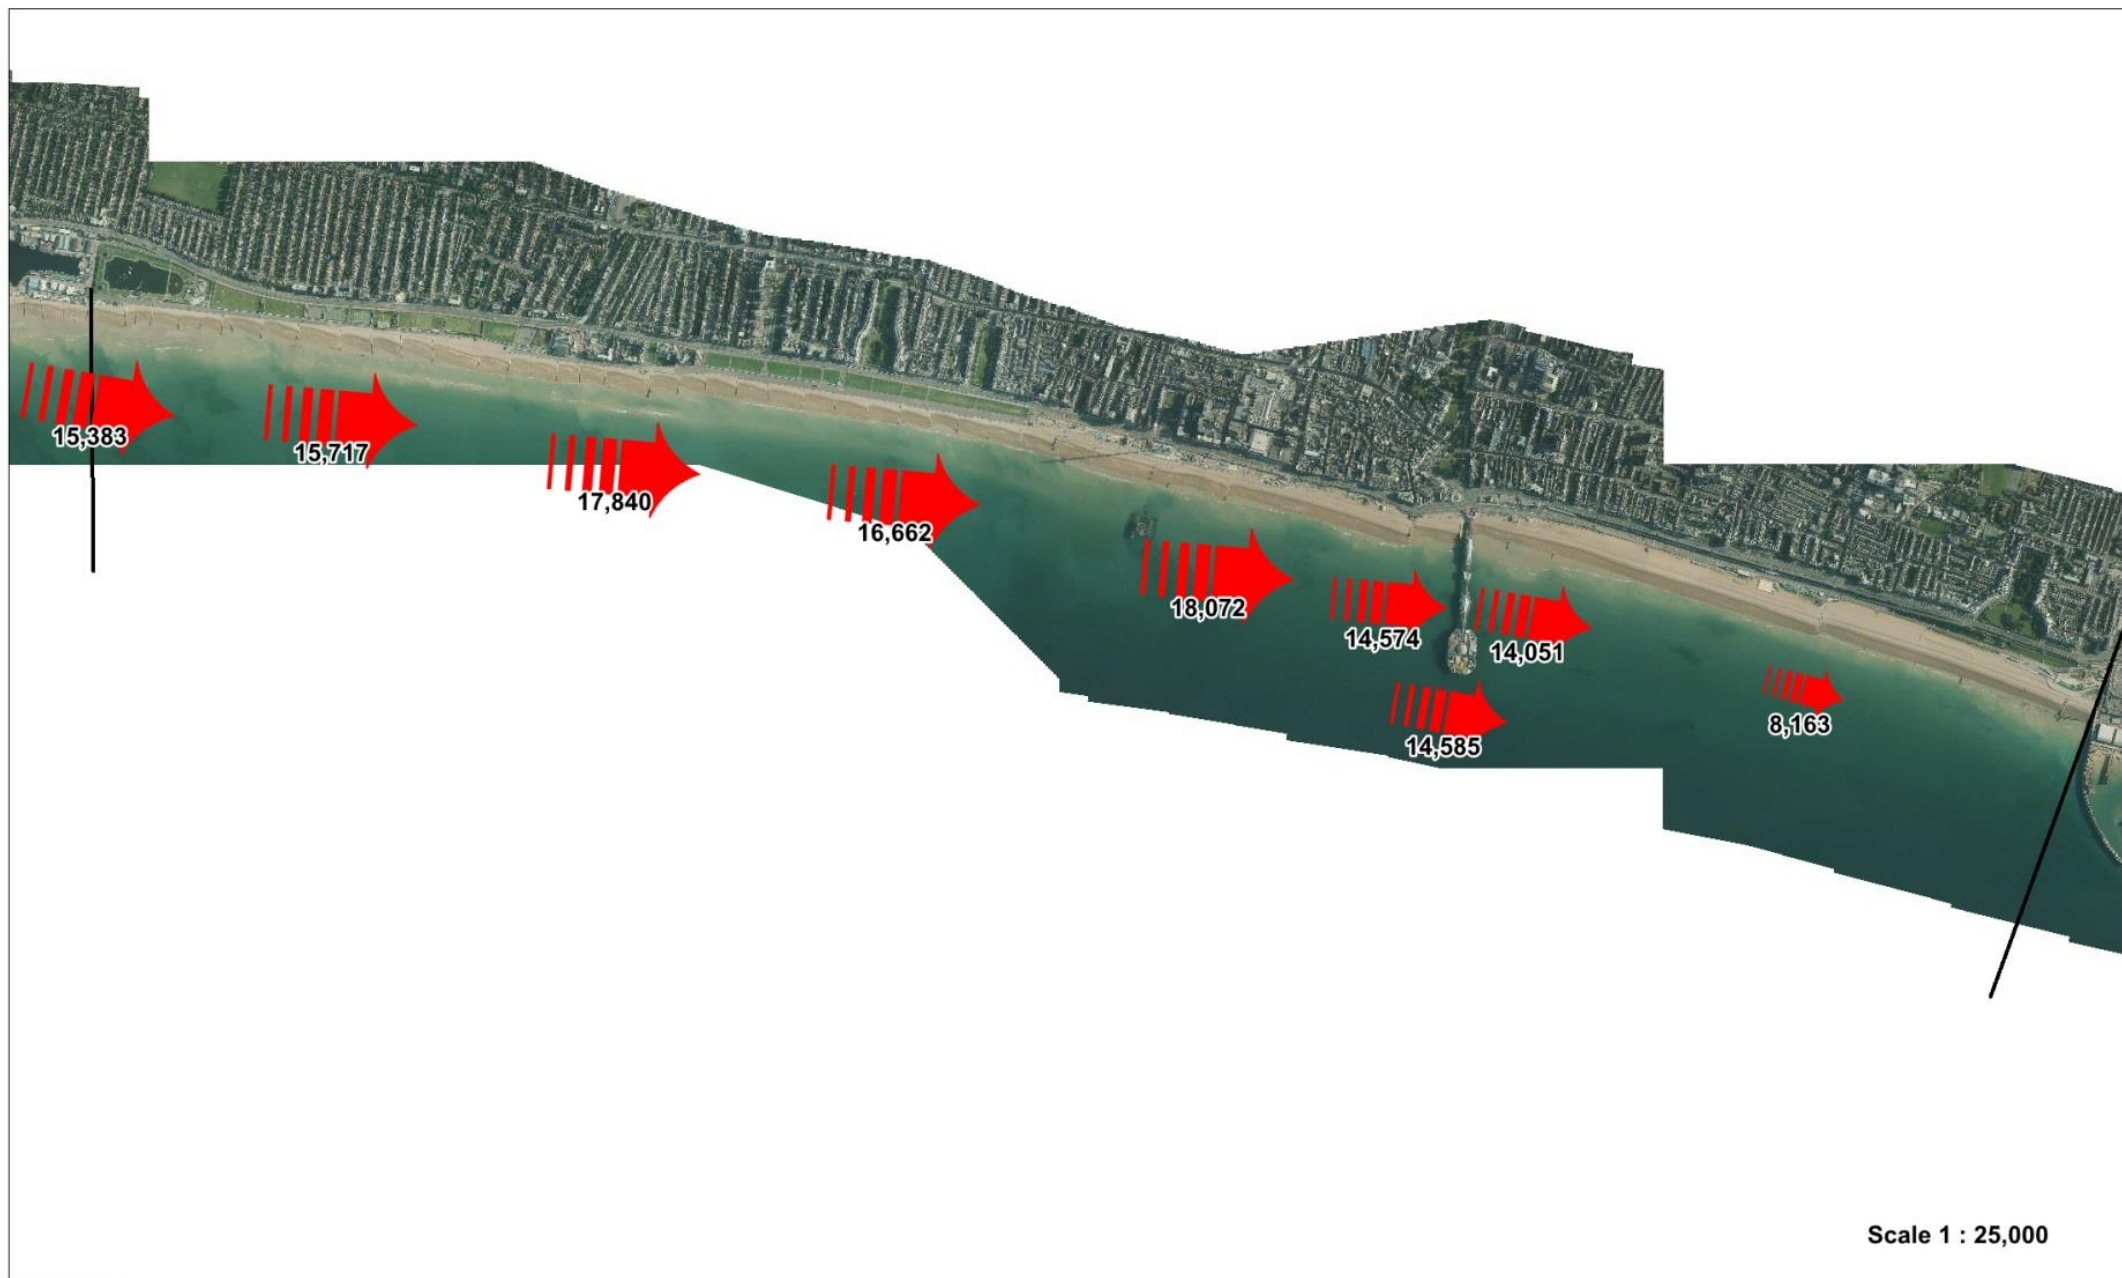
FIGURE 5-8 SEDIMENT TRANSPORT – BRIGHTON

Estimated annual sediment transport in cubic meters.

Brighton is a gravel beach which becomes increasingly coarse towards the east. The predominant drift direction is west to east. Net sediment transport averages around 14,000m³ between the western unit boundary and the Pier (Figure 5-8). East of the pier this value decreases exponentially as material is deposited in front of the Brighton Marina arm. No material bypasses the Marina.

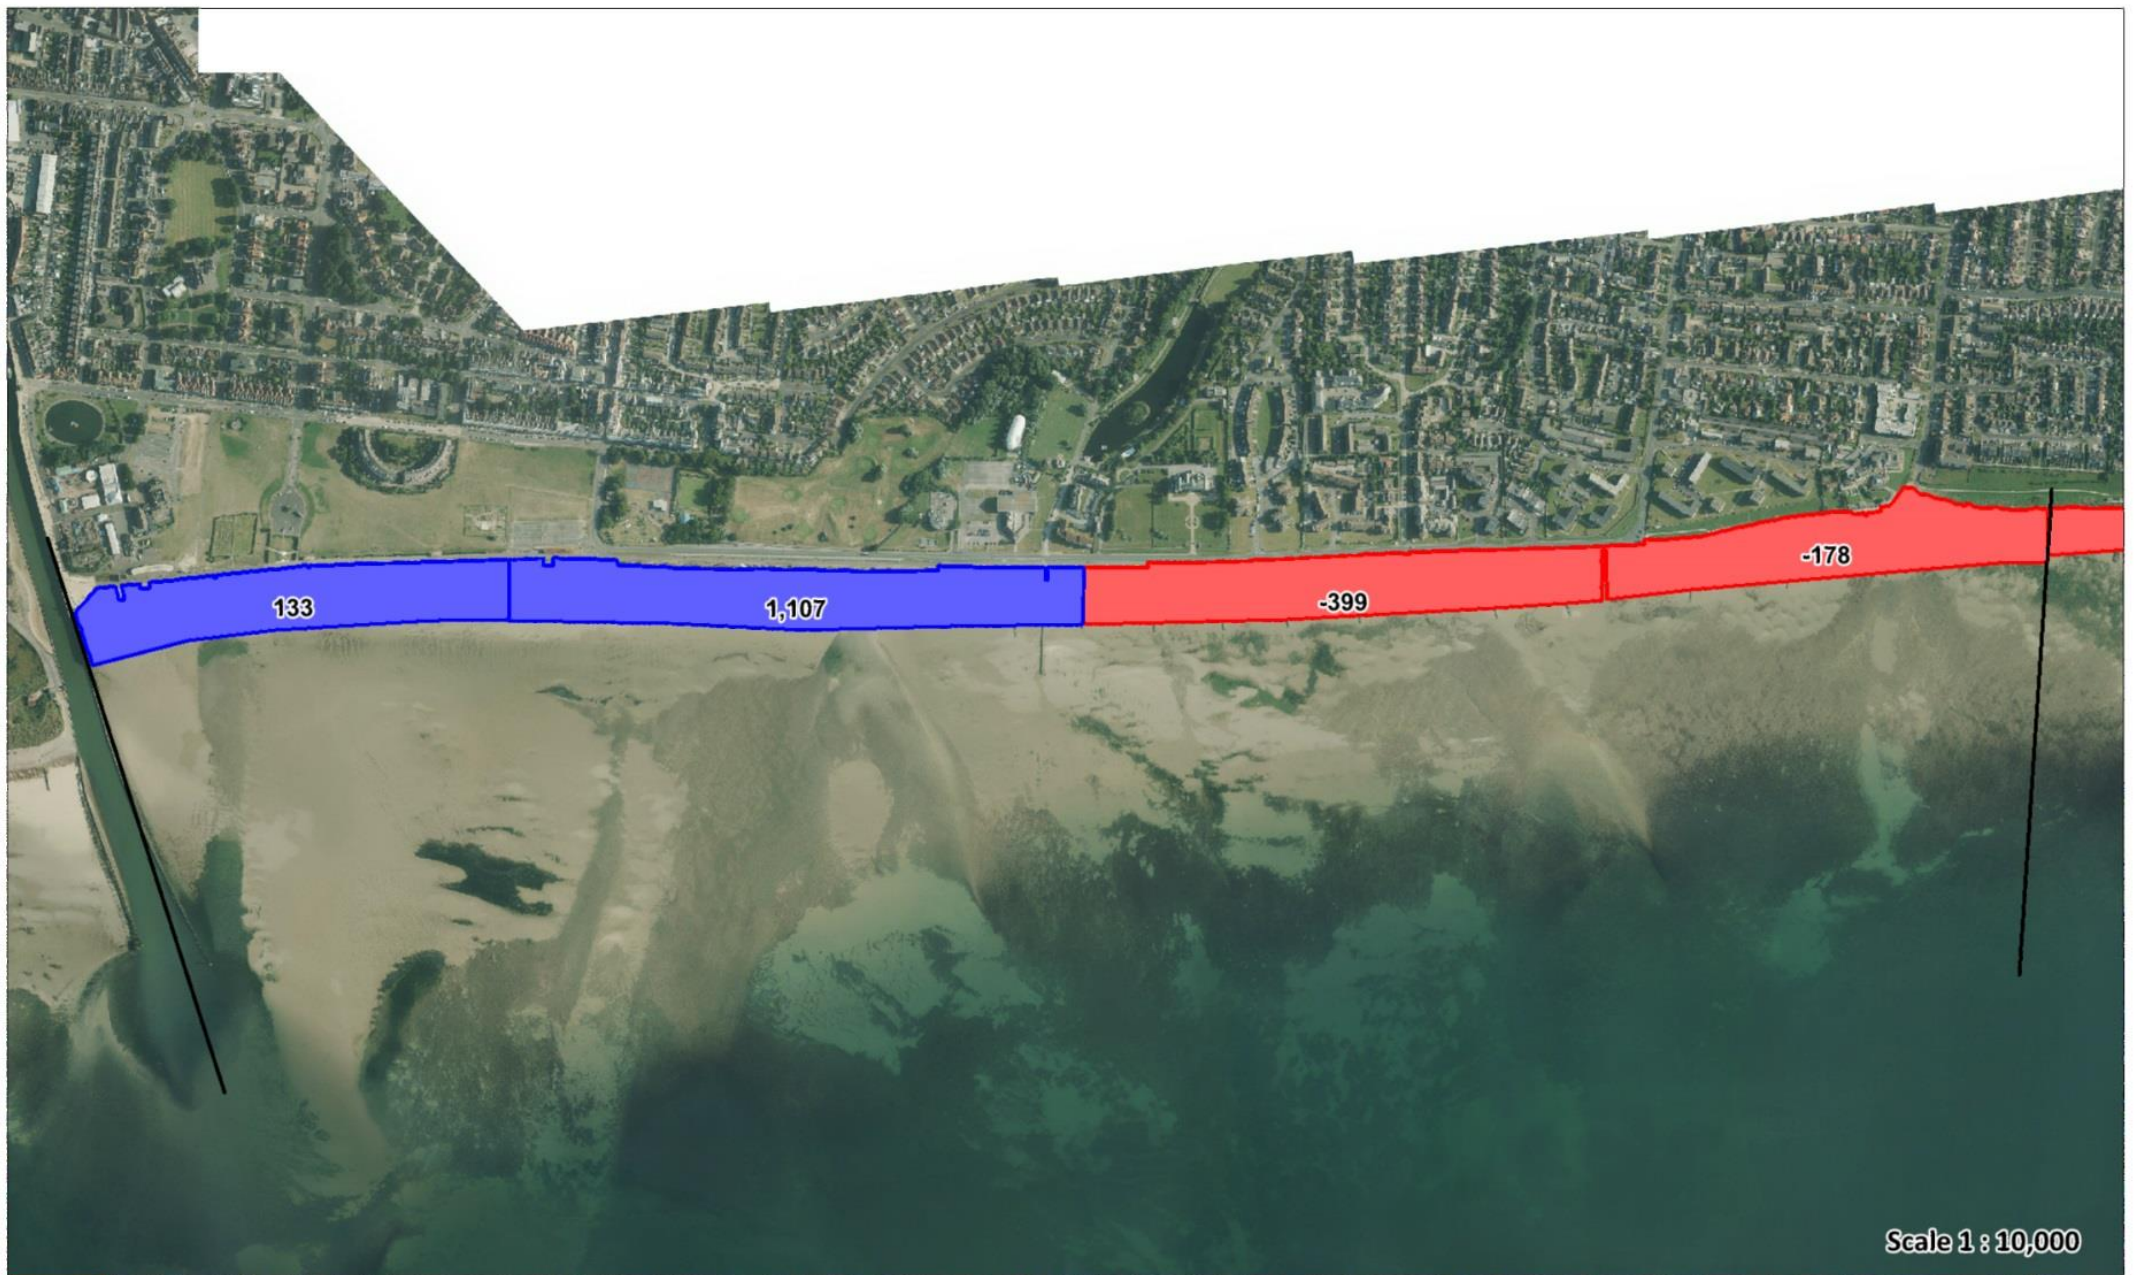
FIGURE 5-9 NET ANNUAL EROSION/ACCRETION – LITTLEHAMPTON TO RUSTINGTON

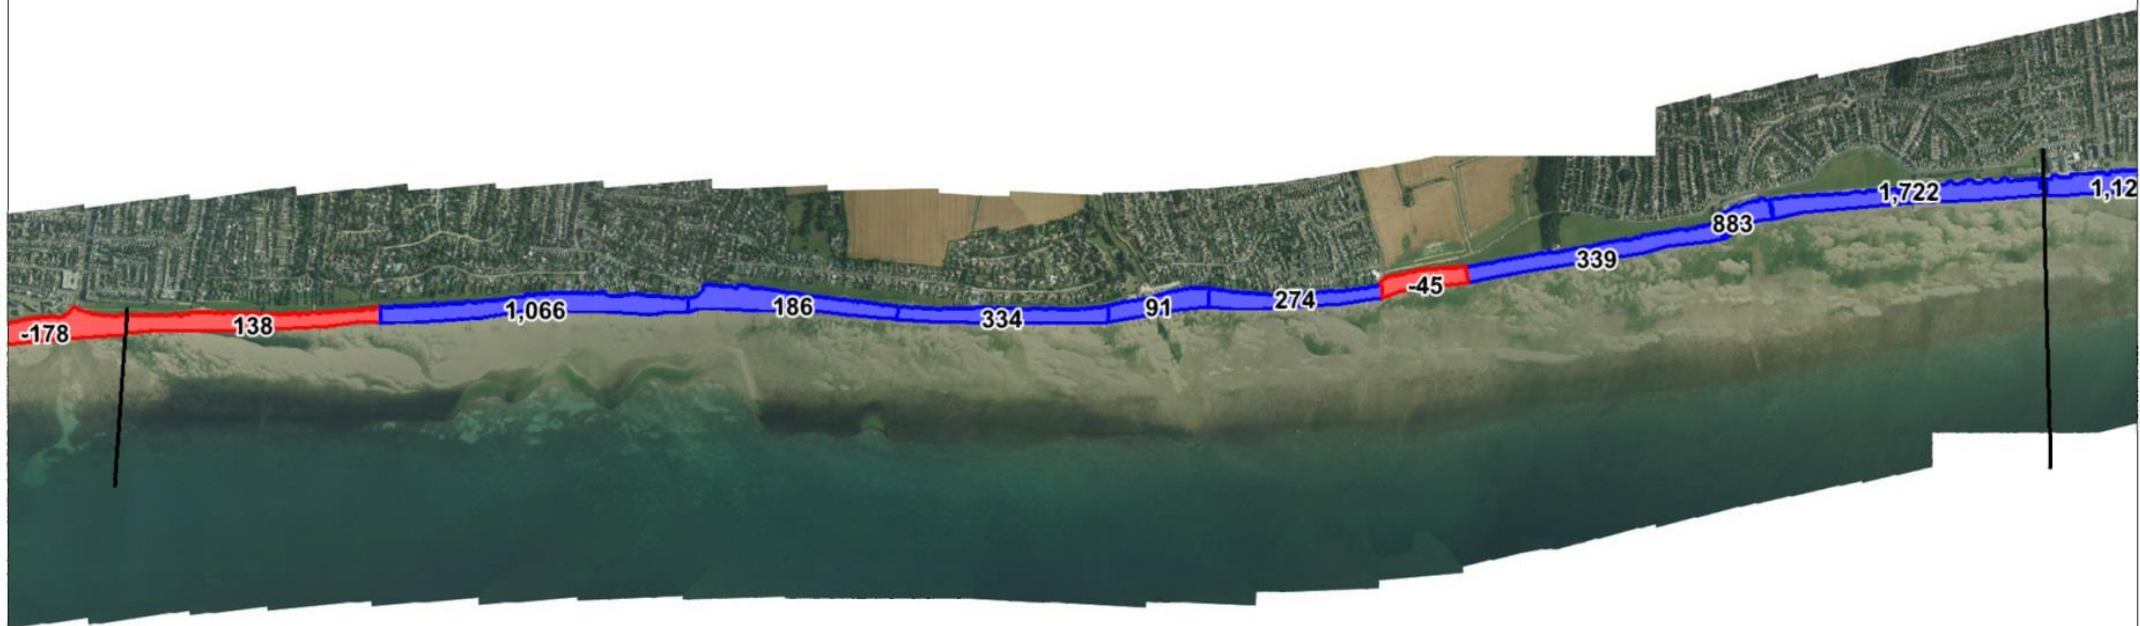
FIGURE 5-10 NET ANNUAL EROSION/ACCRETION –RUSTINGTON TO FERRING

The net annual erosion/accretion (Figure 5-10) illustrates each polygon, bar one, is accretive within the Ferring frontage with a net gain of 4,988m³ per annum. There is no obvious relationship between the length of the unit or the longitudinal distribution to the accretion rates.

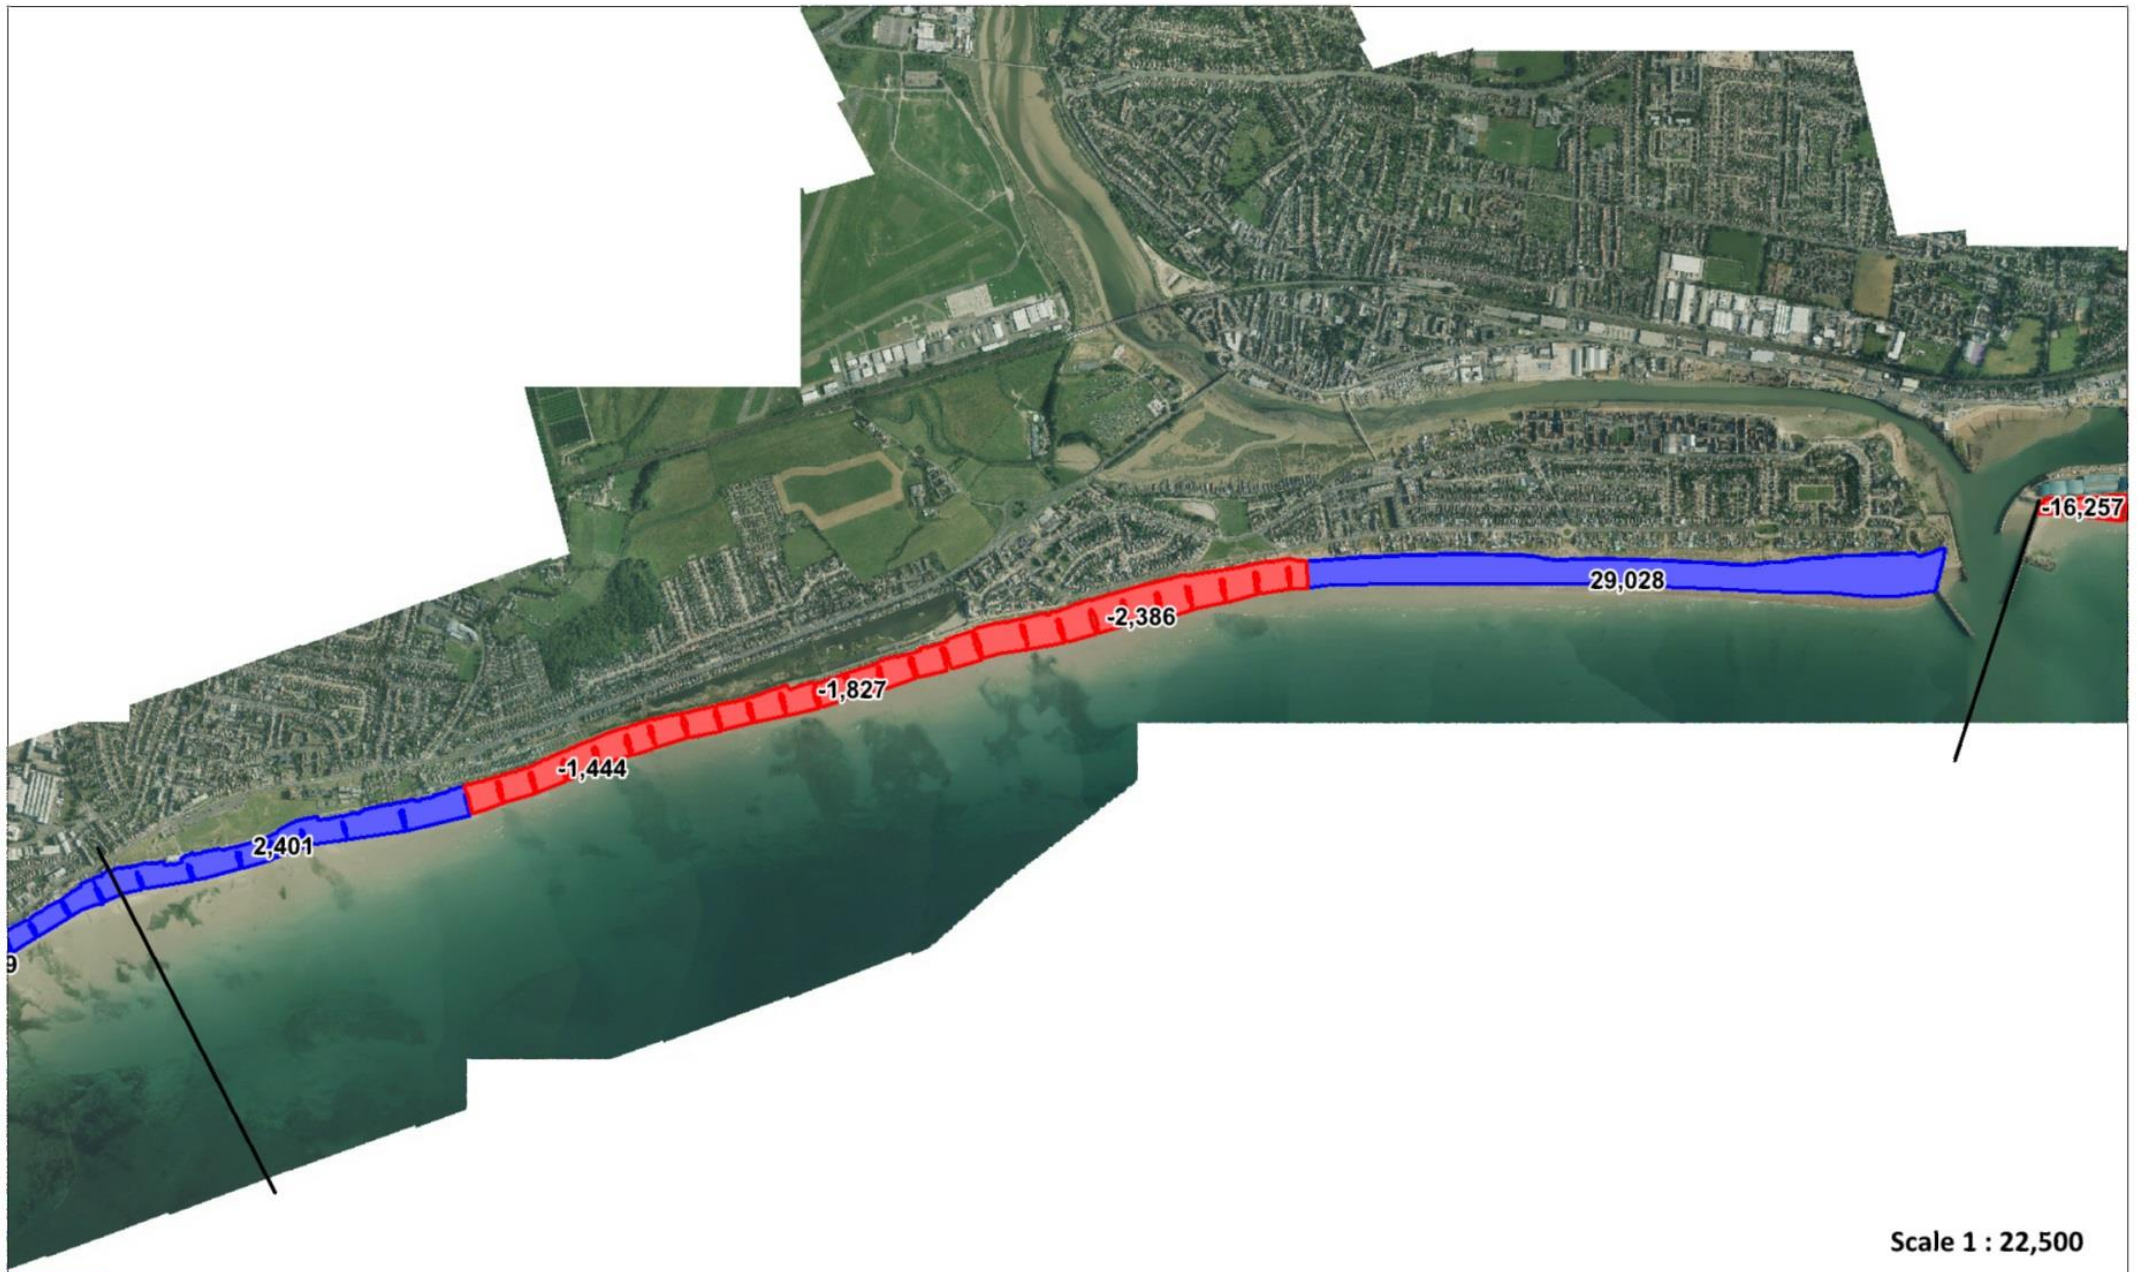
FIGURE 5-12 NET ANNUAL EROSION/ACCRETION - LANCING

The net accretion/erosion rate.

The net annual erosion/accretion shows a clear dichotomy between the erosive western half of the unit and the accretive east. The split between erosion and accretion is positioned to the point where the coastline changes direction. West of this position the beach loses 5,500m³ of sediment a year whilst to the east there is a sediment gain of 29,000m³(Figure 5-12).

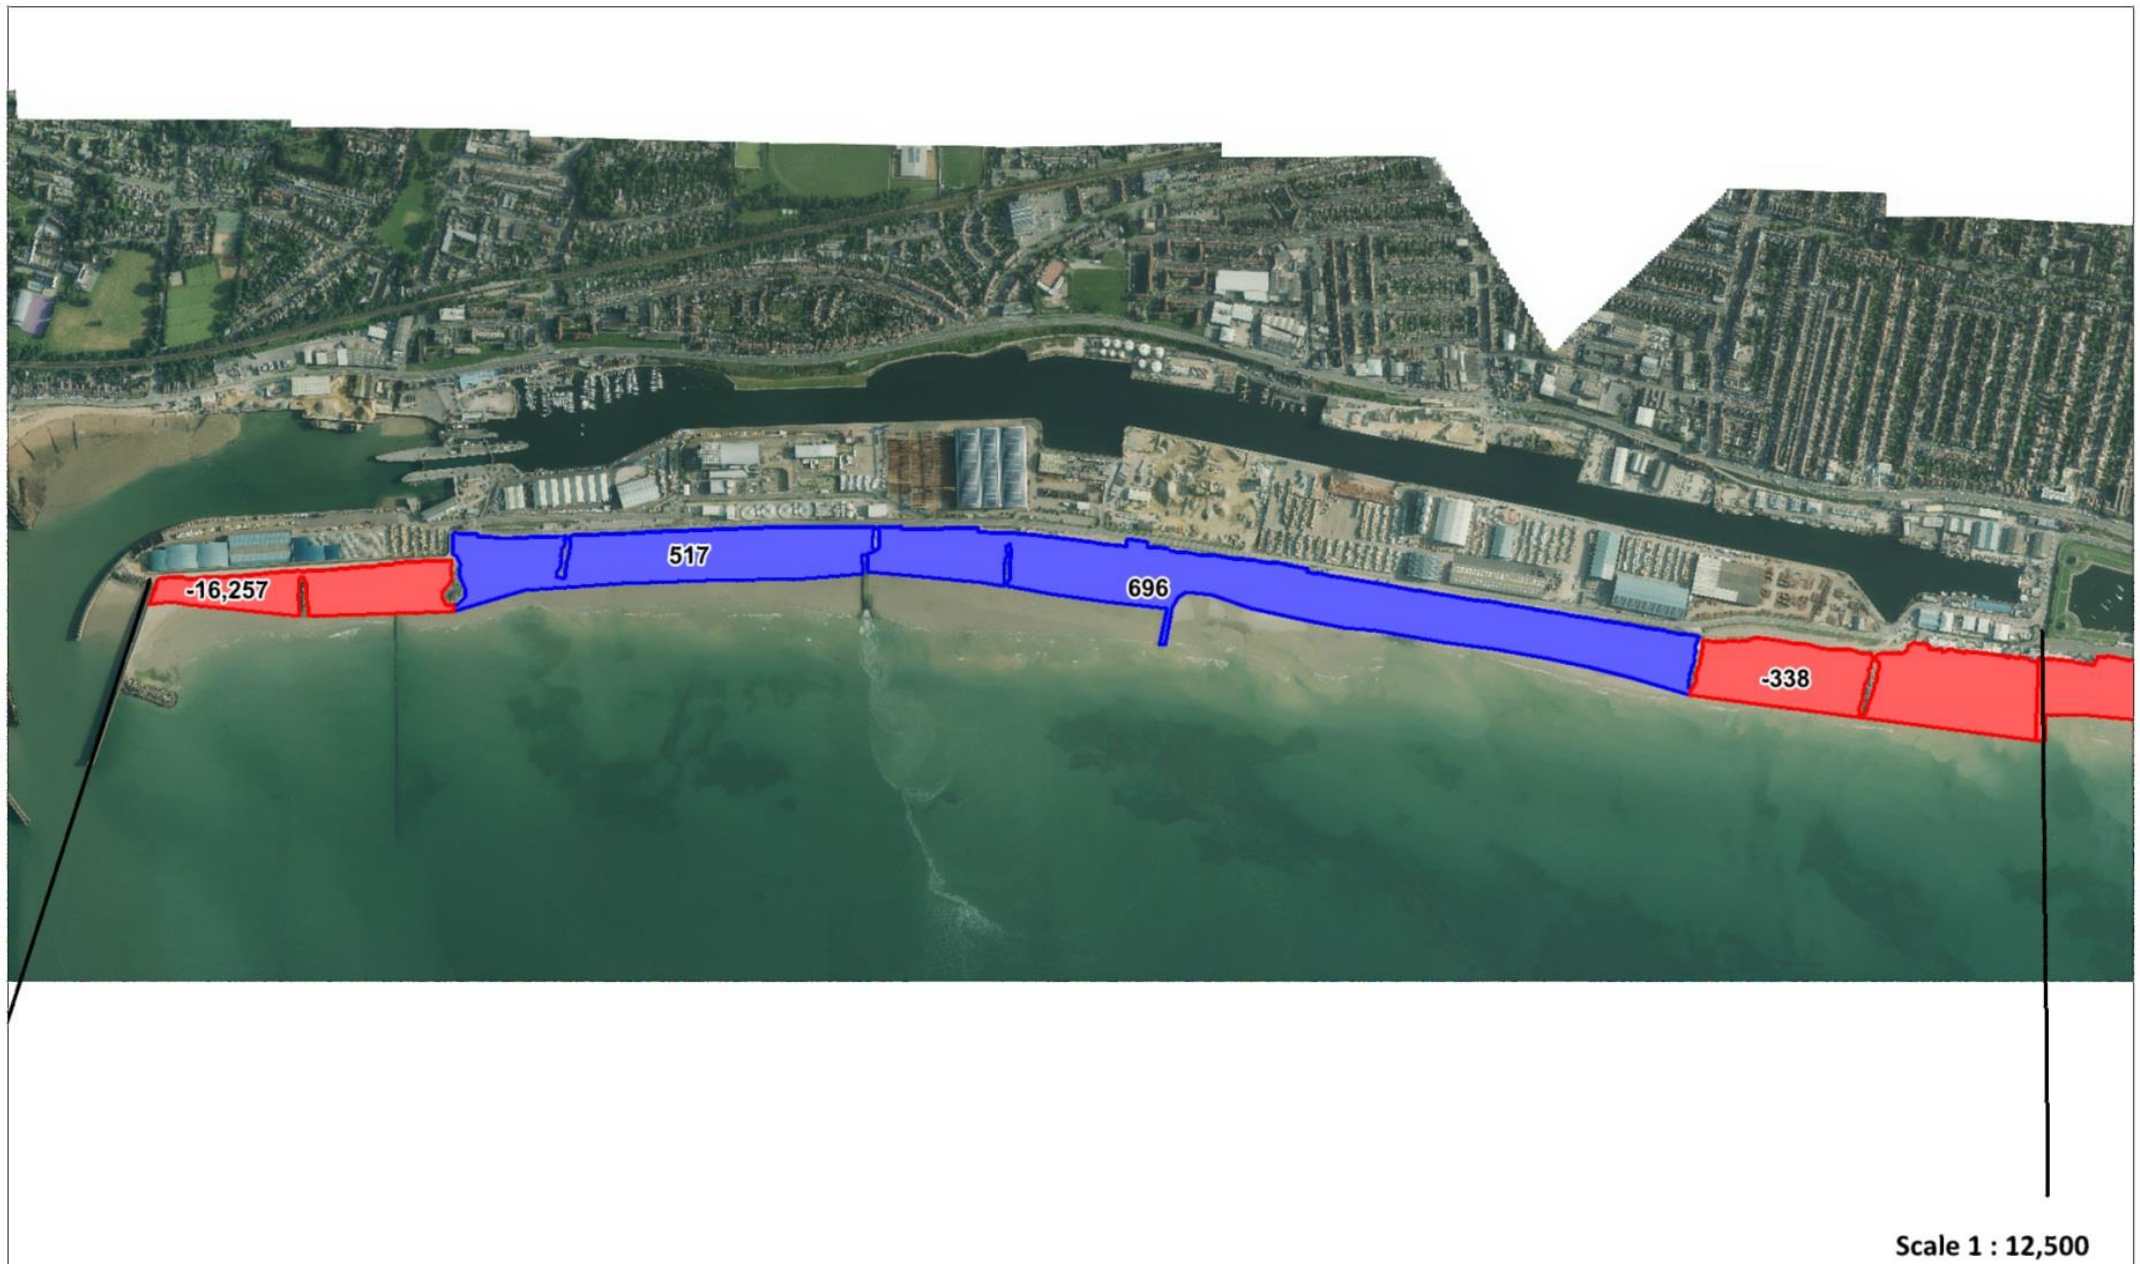
FIGURE 5-13 NET ANNUAL EROSION/ACCRETION - SOUTHWICK

The net accretion/erosion rate.

The net annual erosion/accretion (Figure 5-13) suggests the western most polygon is losing the highest volume of material at $16,257\text{m}^3$ per year. This is due to the position of the sea wall, which is fixed seaward of the point required to allow beach material to be accommodated. The losses in the adjacent polygon are demonstrating small gains of $500\text{--}700\text{m}^3$ as they are directly benefitting from the replenishment up drift.
