Regional Beach Management Plan 2017: Littlehampton to Brighton Marina

Report – ENVIMSE100035/R-01

Final Report, July 2017

Main Report

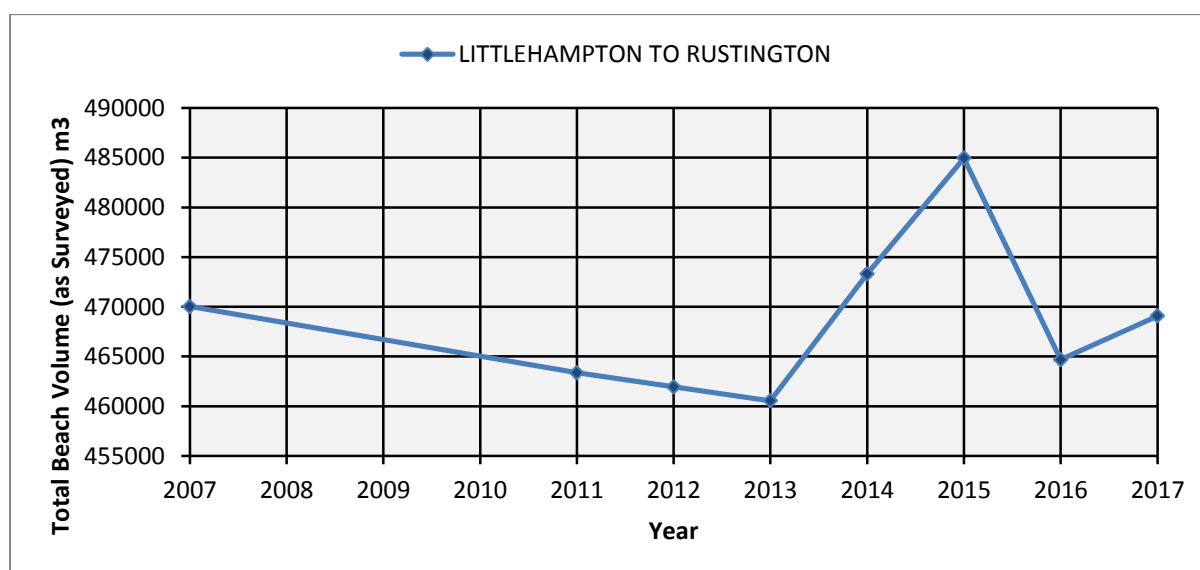
FIGURE 5-15 TOTAL BEACH VOLUME CHANGE BETWEEN 2007 – 2017 IN LITTLEHAMPTON TO RUSTINGTON.

The Total Beach Volume graph, (Figure 5-15) demonstrates that between 2007 and 2013 Rustington had been losing material at a steady rate (approximately 1,500m³ per year), as this volume was interpolated from the two grids, 2007 and 2011. As the years progress the units were surveyed each year and show more varied changes, followed by a gain in 2014 and 2015. A larger loss in 2016 reduced the beach volume to its 2010 position which then gained in 2017. The total volume shows a negligible loss of -956m³ between 2007 and 2017, which differs slightly from the sediment budget (+663m³) because it has considered every dataset since 2007 whereas the sediment budget uses 2007 and 2017 and analyses the trends between only these years. These volumes are deemed negligible and this unit is considered relatively stable.

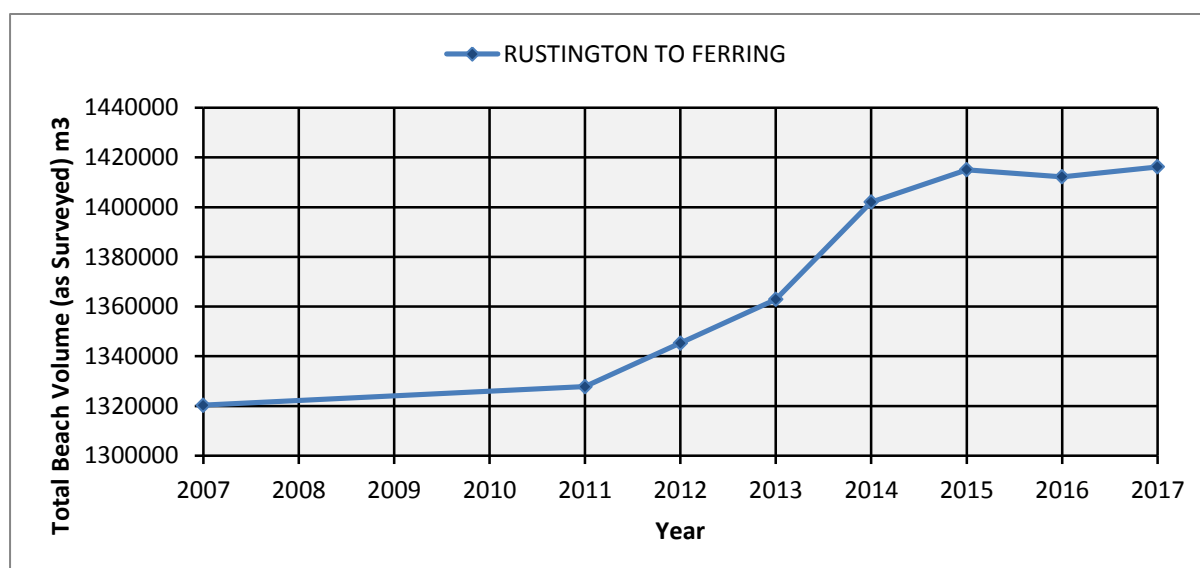
FIGURE 5-16 TOTAL BEACH VOLUME CHANGE BETWEEN 2007 – 2017 IN RUSTINGTON TO FERRING.

The Total Beach Volume graph shows that, between 2007 and 2012, the beach had been gaining material steadily, approximately 3,000m³ per year (Figure 5-16). During 2013 and 2014 the beach gained material at a higher rate and has seemingly plateaued since 2015.

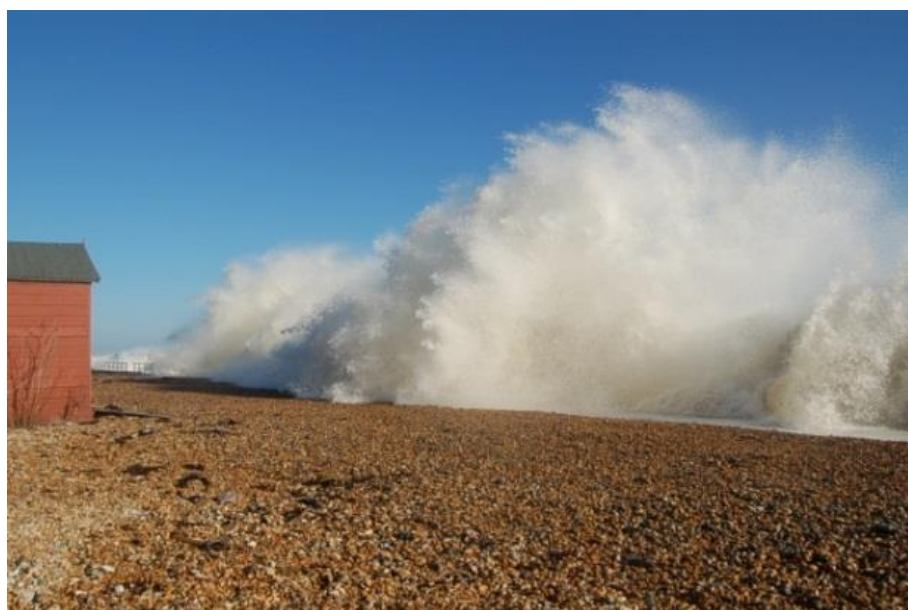
FIGURE 6-2-1 DISSIPATION OF WAVE ENERGY ON A SHINGLE BEACH (KINGSDOWN, 2009)

Shingle beaches are very efficient at dissipating wave energy (Figure 6-2-1). To calculate overtopping rates under different scenarios a methodology was developed and applied consistently to the whole frontage. This is summarised in Figure 6-2-2 and described in the following text.

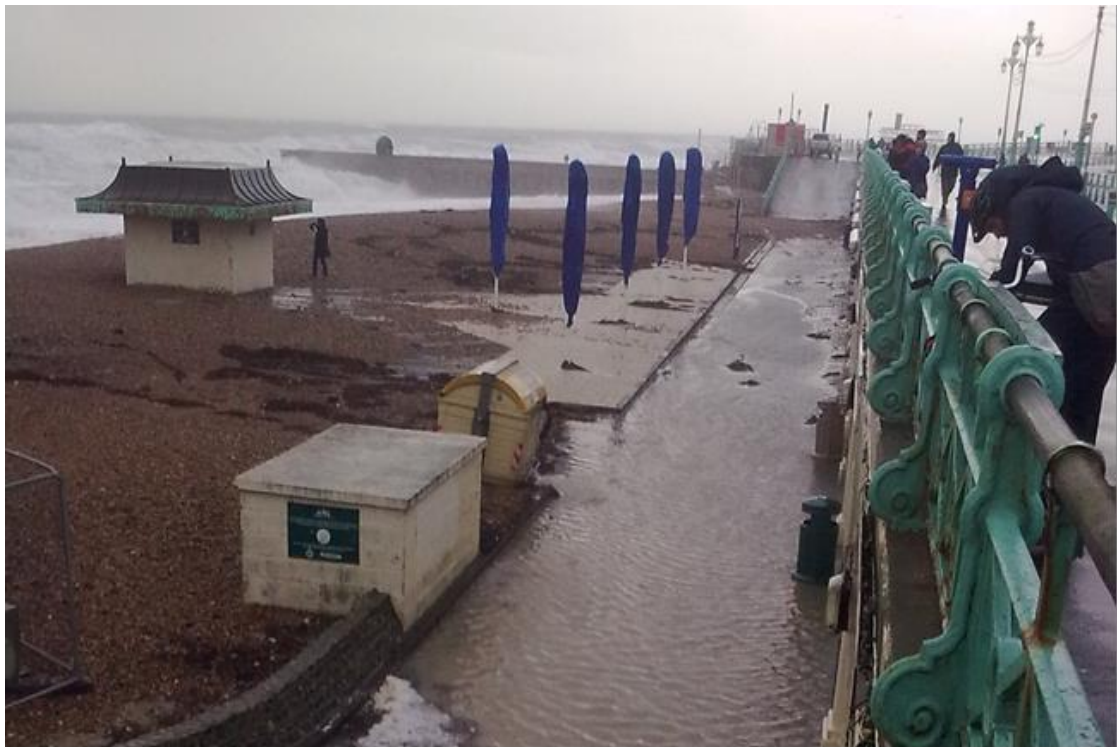
FIGURE 6-2-7 WAVE OVERTOPPING, BRIGHTON (FEBRUARY, 2016)

1. Photographic evidence of large overtopping events and retrospective comparison with predicted overtopping (e.g. Figure 6-2-7).

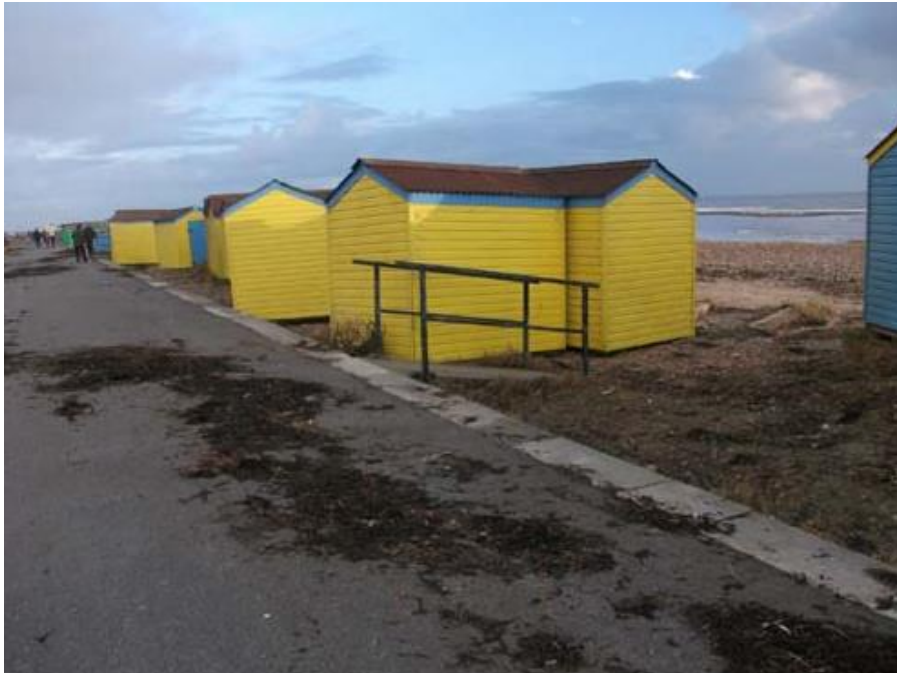
FIGURE 6-2-8 EVIDENCE OF OVERTOPPING ON TO THE PROMENADE, LITTLEHAMPTON (2014)

2. Anecdotal evidence in the form of information that is not well documented or photographed. The prime example of this is shingle on the promenade, which is indicative of small scale overtopping (e.g. Figure 6-2-8). Where management authorities have to periodically clear this it is evident that the defence is subject to minor overtopping on a regular basis. Results can be queried to ensure these events are predicted.

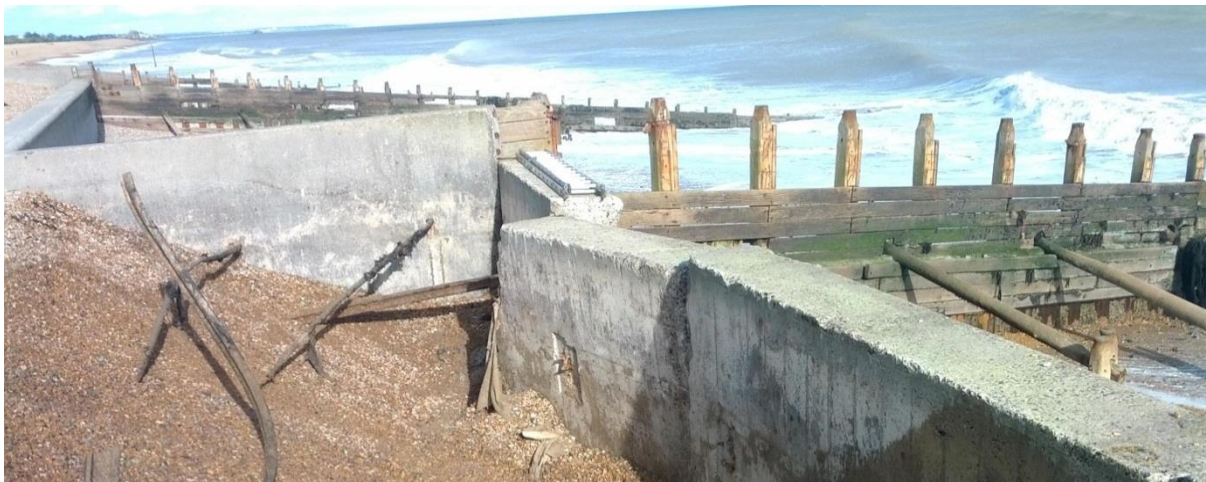
FIGURE 6-2-11 DILAPIDATED GROYNES, LOW BEACH AND SEAWALL FAILURE AT KINGSOWN (2013)

As beach levels lower due to erosion, draw down in a storm, or failure of groynes that act as controlling structures the seawall becomes increasingly exposed to direct wave attack. In addition to a probable increase in overtopping rates, this significantly increases the risk of seawall failure.

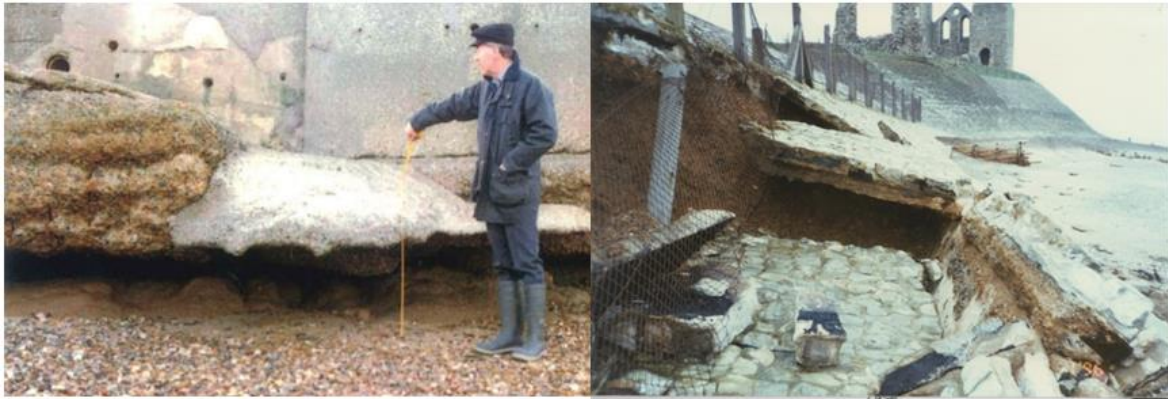
FIGURE 6-2-12 EXAMPLES OF UNDERMINING AT TANKERTON (LEFT) AND RECVLVER (RIGHT)
(BOTH PHOTOS 1999)

Typically, before beach levels get low enough to pose a credible threat to the structure the standard of protection has already become sub-standard due to the increased likelihood and severity of overtopping. There are instances where the structure itself provides a sufficient barrier to overtopping, but often in these cases a beach is required to be maintained in order to protect the structure and prevent undermining.

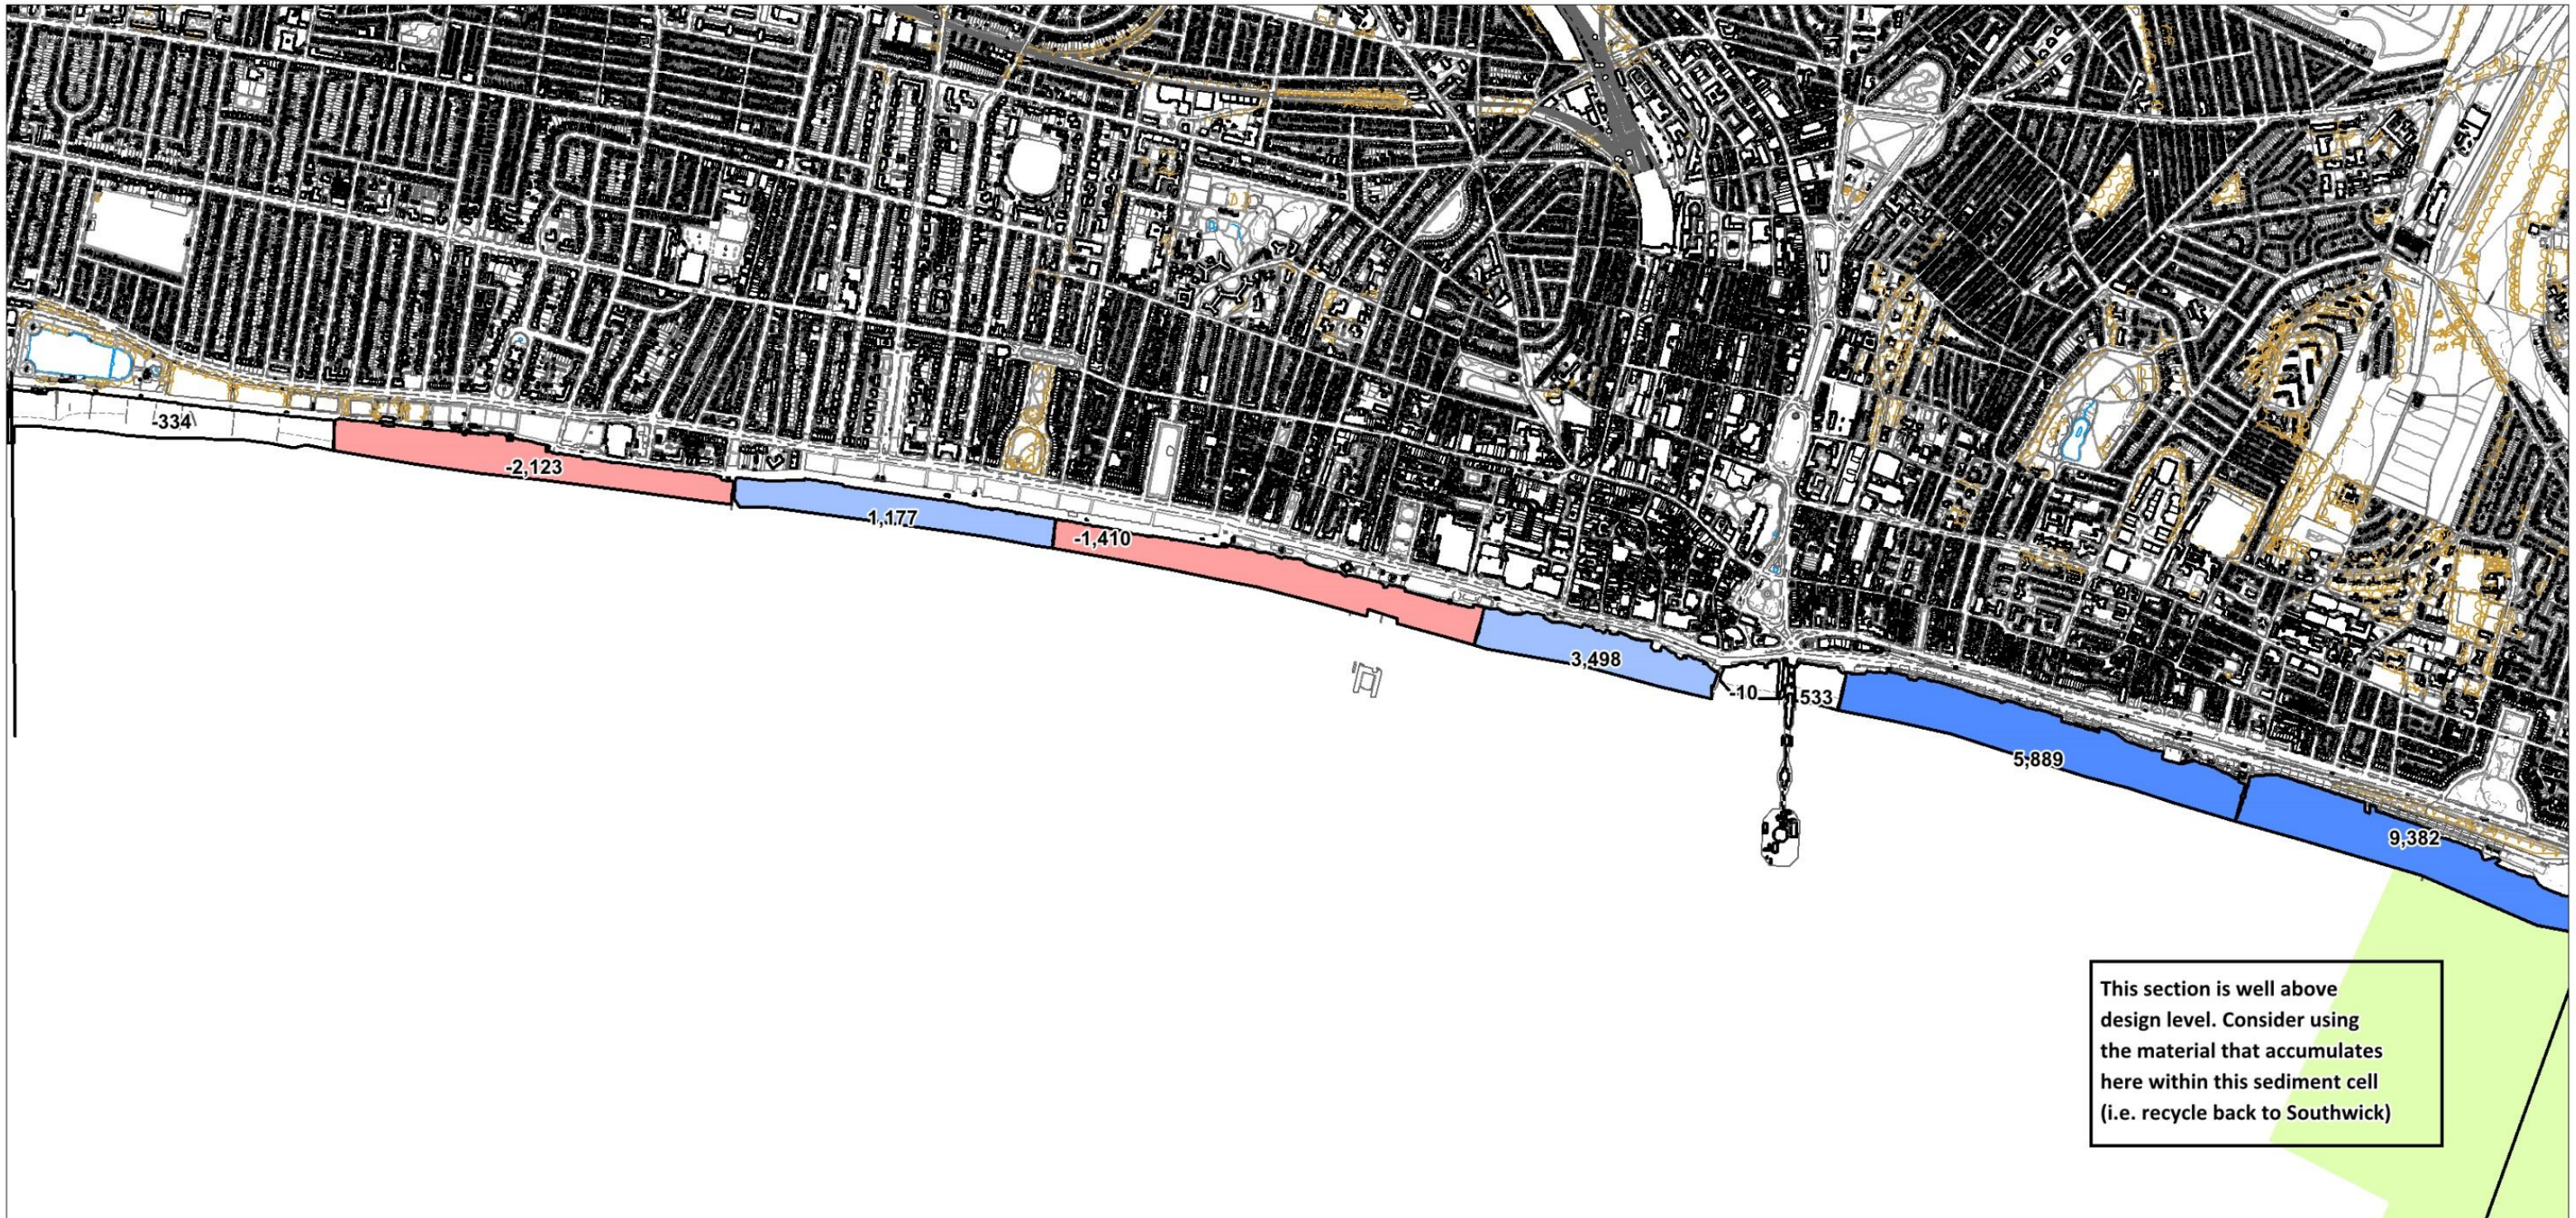
FIGURE 8-6 SUMMARY OF SEDIMENT BUDGET TRANSPORT RATES, ENVIRONMENTAL RESTRICTIONS AND RECOMMENDED MANAGEMENT ALONG THE BRIGHTON FRONTAGE
