Regional Beach Management Plan 2015: Graveney to Northern Sea Wall

Report – ENVIMSE100035/R-01

Final Report, February 2017

Main Report

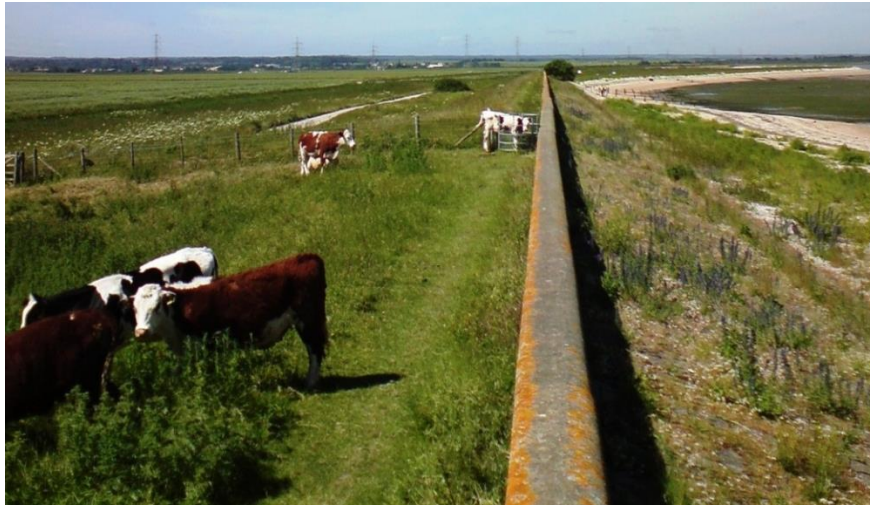
FIGURE 1-9 VEGETATED BLOCK WORK APRON AND WAVE RETURN PROFILE WALL ON CLAY BUND, BACKED BY GRAVENEY GRAZING MARSH (2008).

Figure 1-9 shows a typical example with the concrete sea wall sitting on a clay bund with the seaward side protected by a block work apron. The wall itself has a wave return profile and is in fairly good condition, although short sections are affected by differential settling. At the Sportsman Pub the defence is a grass covered clay bund with a crest level of +5.7mOD that is set back but protected by a beach and high shingle ridge.

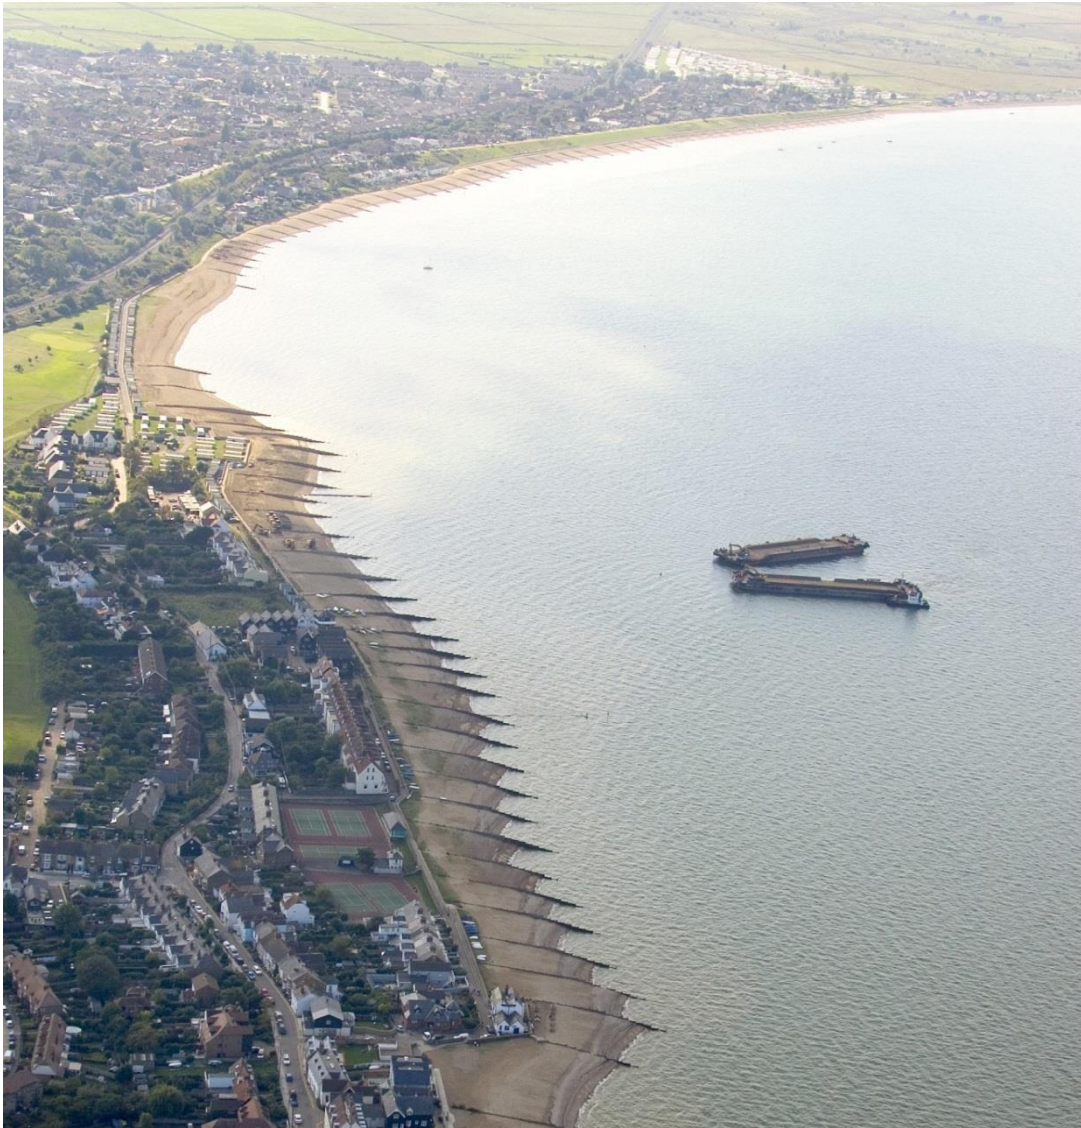
FIGURE 1-10 NEW TIMBER GROYNES AND BEACH REPLENISHMENT: THE 2006 CAPITAL SCHEME

The clay foreshore extends up to a kilometre offshore and this shallow intertidal area (+1.0mOD) supports mussels and shellfish banks. The beach between Admiralty Walk and the caravan site is dredged material, deposited in 2006. The beach between the caravan site and the harbour is dredged material deposited in 1989 and topped up in 2006, with a D₅₀ of 10-15mm.

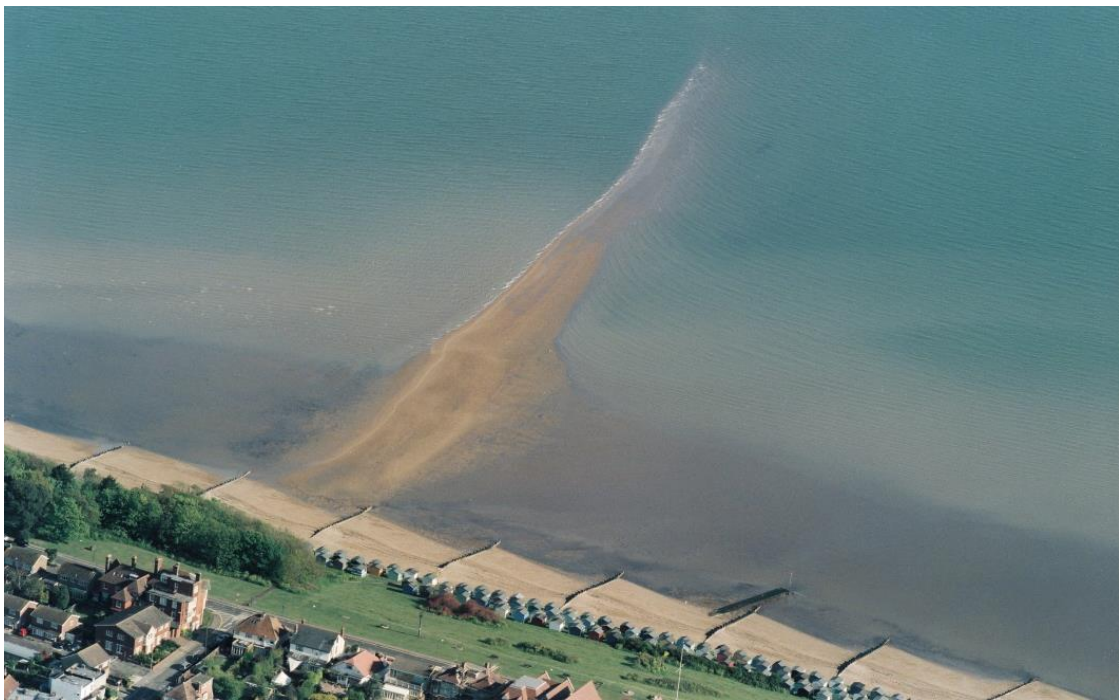
FIGURE 1-11 THE STREET, TANKERTON

The sea wall extends from East Beach to Swalecliffe Brook and varies between + 4.6 to +5.8mOD with rear walls (between +5.5 and +6.7mOD) present in places. The wall was built in several phases over the last century hence slight variations in design. An unusual feature is “The Street”; a long narrow shingle ridge which is exposed at low tide and runs perpendicular to the coastline (Figure 1-11), see also Features of Interest in section 1.1.3.

A shingle bar perpendicular to the Tankerton coastline, locally known as The Street, is located near the western boundary of Tankerton, extending one kilometer offshore at Mean Low Water Springs (Canterbury City Council, 1996c) (Figure 1-11). In the Tankerton Study (1994), Delft Hydraulics concluded that the Street has only a very marginal influence on the coastal processes at Tankerton. A topographic survey of this feature is conducted every 2-3 years.

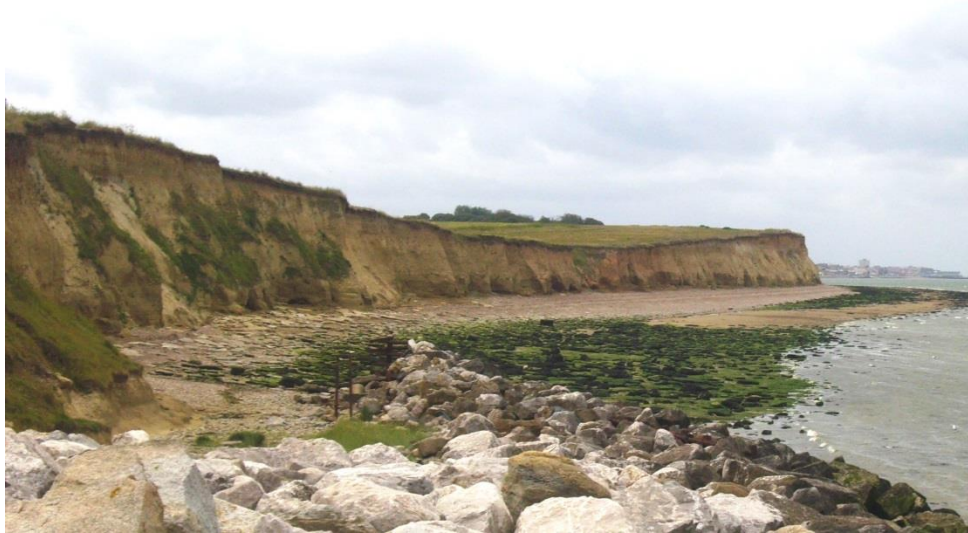
FIGURE 1-12 SANDSTONE CLIFFS AND ROCK DEBRIS FORESHORE

A narrow shingle sand composite beach lies at the base of the cliffs with a sand and rock debris foreshore (Figure 1-12), rising from +1.7mOD in the west too -1m OD at Reculver Towers. This frontage is “No Active Intervention” under the Shoreline Management Plan.

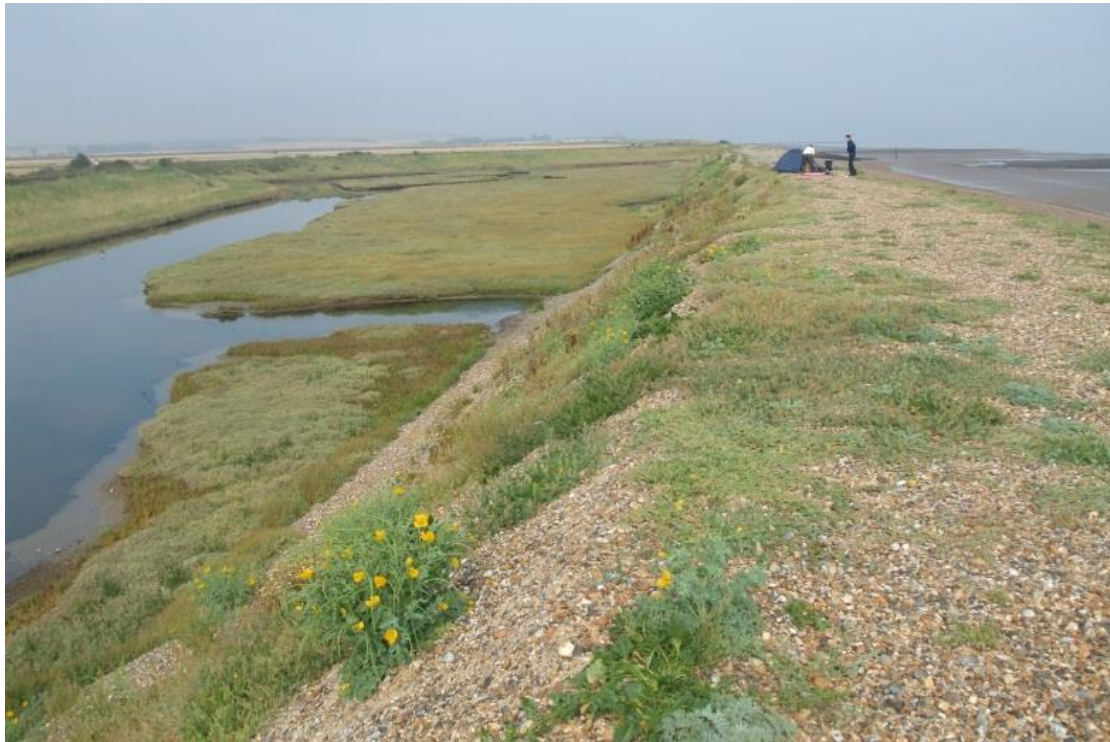
FIGURE 1-13 SALINE LAGOON BEHIND SHINGLE RIDGE AT THE WANTSUM DELTA

The sea wall is situated immediately behind the beach for the majority of the frontage with the exception of the Wantsum Delta, also known as Cold Harbour Lagoon, and St Augustine's Bank (Figure 1-13). At these locations, the wall is set back due to the presence of two saline lagoons. In front of these lagoons is a shingle ridge which reduces any salt water intrusion to occasional spray and percolation through the shingle bank.

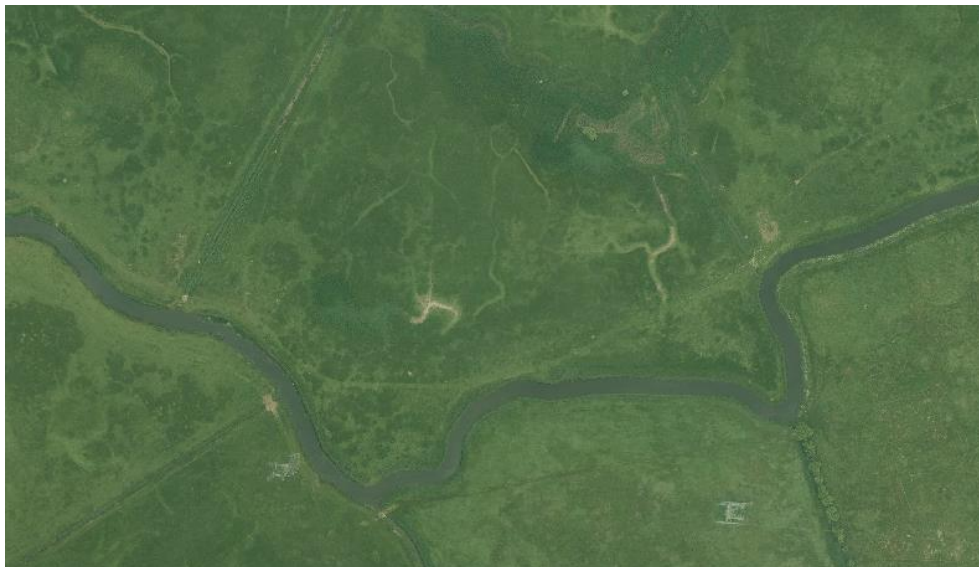
FIGURE 1-19 AERIAL PHOTOGRAPHY OF SEASALTER SHOWING RELICT TIDAL CREEKS ©CHANNEL COASTAL OBSERVATORY

A wide sea strait, the Wantsum Channel, occupied what are now the Wantsum and lower Stour valleys . Gradually the strait silted up, but it remained navigable until at least the tenth century, possibly even the fifteenth century (CCC, 1996). As with the Swale, once the channel had begun to silt up land was reclaimed by man, who converted the flat to arable land. This practice began in Roman times in the South East and continued into the 19th century (Woodrow, 1984). The reclamation of land cut off the tidal creeks and imposed an artificial straight coastline. Despite this it is still possible to see relict dendritic creeks from aerial photography (Figure 1-19).

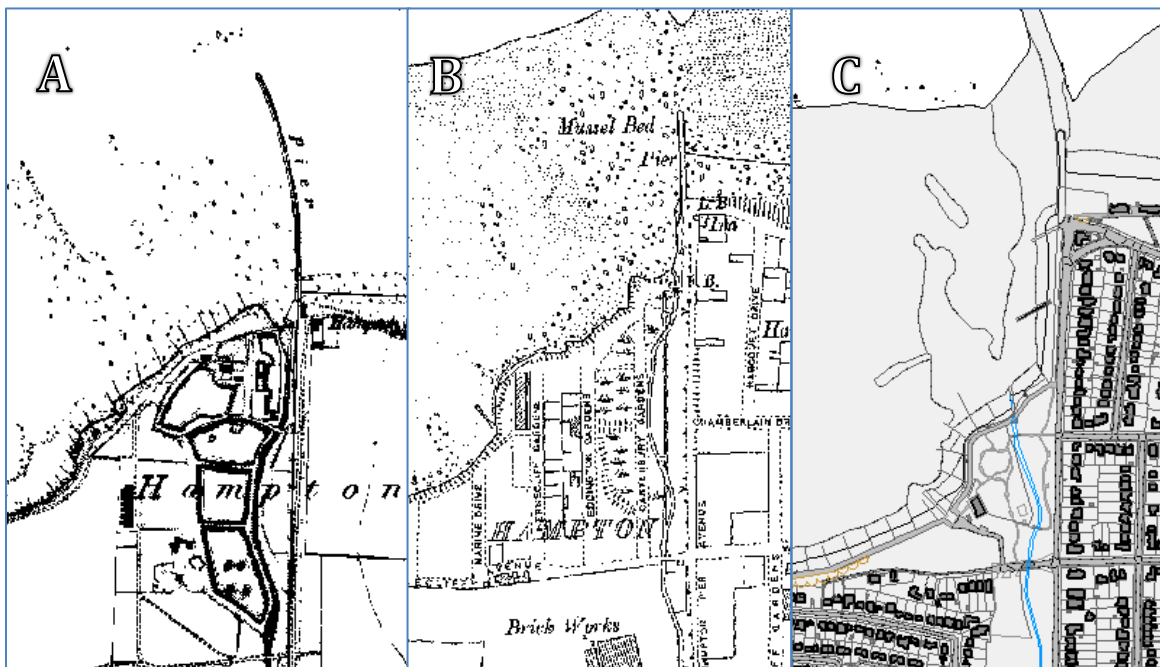
FIGURE 1-21 EROSION CAUSED BY THE CONSTRUCTION OF HAMPTON PIER: A – HAMPTON IN 1872, B – HAMPTON IN 1910 AND C – HAMPTON TODAY

The construction of the original Hampton Pier in 1865, by the Herne Bay and Reculver oyster fisheries company, led to significant scour to the west of the structure (Figure 1-21). Concurrently beach growth occurred to the east of the structure. The structure was 1065ft long and built from wood and concrete. In total 175m of land was lost to the sea by 1921 as well the original fishing hamlet Hampton-on-Sea; two farmhouses, a beer house and a few cottages containing the Mount and Quick fishing families (Easdown, 2008). The pier was dilapidated by 1901 and a smaller pier (305ft long) was rebuilt in its place in 1905.

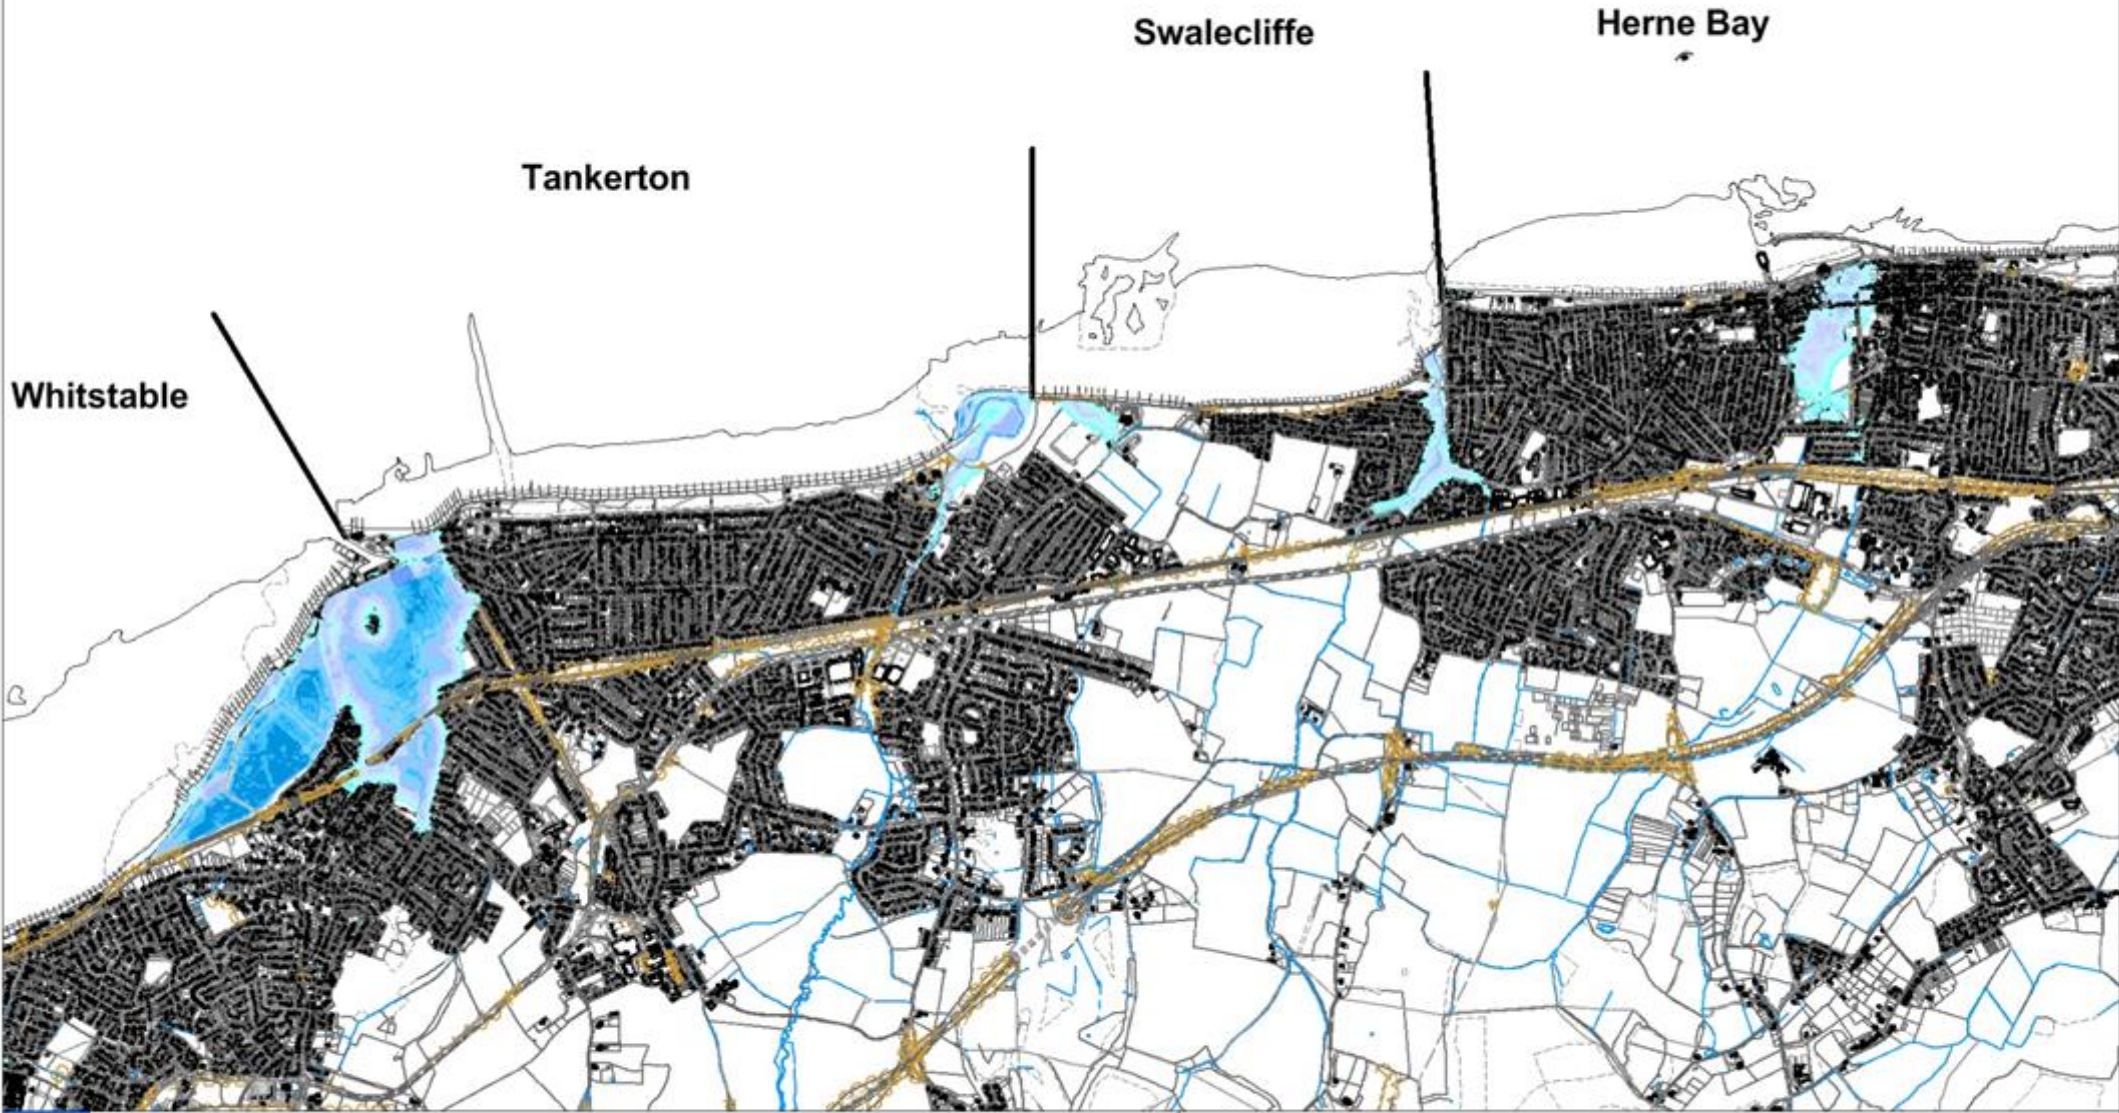
FIGURE 2-2 WHITSTABLE TO HERNE BAY FLOOD DEPTH FOR 1 IN 200 YEAR STILL WATER LEVEL (PLANAR FLOOD MAP)

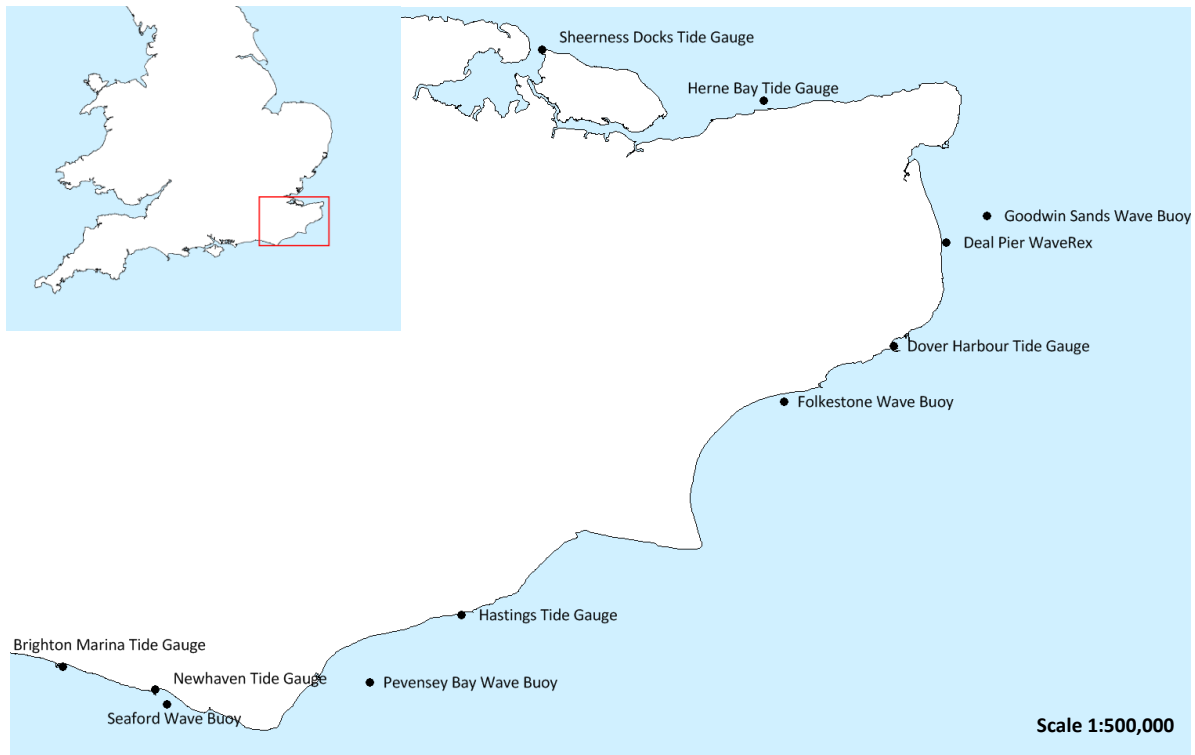
FIGURE 3-2 LOCATION OF ETROMETER STEP GAUGE

As part of the Regional Coastal Monitoring Programme an Etrometa Step Gauge is situated on the old pier head at Herne Bay, in approximately 9m of water (Figure 3-2). The gauge was installed in 2004.

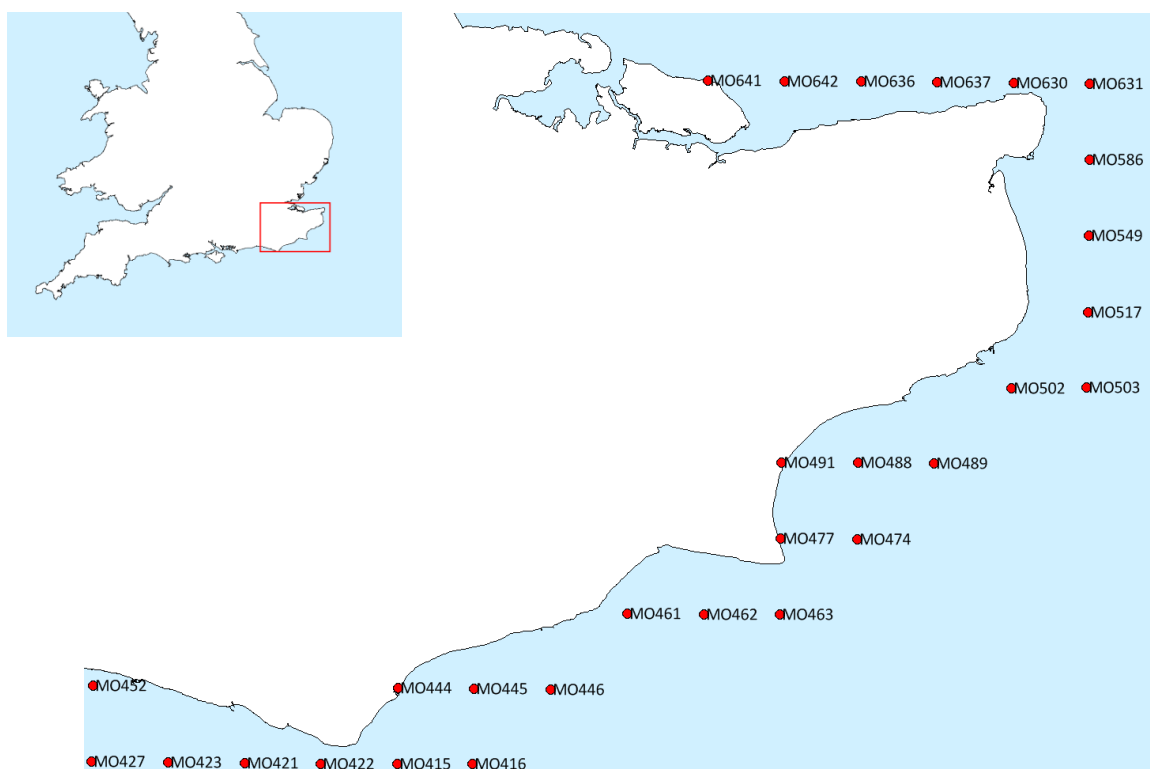
FIGURE 3-4 LOCATION OF MET OFFICE HINDCAST POINTS

Using thirty-three years of Met Office Hindcast data for 52 nearshore locations at ~5km intervals (Figure 3-4) the Joint Return Probability for Beach Management study (Mason, 2014), calculated extreme return periods for each of these points.

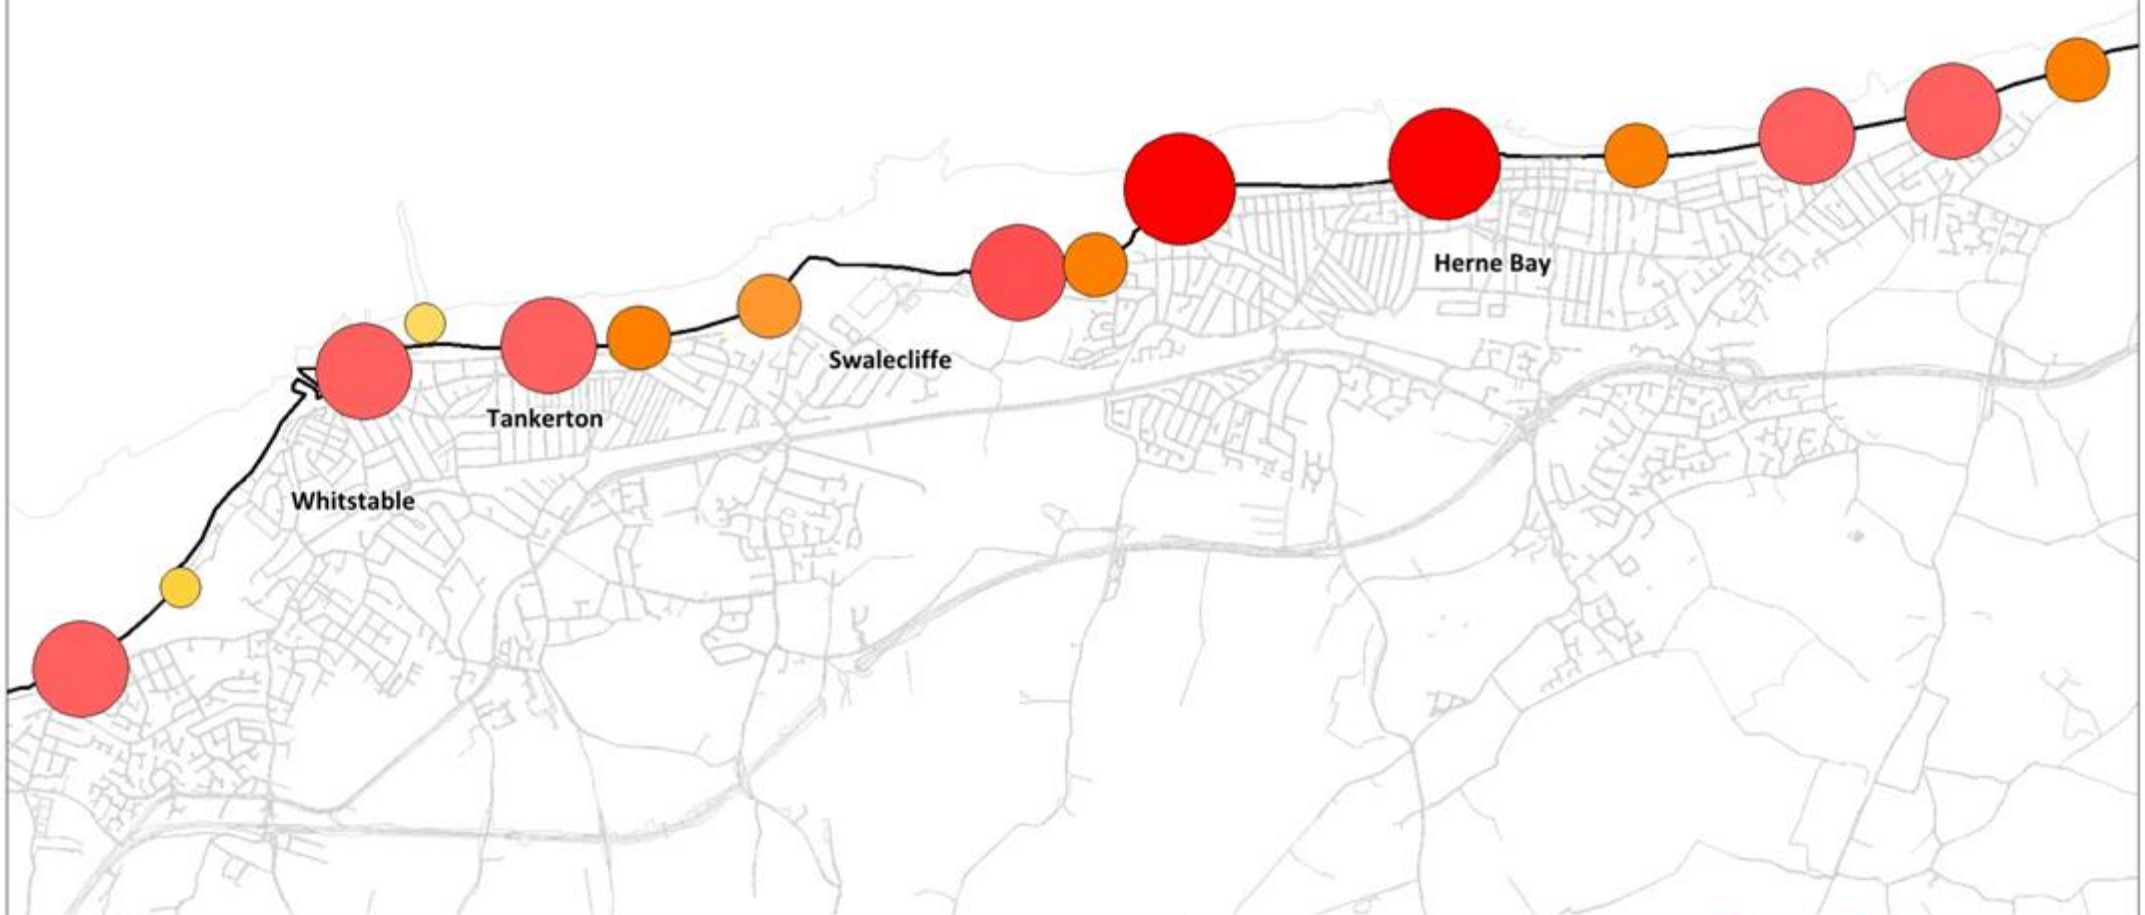
FIGURE 3-9 AVERAGE GRAIN SIZE (D50) AT MEAN HIGH WATER SPRING, 1986

Sediment size and characteristics were obtained through previous studies undertaken by Canterbury City Council, and are summarised in the following table and illustrated on Figures 3-9 and 3-10. Sediment grading curves are included within Appendix E.

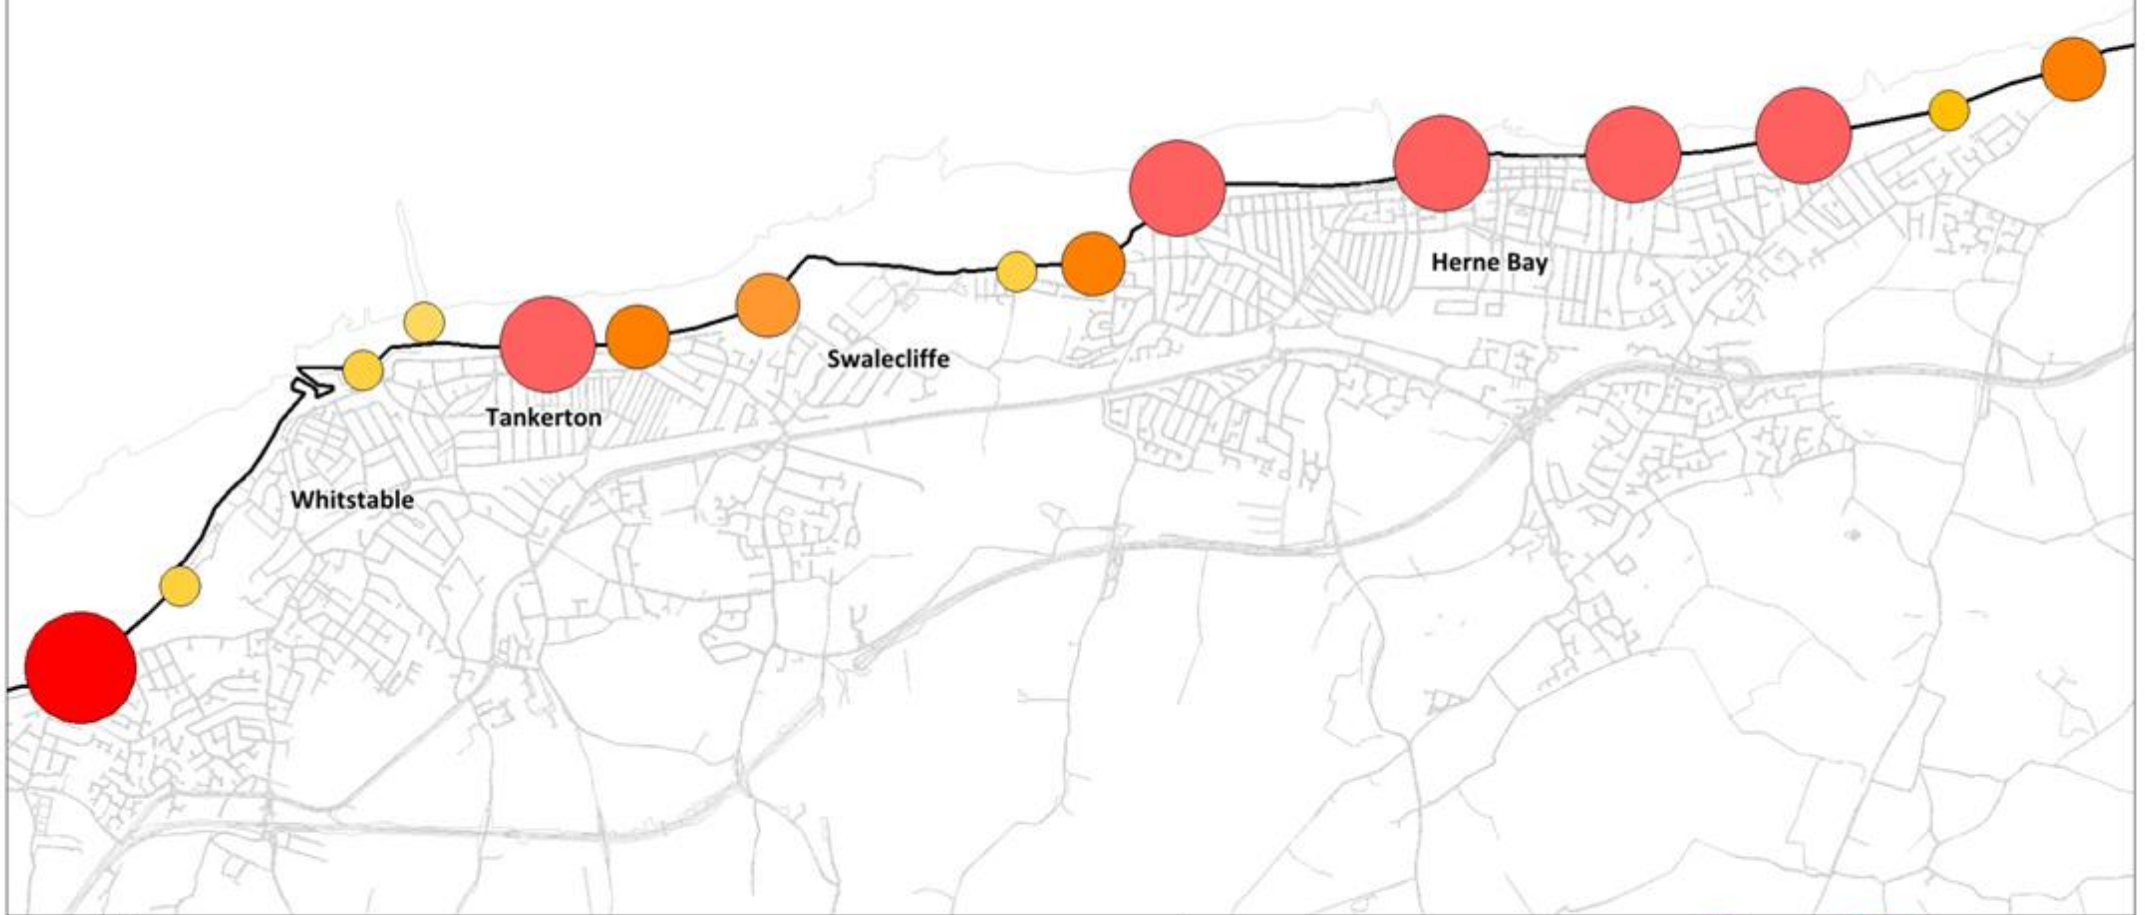
FIGURE 3-10 AVERAGE GRAIN SIZE (D50) AT MEAN HIGH WATER NEAP, 1986

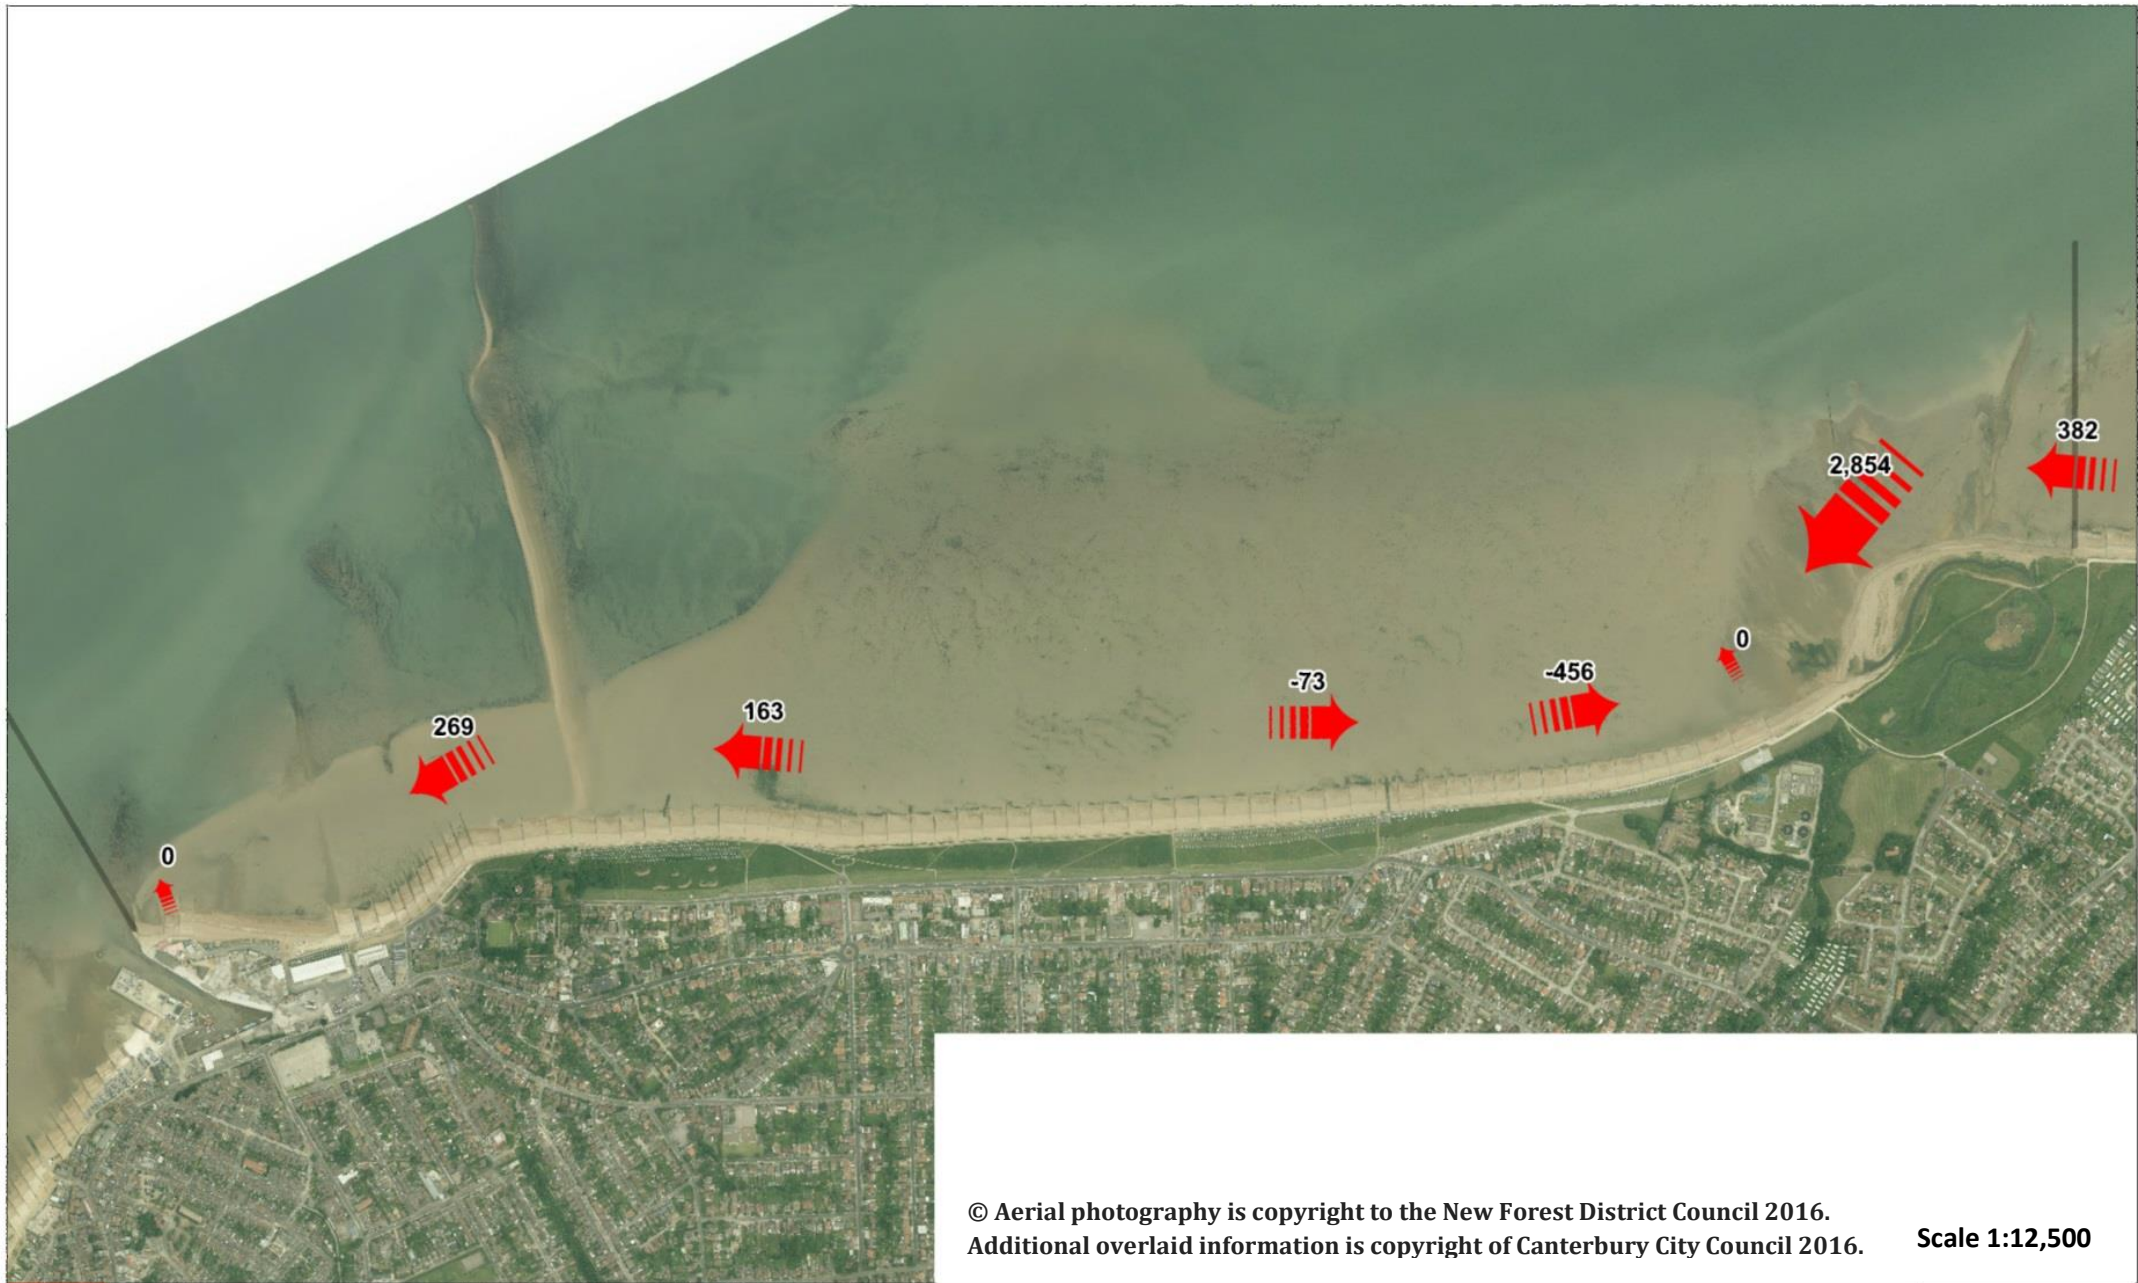
FIGURE 5-6 SEDIMENT BUDGET – TANKERTON

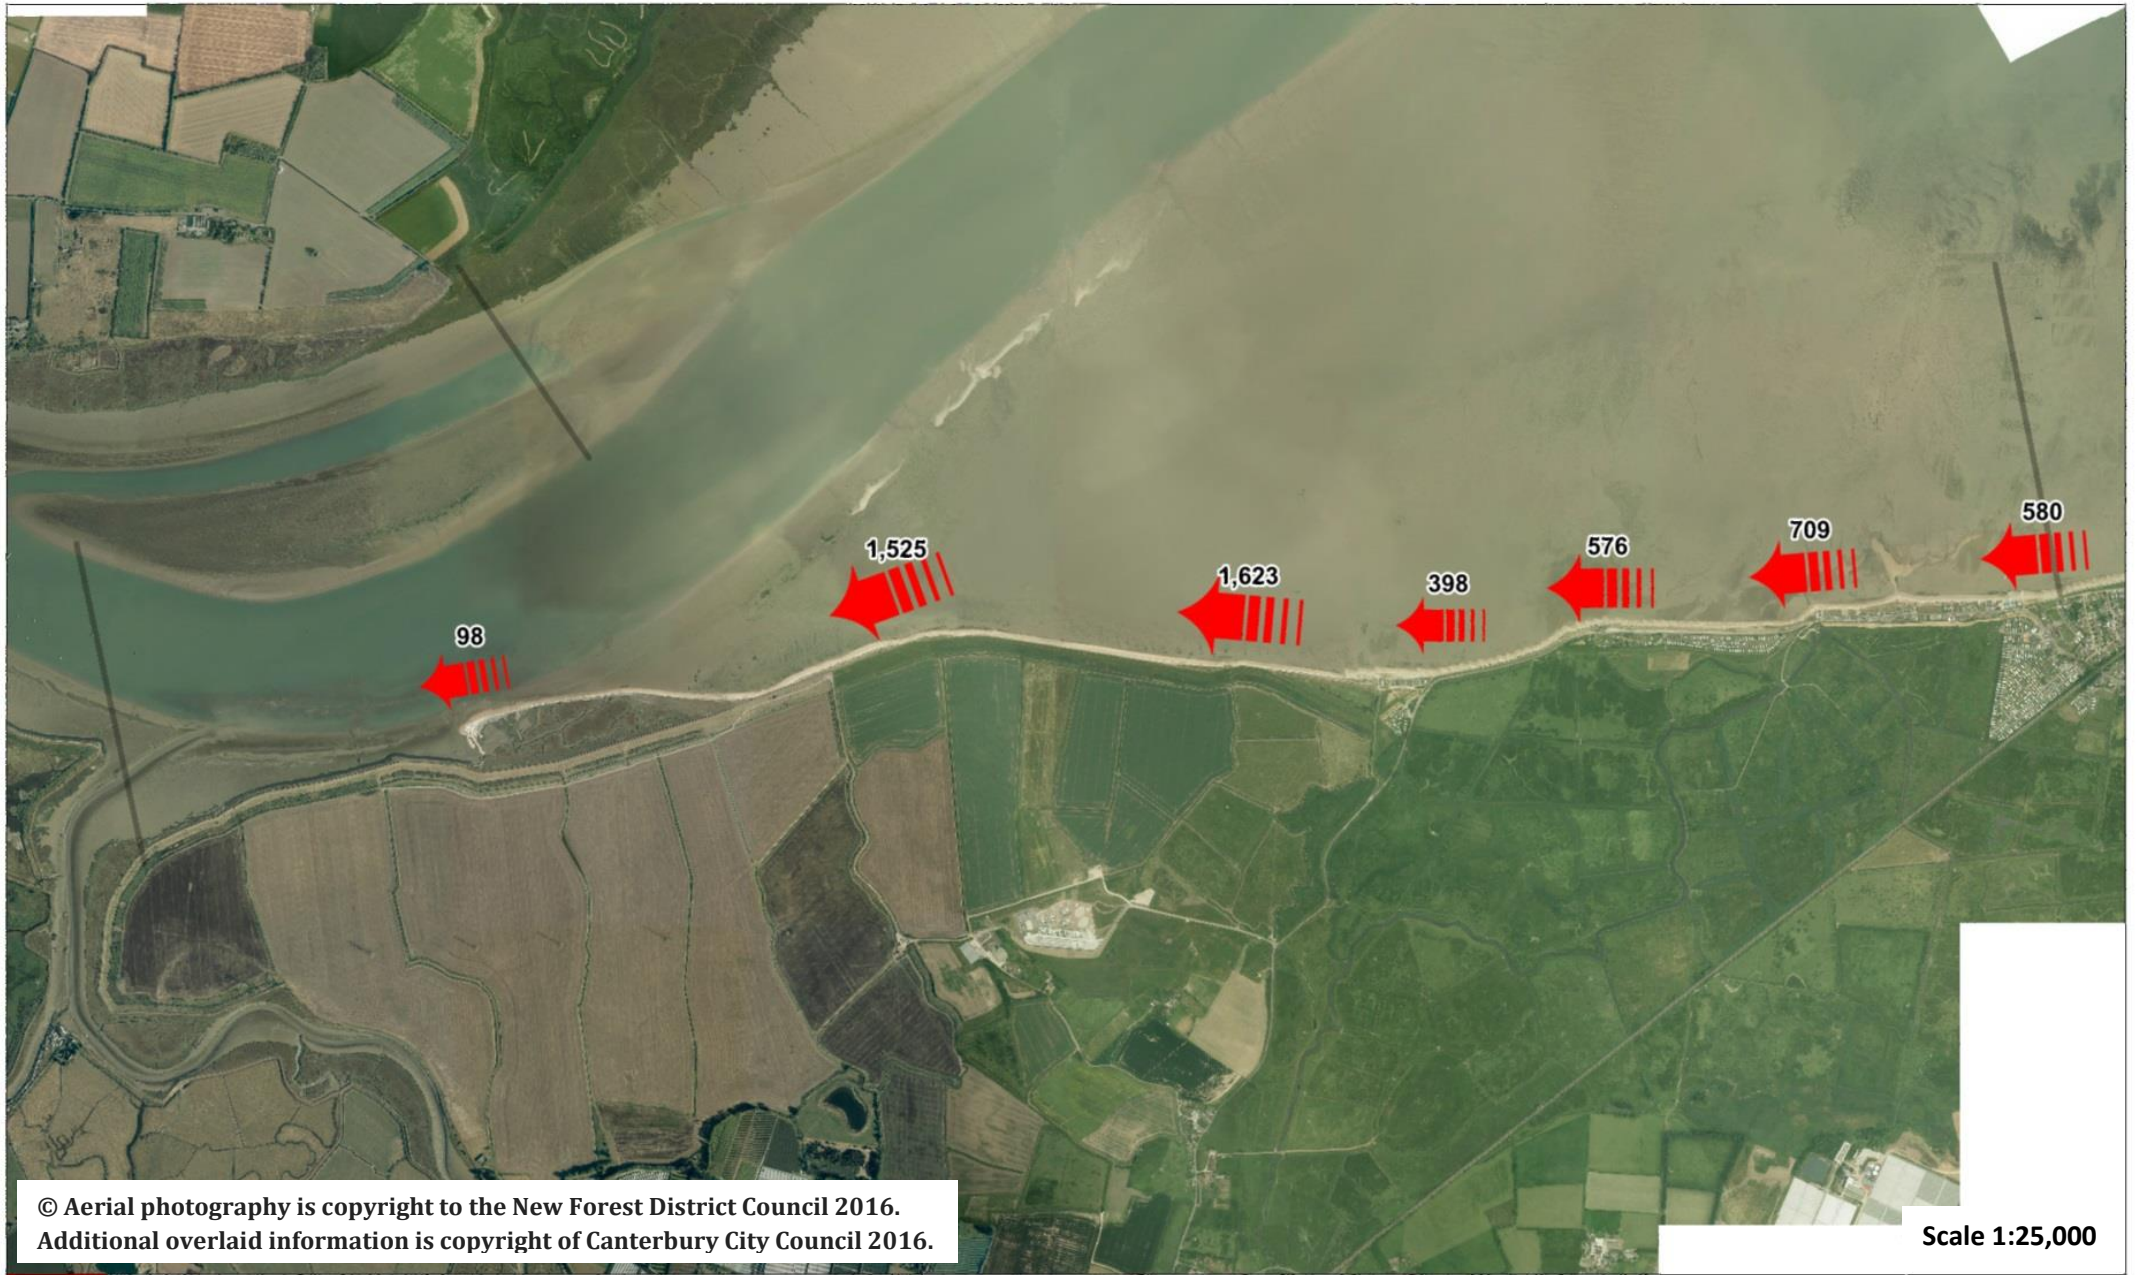
FIGURE 5-8 SEDIMENT BUDGET – SEASALTER

Estimated annual sediment transport in cubic meters.

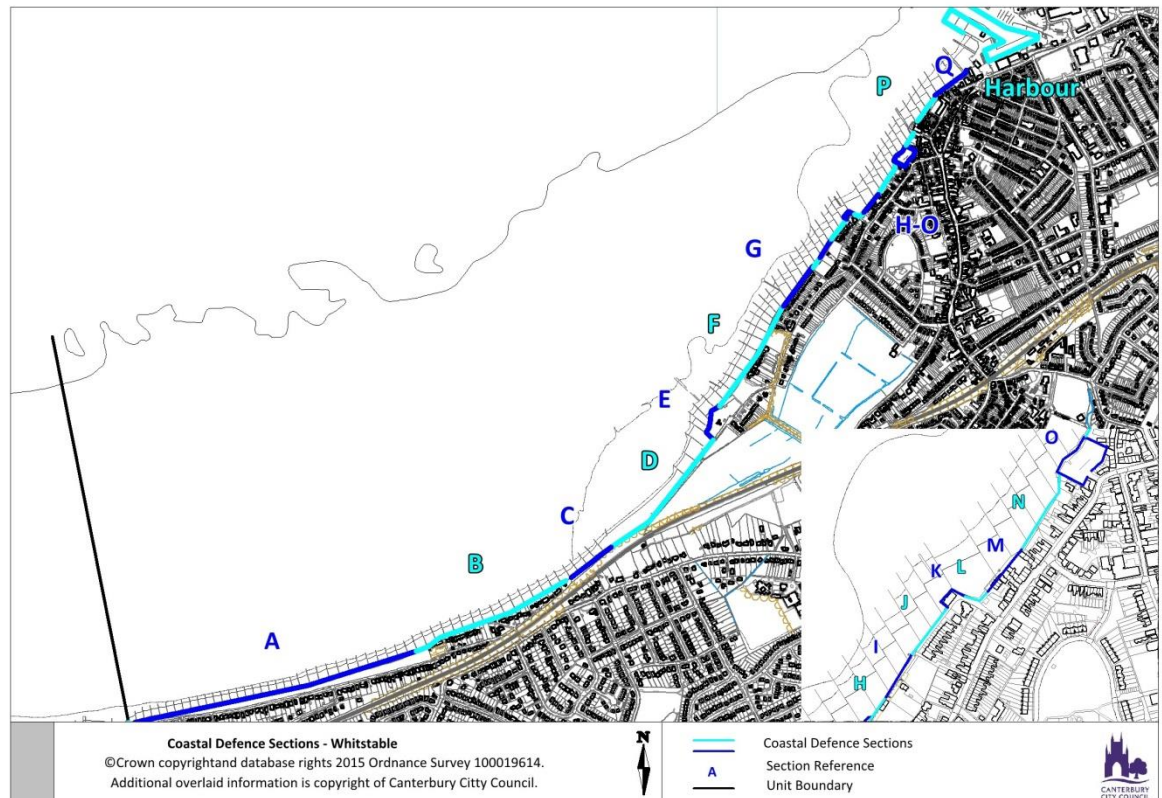
FIGURE 6-1-1 EXAMPLE OF DEFENCE SECTIONS FOR WHITSTABLE

In order to perform the risk analysis the coastline was split into representative defence sections based upon sea defence, beach and foreshore characteristics (Figure 6-1-1).

Details on the defence type, elevation and geometry, foreshore levels and the calculations performed for each defence section is provided in Appendix G.

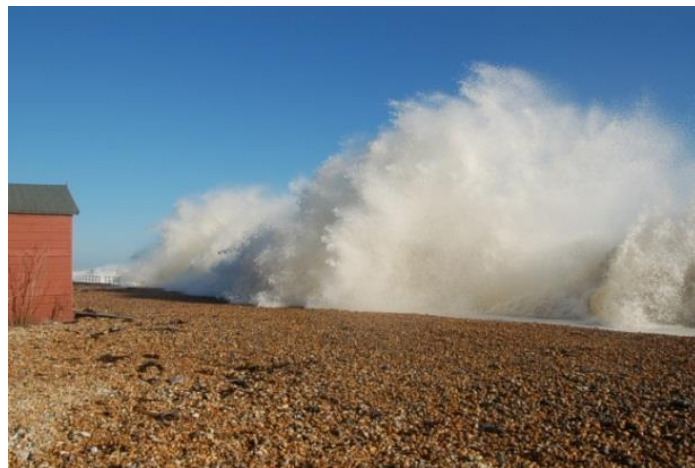
FIGURE 6-2-1 DISSIPATION OF WAVE ENERGY ON A SHINGLE BEACH (KINGSDOWN, 2009)

Shingle beaches are very efficient at dissipating wave energy (Figure 6-2-1). To calculate overtopping rates under different scenarios a methodology was developed and applied consistently to the whole frontage. This is summarised in Figure 6-2-2 and described in the following text.
