Regional Beach Management Plan 2015: Graveney to Northern Sea Wall

Report – ENVIMSE100035/R-01

Final Report, February 2017

Main Report

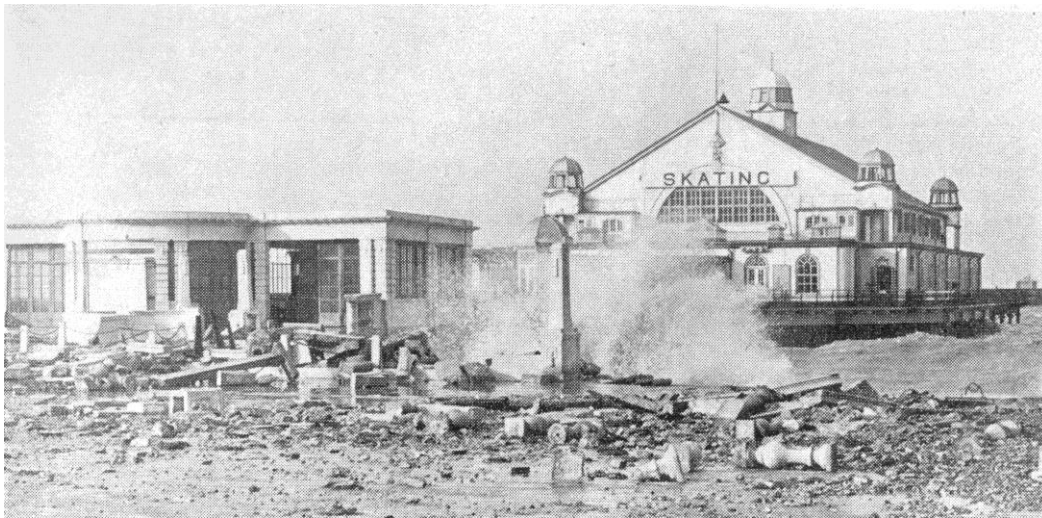
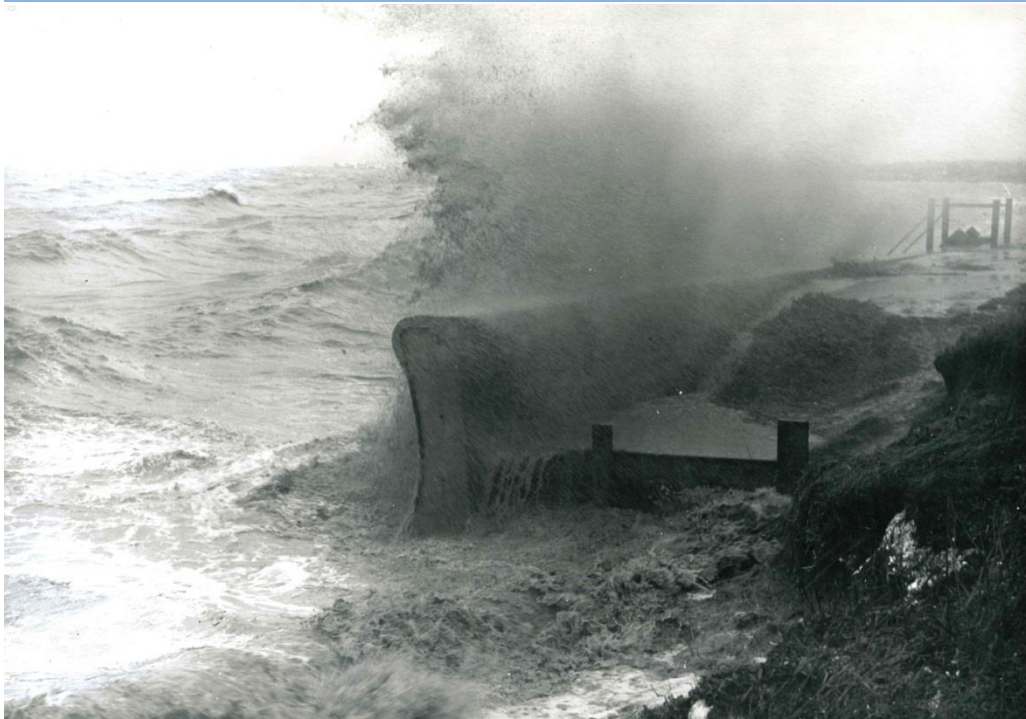
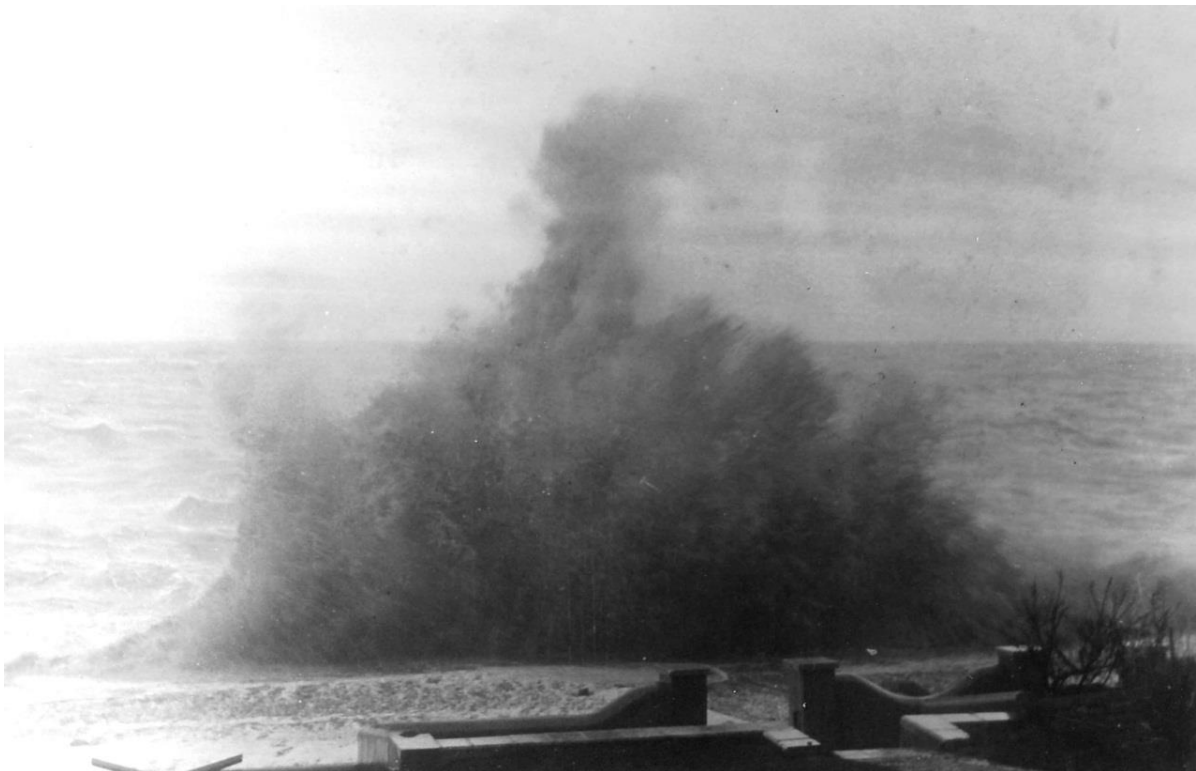
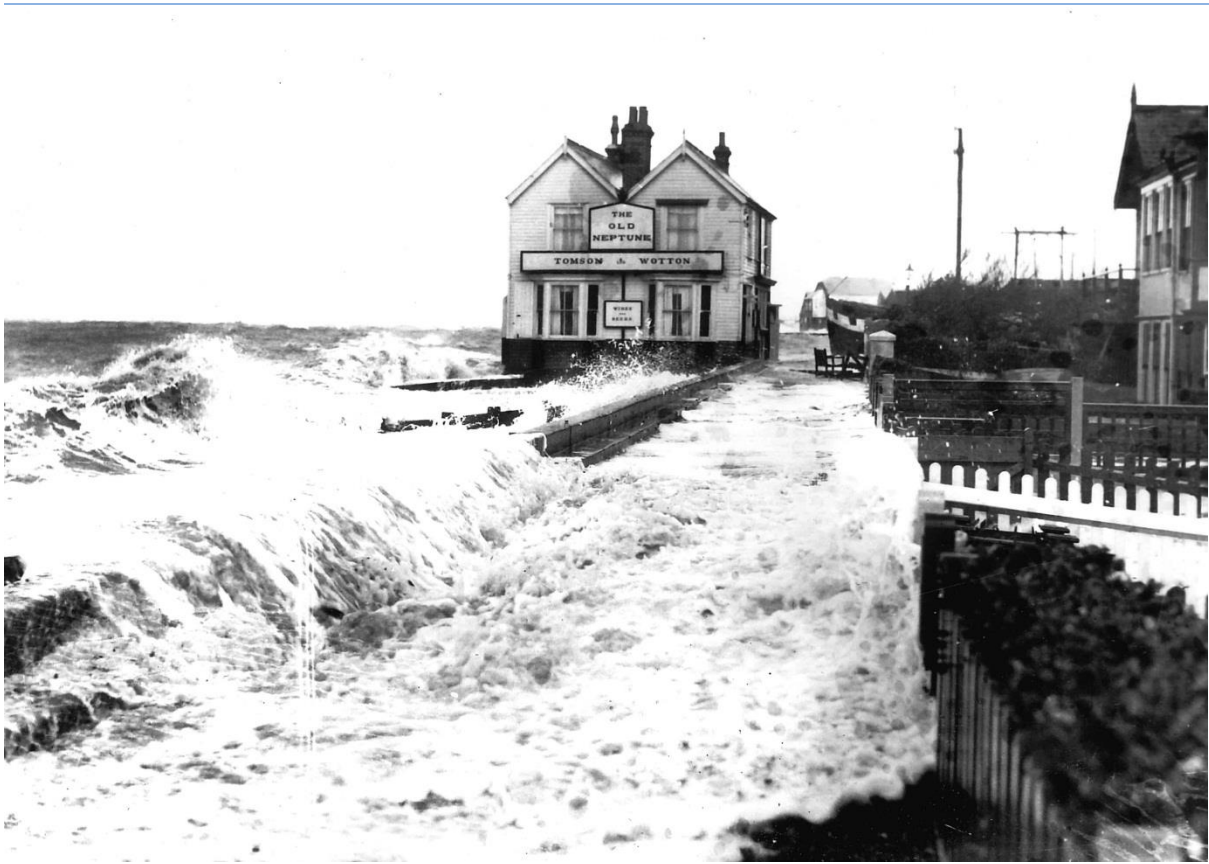
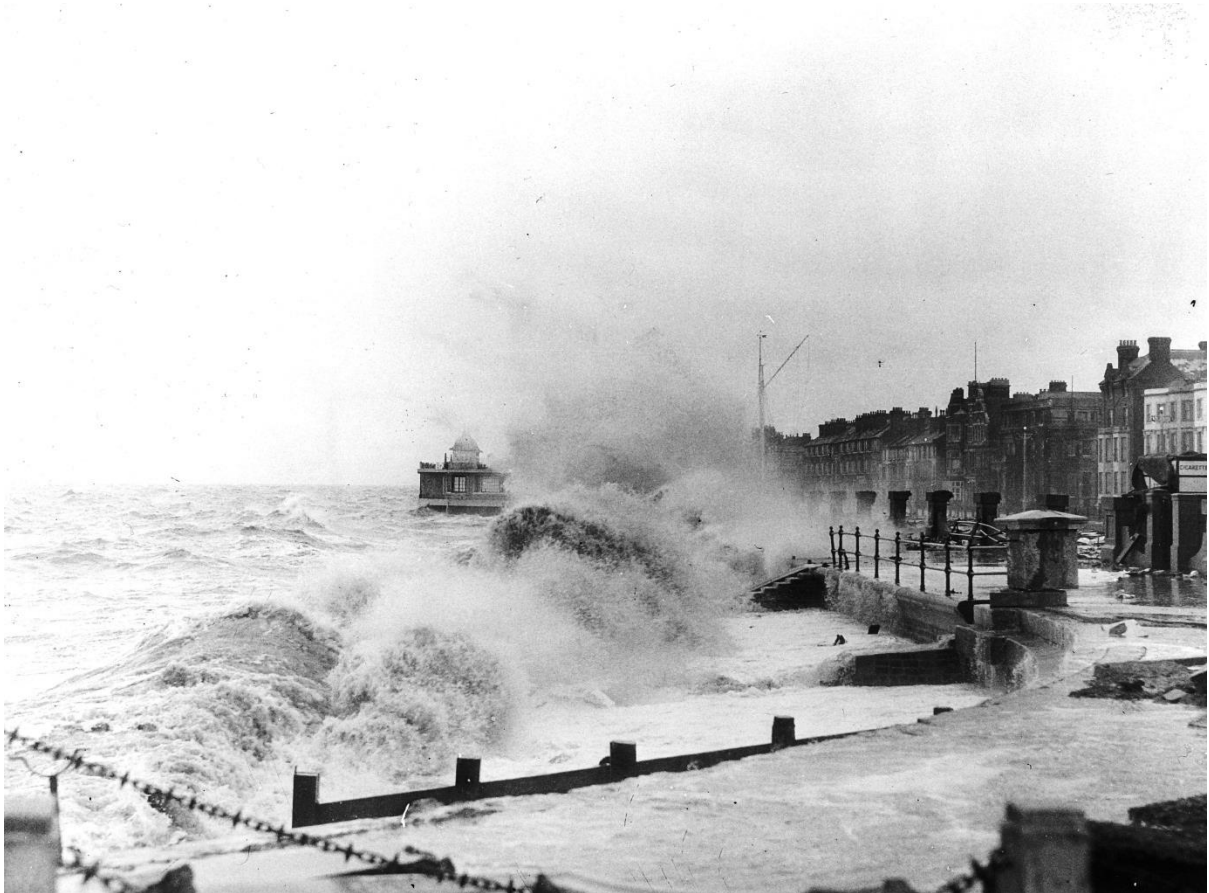
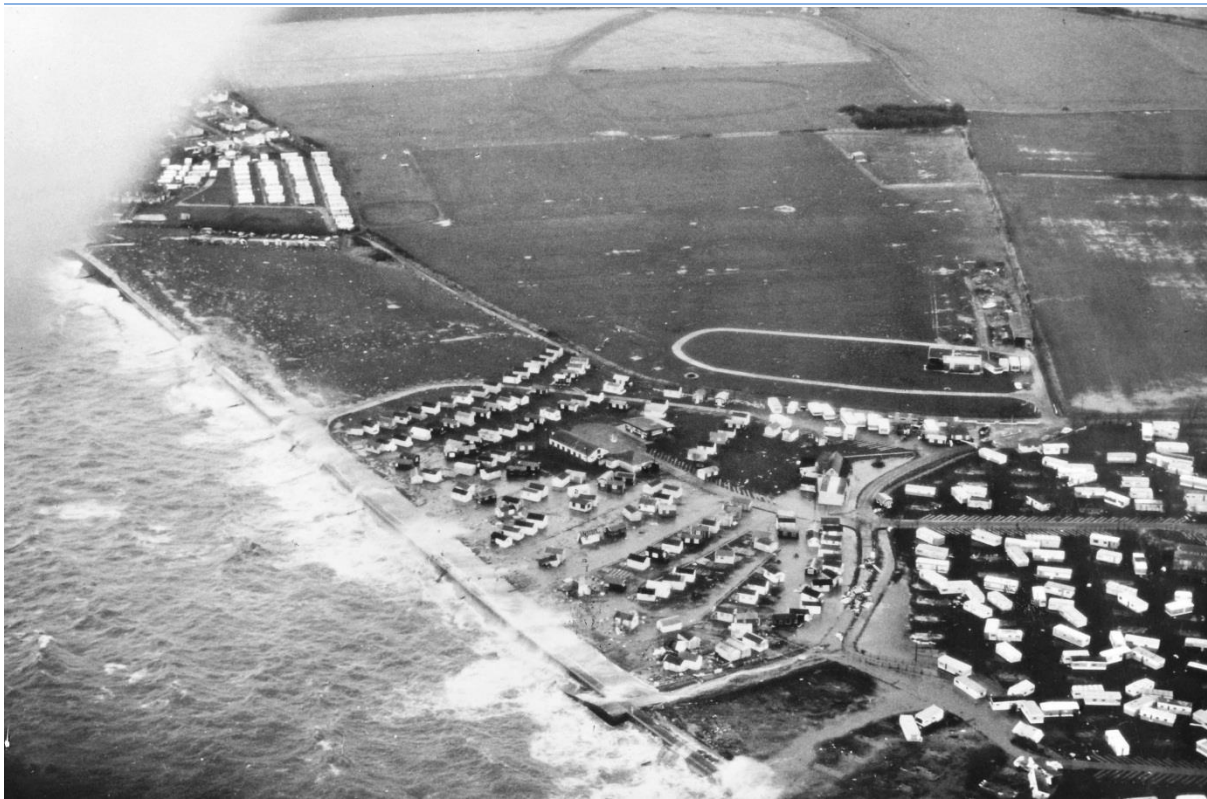
FIGURE 6-2-7 OVERTOPPING AT HERNE BAY PIER, 1953

FIGURE 6-2-8 OVERTOPPING AT SWALECLIFFE, 1953

FIGURE 6-2-9 OVERTOPPING AT HERNE BAY, 1953

FIGURE 6-2-10 OVERTOPPING AT WHITSTABLE, 1978

FIGURE 6-2-11 OVERTOPPING AT HERNE BAY, 1953

FIGURE 6-2-12 OVERTOPPING AT SWALECLIFFE, 1953

1. Photographic evidence of large overtopping events and retrospective comparison with predicted overtopping. There were several instances where this was possible, examples shown below.

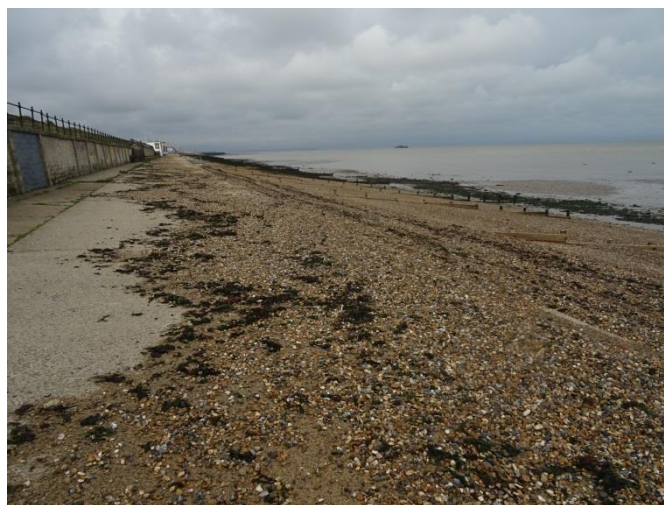
FIGURE 6-2-13 EVIDENCE OF OVERTOPPING ON TO THE PROMENADE (HERNE BAY, 2016)

2. Anecdotal evidence in the form of information that is not well documented or photographed. The prime example of this is shingle on the promenade, which is indicative of small scale overtopping (e.g. Figure 6-2-13). Where management authorities have to periodically clear this it is evident that the defence is subject to minor overtopping on a regular basis. Results can be queried to ensure these events are predicted.

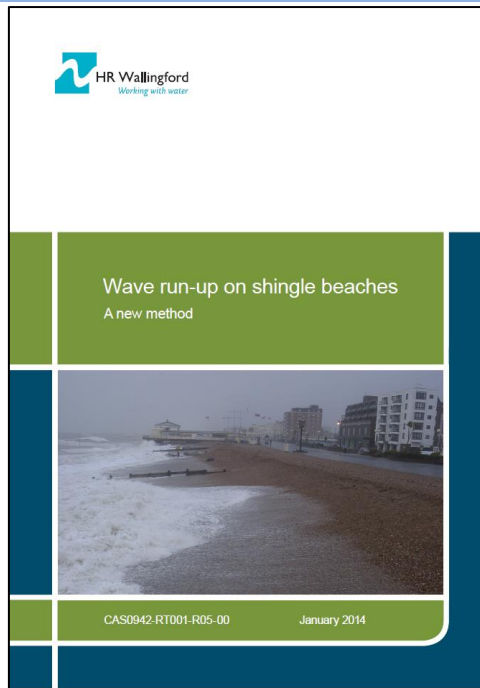
FIGURE 6-2-15 SUB-PROJECT RESEARCH AND DEVELOPMENT OF IMPROVED RUN-UP FORMULA.

The improved formula presented in Wave run-up on shingle beaches: a new method (HRW, 2014, Figure 6-2-15) was used in areas that were prone to green water overtopping (No structure and run-up exceeds crest). By running calculations for a number of swell components results could be verified as reasonable and ensure that an underestimation had not been made.

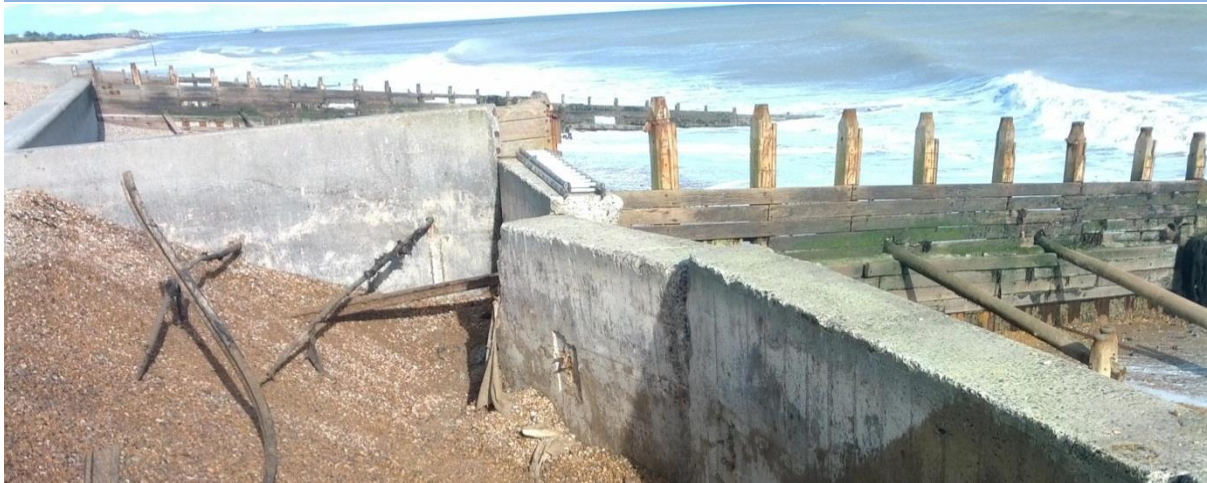
FIGURE 6-2-16 DILAPIDATED GROYNES LOW BEACH AND SEA WALL FAILURE AT KINGSDOWN (2013)

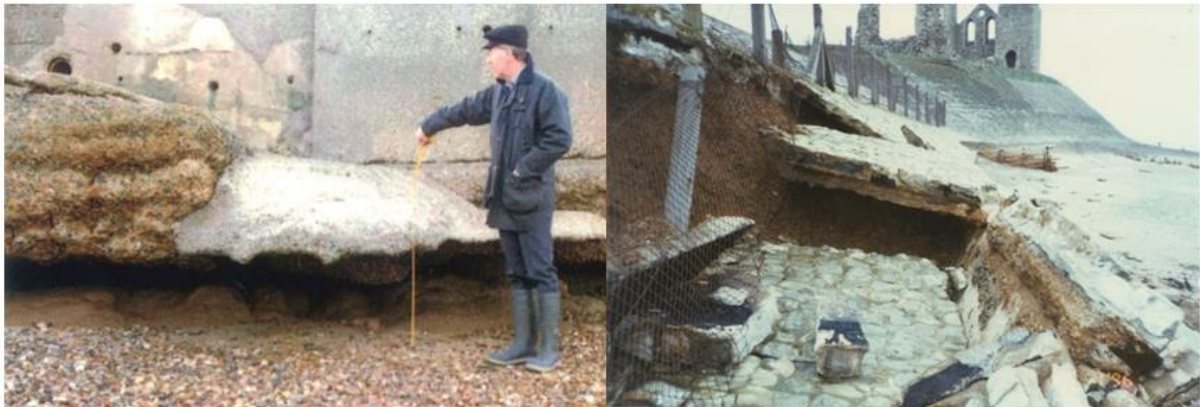
FIGURE 6-2-17 EXAMPLES OF UNDERMINING AT TANKERTON (LEFT) AND RECVLVER (RIGHT) (BOTH PHOTOS 1999)

Typically, before beach levels get low enough to pose a credible threat to the structure the standard of protection has already become sub-standard due to the increased likelihood and severity of overtopping. There are instances where the structure itself provides a sufficient barrier to overtopping, but often in these cases a beach is required to be maintained in order to protect the structure and prevent undermining.

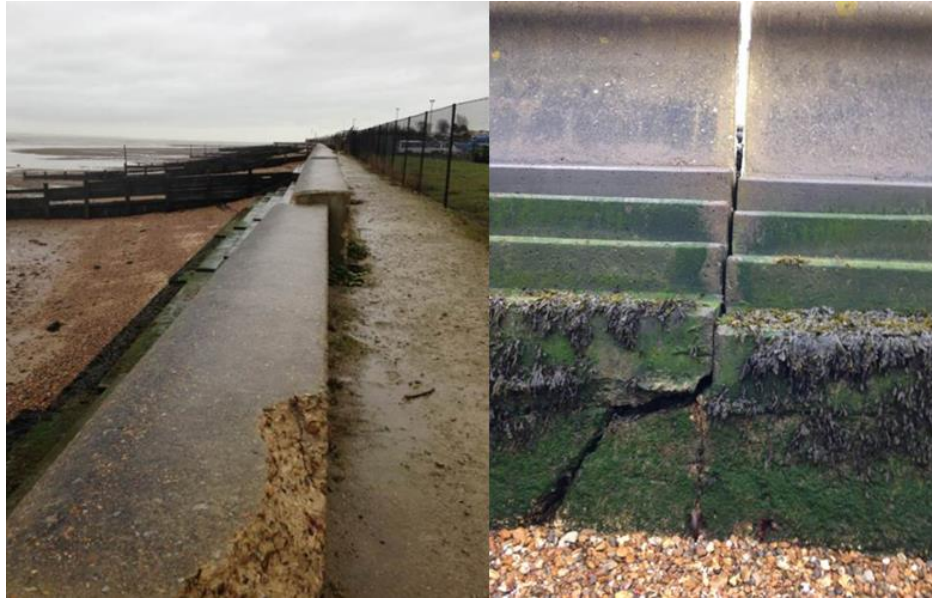
FIGURE 6-2-18 FAILURE OF A SEA WALL AT ALL HALLOWS DUE TO SLIDING/TOPPLING OF DEFENCE SECTIONS (2015)

As beach levels continue to drop there is an additional threat of undermining of the sea wall foundations. This can cause the structure to collapse and/or a draining of the fill material from behind the sea wall that reduces the structural integrity (Figure 6-2-17). A beach also provides a lot of support and weighting in front of the structure, without which toppling or sliding of sea wall sections can occur (Figure 6-2-18).

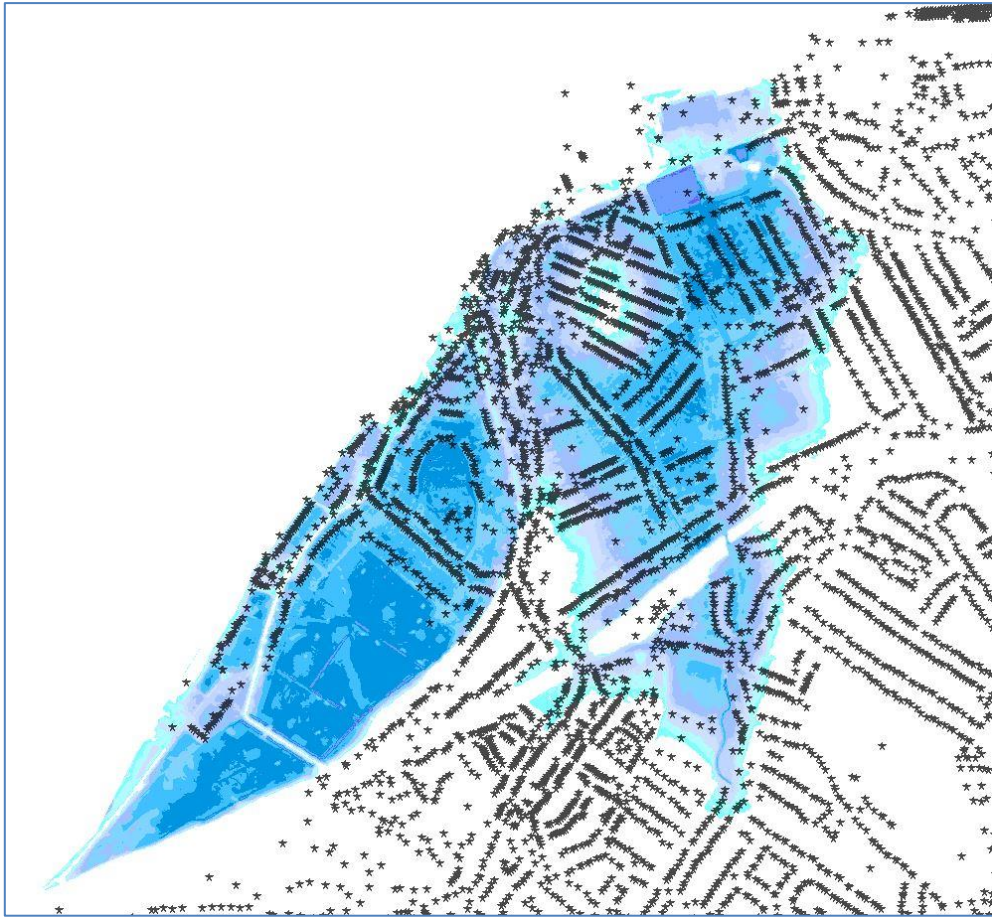
FIGURE 62-20 EXAMPLE OF PROPERTIES (STARS) IN WHITSTABLE WITHIN THE 1:200 YEAR EXTREME WATER LEVEL PLANAR FLOODPLAIN

There are five main flood basins within the frontage, at Graveney/Seasalter, Whitstable, Swalecliffe, Herne Bay and Northern Sea Wall. In order to calculate the properties at risk from a 1:200 year event (4.3-4.5mOD) a planar still water level flood map was created using LiDAR data (most recent dataset, 2015) and combined with the Ordnance Survey's AddressBase property layer (Figure 6-2-20).

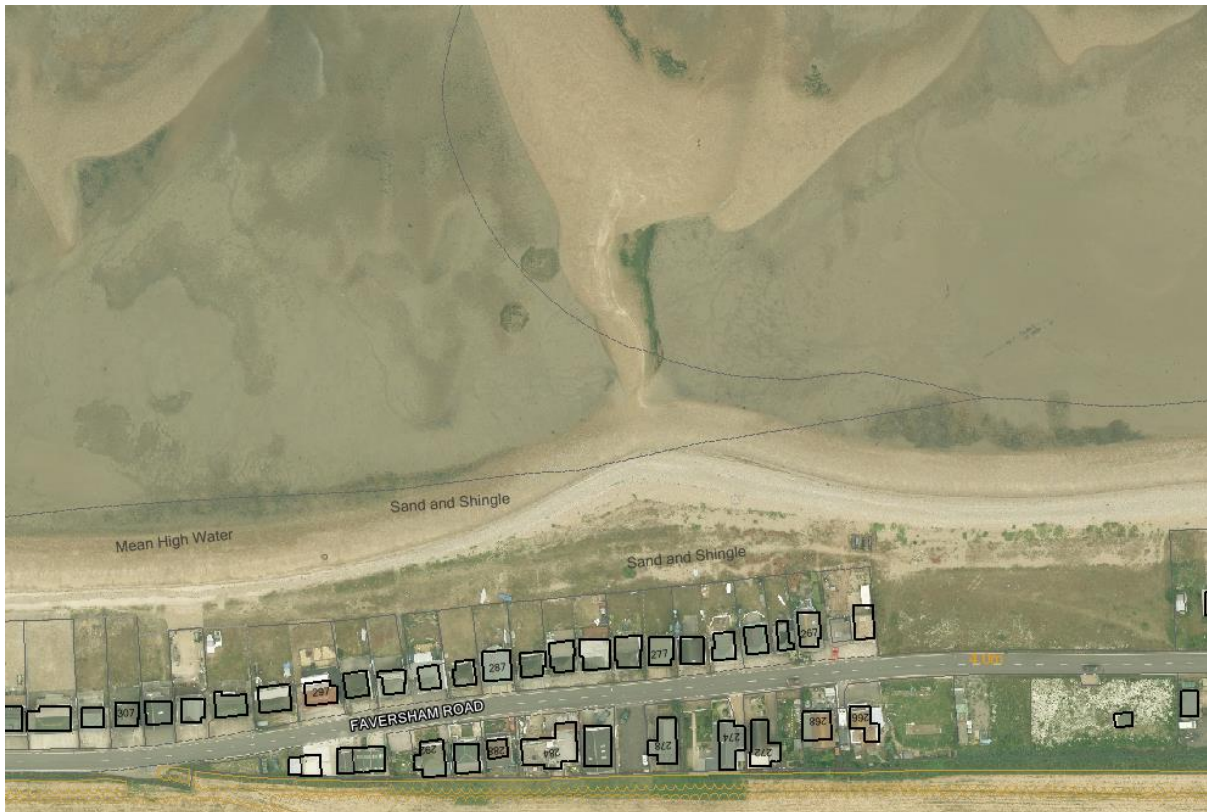
There are a number of houses along Faversham Road which are built in front of the sea defence and are vulnerable to flooding and erosion (Figure 8-2); these properties flooded in 1978 during a storm surge. Whilst the beach changes are relatively low year to year there is the potential for beach material to be lost in front of these properties.

FIGURE 8-2 FAVERSHAM ROAD PROPERTIES AND THE SHINGLE BAR WHICH IS TRANSGRESSING ONSHORE
© CROWN COPYRIGHT AND DATABASE RIGHTS 2016 ORDNANCE SURVEY 100019614. AERIAL
PHOTOGRAPHY ©CHANNEL COASTAL OBSERVATORY.

Scour of the beach either side of tombolo is increasing as the shingle bar is moving onshore. As material is transported alongshore it is deposited along the tombolo as the waves shoal around this feature. However there is no net movement of shingle back to replenish the area that it had originated from, as waves do not propagate from the shingle bar or tombolo, so the beach either side of the tombolo is becoming depleted.

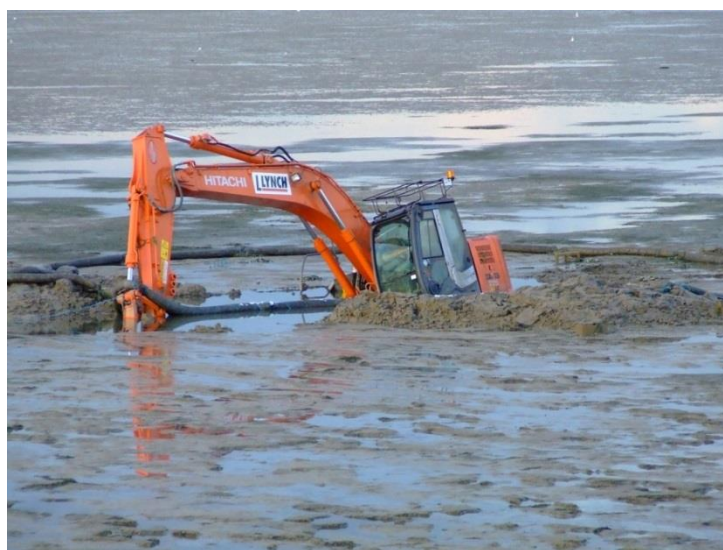
FIGURE 8-3 EXCAVATOR LOST IN THE DEEP MUD DURING THE WINDFARM CABLE INSTALLATION

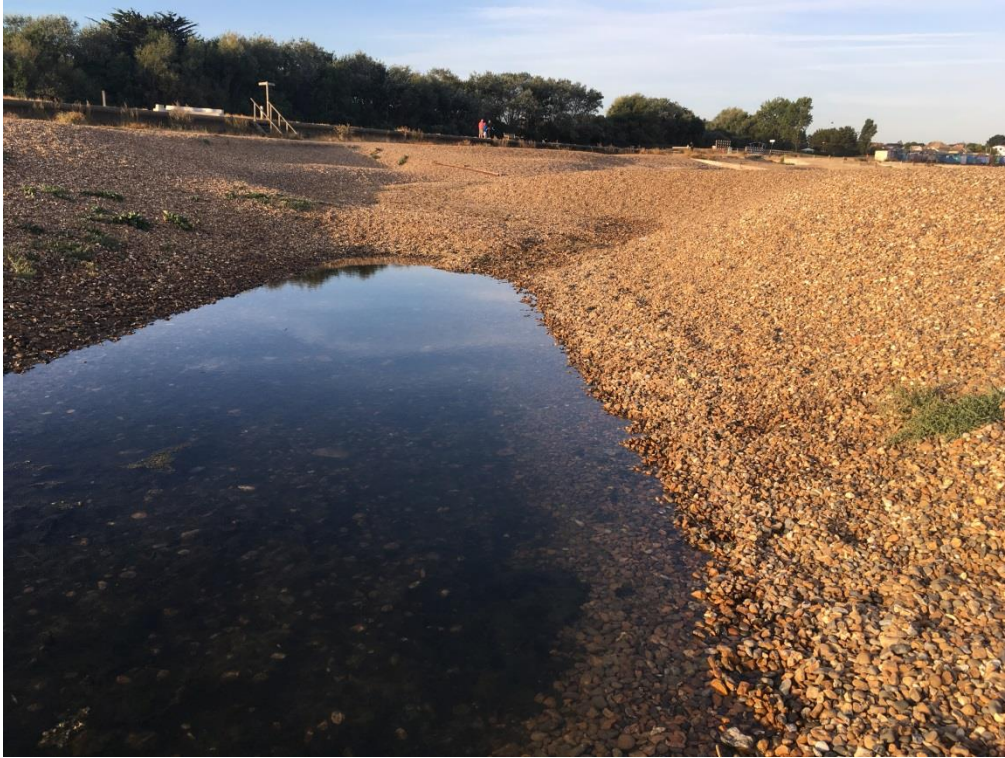
FIGURE 8-5 BLOCKAGE OF SWALECLIFFE BROOK MOUTH (2016)

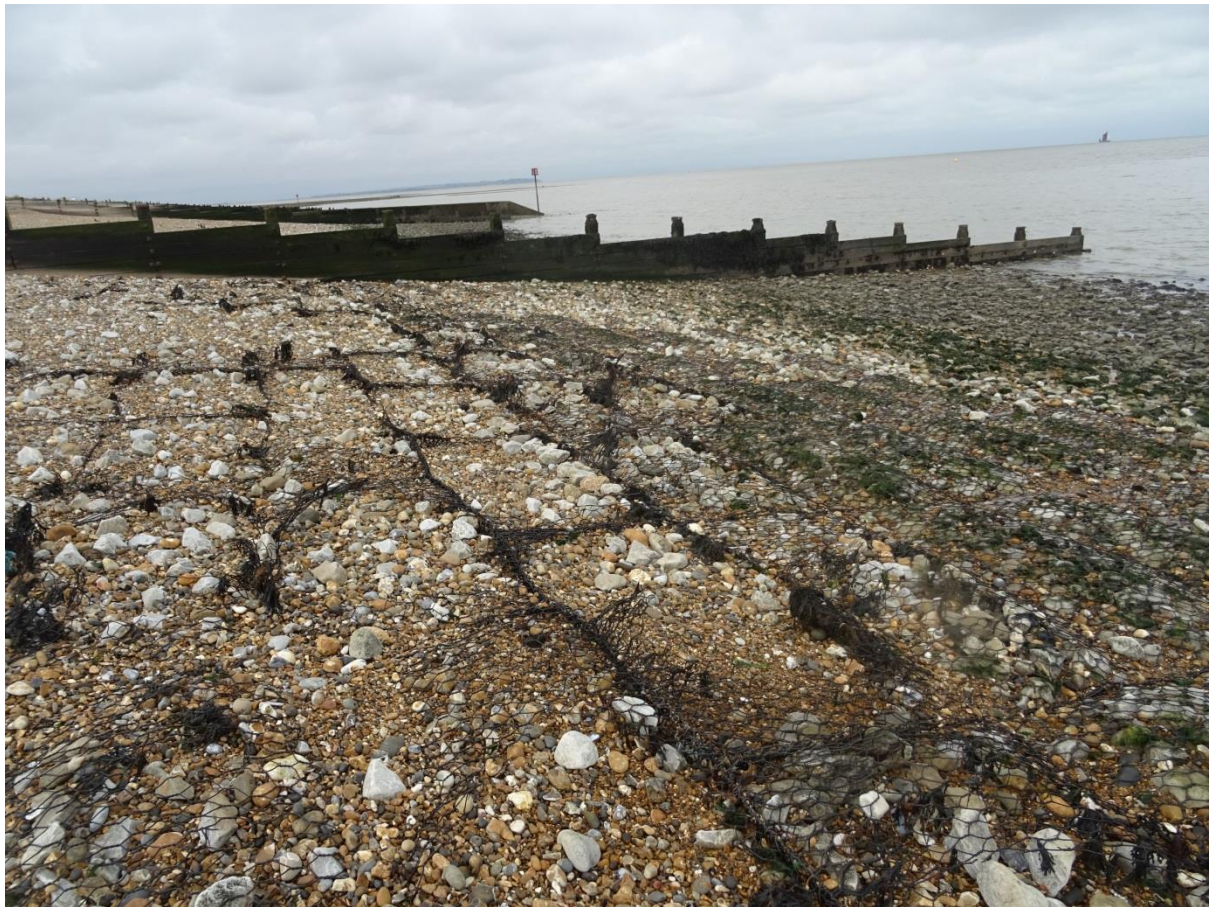
Wire mattresses (300mm thick wire baskets filled with ragstone) were installed in the early 1990's and span from the most western groyne bay at Swalecliffe towards the centre of the unit for a length of approximately 450m. The mattresses maintain a minimum beach CSA to prevent the sea wall from undermining as the shingle bank to

the west of the structure receded landwards. However; the erosive trend of low level losses can expose these mattresses. The mattresses are exposed from time to time but often naturally recover (Figure 8-7).

FIGURE 8-7 WIRE MATTRESS EXPOSURE AT EASTERN END OF SWALECLIFFE (2016)

The large extent of the wire mattresses means that removal of the entire structure would be costly and the most practical method is to cut back the wire as it becomes exposed or to cover it with shingle. Regular visual inspections are recommended.

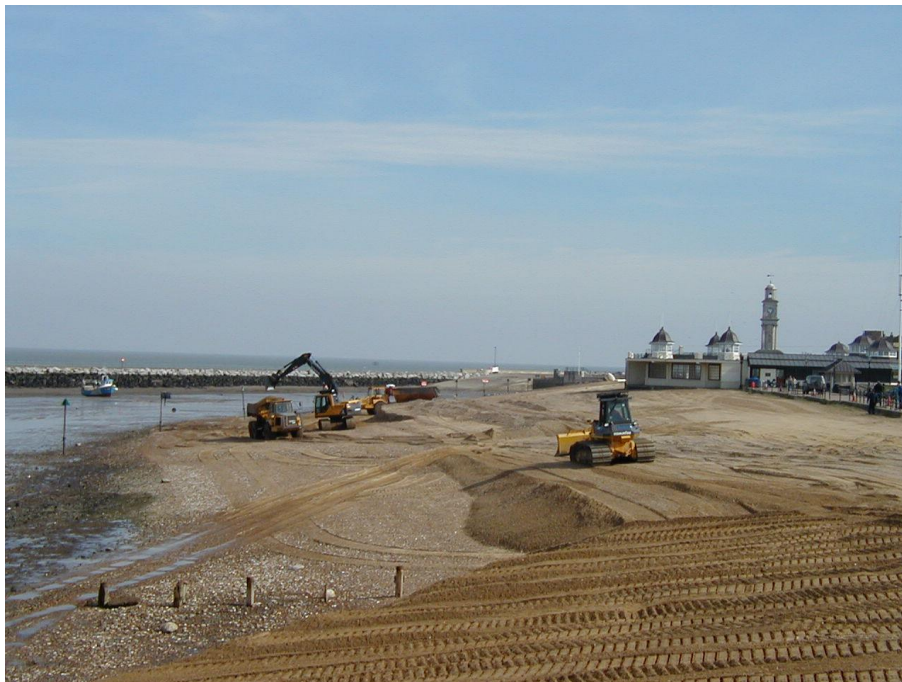
Small annual or biennial recharges are currently undertaken adjacent to Herne Bay Pier. Approximately 2,500 m³ of material is to be moved from the Bandstand to the area of scour within and next to the timber groynes (Figure 8-8). Approximately 1,000-2,000m³ is extracted from immediately west of the Pier to replenish bays towards the Lane End roundabout.

FIGURE 8-8 BEACH RECYCLING WITHIN THE HARBOUR
SECTION H (EAST CLIFF PARADE)

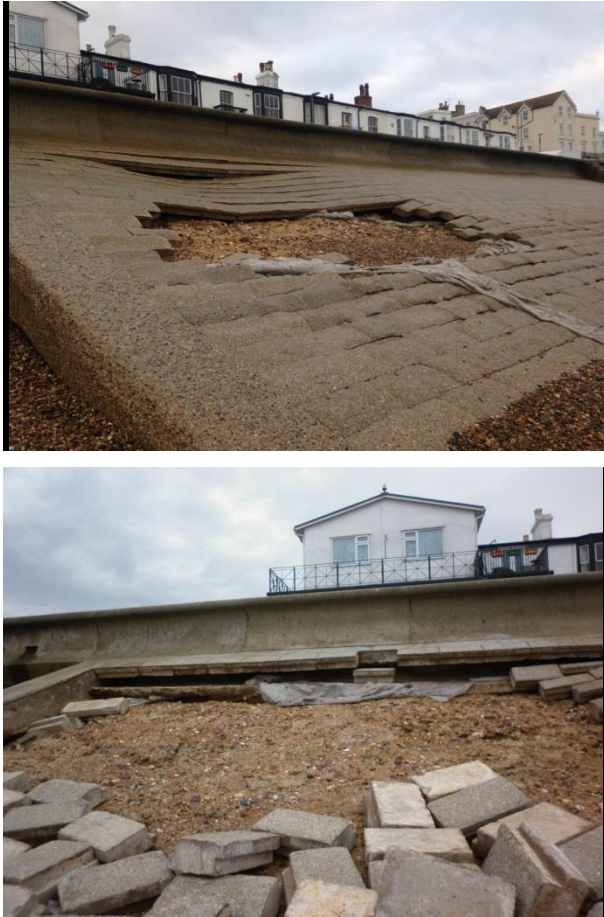
FIGURE 8-9 SEA WALL FAILURE IN HERNE BAY SECTION H AFTER ONE TIDE 9 (LEFT) AND AFTER TWO TIDES (RIGHT)

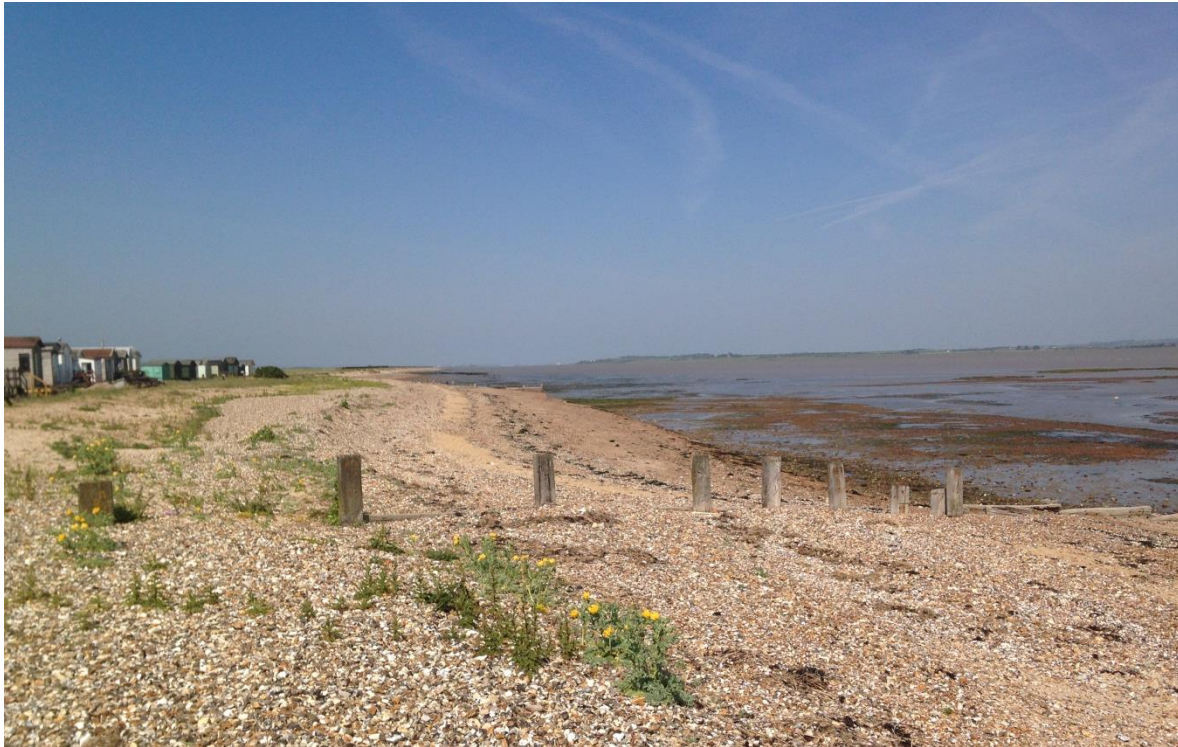
FIGURE 9-1 VEGETATED SHINGLE, SEASALTER

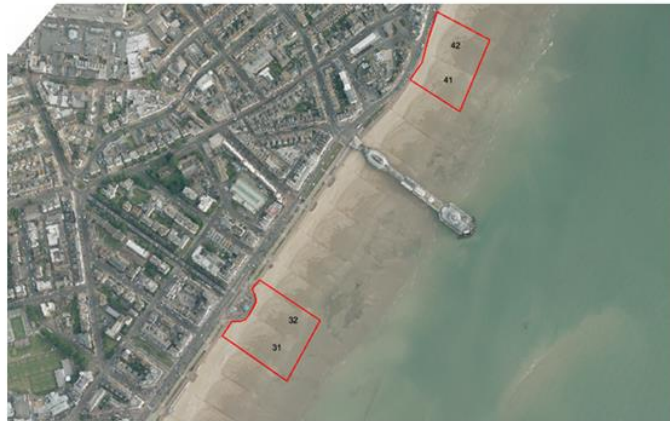
Date	13 April 2015 – 21 April 2015	Logged by	EBC			
Description of Works/Notes						
Capitally-funded, annual maintenance works. Shingle recharge via Sospan Dau. Values reported below are Net (calculated losses at 17.61%).						
Description of Frontage						
Before	Depleted shingle, low beaches. Groyne Bays 41 and 42: negligible berm prior to recharge. Groyne Bays 32 and 33: Bandstand beaches, depleted as per Spring 2015 difference model	After	No reprofilling necessary. No after survey to give new cross-sections, but beaches are visually <u>more well</u> built up.			
Quantify extraction/deposition (Note: If volume unknown conversion used is 1 tonne: 1.8 m ³ of material)						
Profile/Groyne No.	Profile/Groyne No.	Quantity (m ³)		Lorry Capacity (m ³)	Number of lorry loads	Material Description (use drop down)
32	33	1409	Or			Shingle
33	34	3228				Shingle
41	42	1620				Shingle
42	43	2445				Shingle
Total:		8702				m³

FIGURE 9-3 EXAMPLE OF COMPLETED RECYCLING LOG FOR DEAL (2015)

It is important that all beach management works (recycling, beach recharge, reprofiling) should be logged on the appropriate form to indicate the extraction and deposition locations, the quantities moved and the start and end date of the activity (Figure 9-3).
