Regional Beach Management Plan 2015: Oldstairs Bay to Pegwell Bay

Report – ENVIMSE100035/R-01

Final Report, February 2017

Main Report

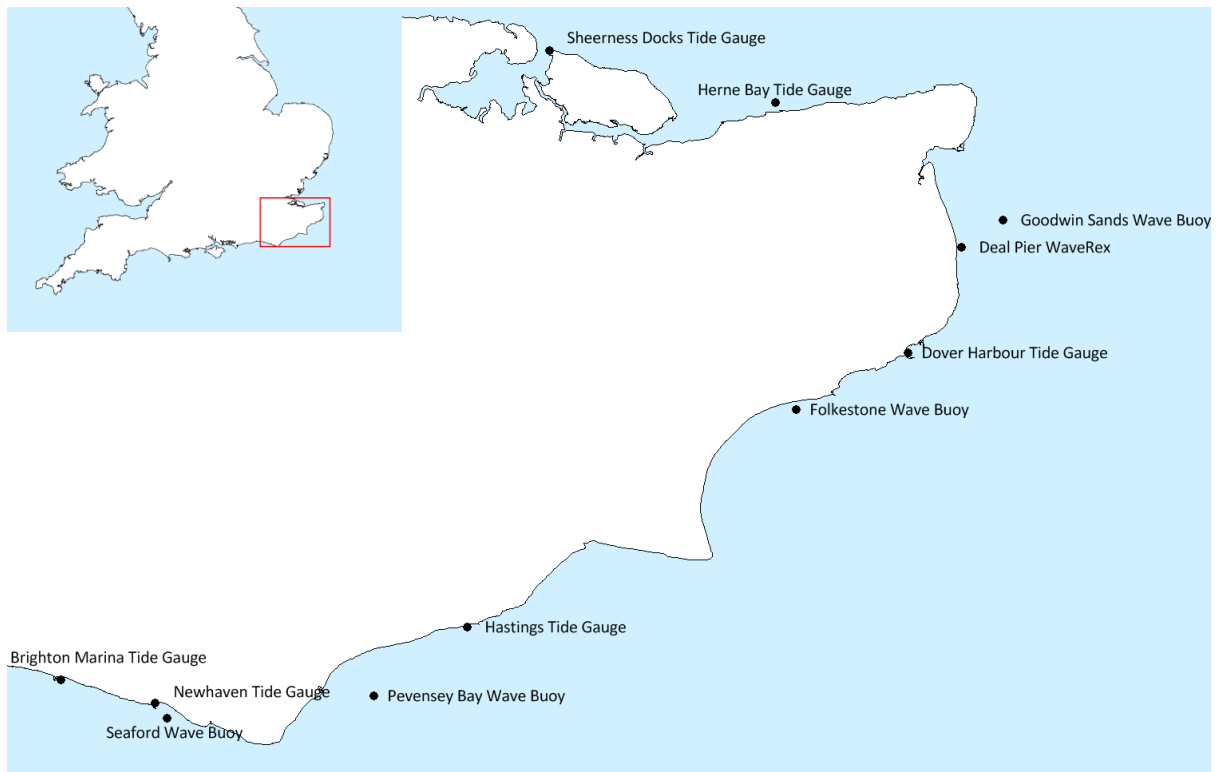
FIGURE 3-2 LOCATION OF WAVE BUOYS ON THE SOUTH EAST COAST

Wave heights are recorded both at Goodwin Sands wave buoy, located at $51^{\circ}15.01' N$ $001^{\circ}28.98' E$ and Deal Pier wave radar, at $51^{\circ}13.4275' N$ $001^{\circ}24.5555' E$. At Goodwin Sands, wave parameters are recorded using a Datawell Directional WaveRider Mk III buoy. The buoy was

As part of the Regional Coastal Monitoring Project a network of wave buoys has been deployed around the coast since 2003.

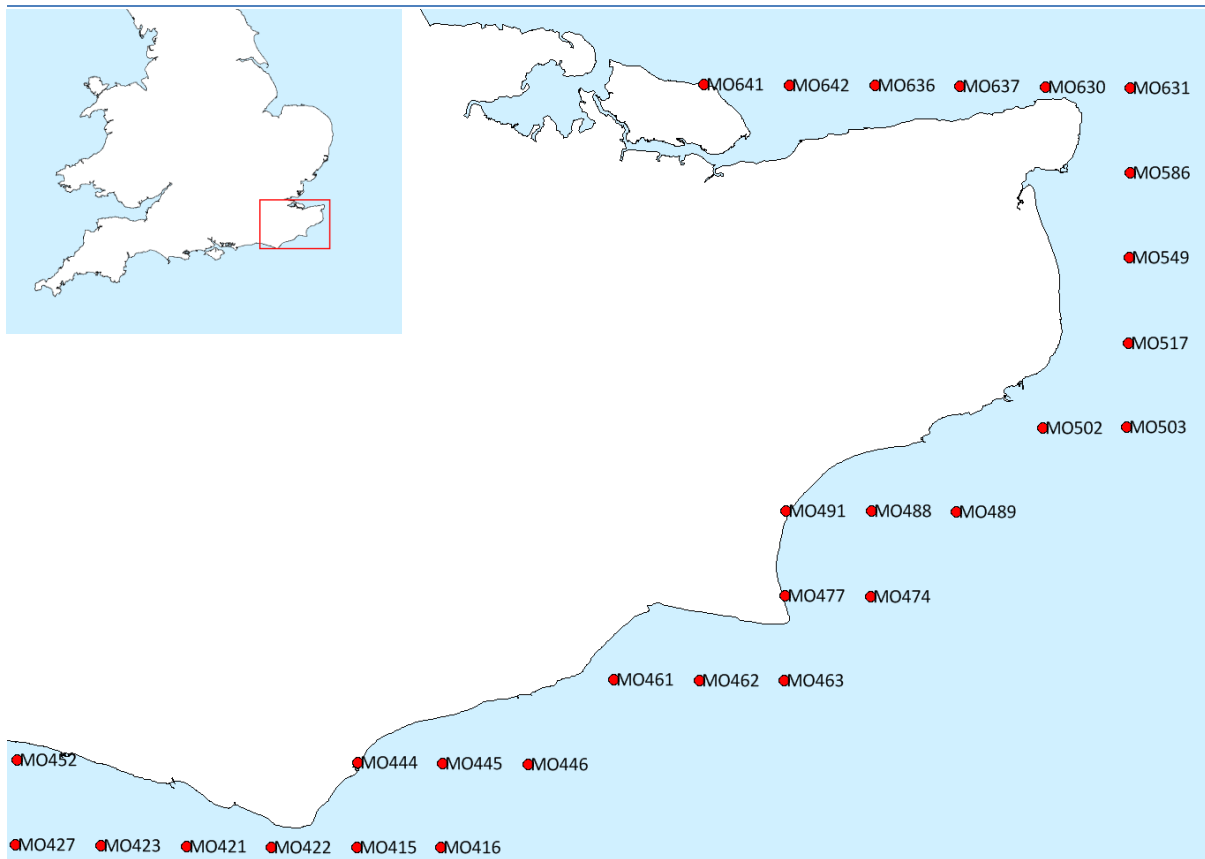
FIGURE 3-4 LOCATION OF MET OFFICE HINDCAST POINTS

Using thirty-three years of Met Office Hindcast data for 52 nearshore locations at ~5km intervals (Figure 3-4) the Joint Return Probability for Beach Management study (Mason, 2014), calculated extreme return periods for each of these points.

Significant wave height return periods for Met Office points MO586, MO549 and MO517 are included for reference in Table 3-2. The drop in wave height from MO517 northwards is the result of the sheltering from westerly and south-westerly wave in the lee of the South Foreland cliffs. The methods employed to generate significant wave heights and their return periods do not take into consideration water depth and whether waves of that size could exist at that point given the effect of depth limitation. This is accounted for later in this report.

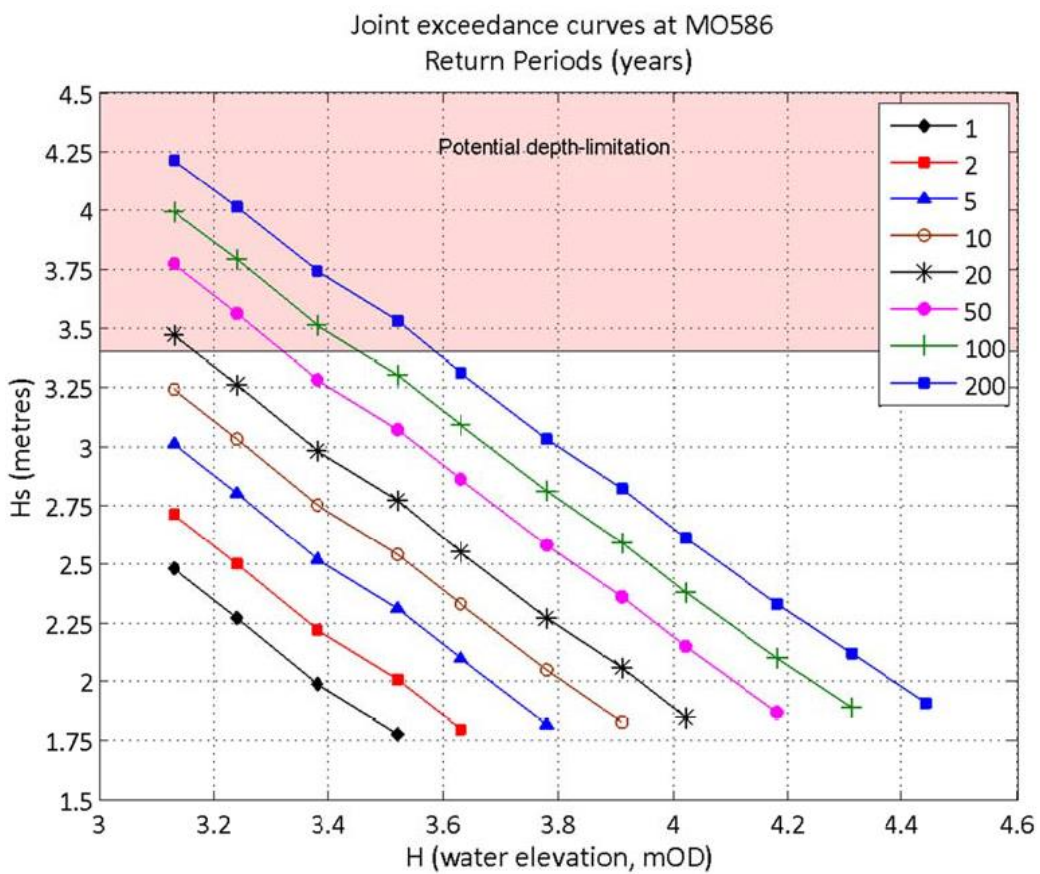
FIGURE 3-7 JOINT PROBABILITY EXCEEDANCE CURVES AT MO549 AND MO586, RETURN PERIOD (YEARS)

Results for Met office points MO586, MO549 and MO517 are presented graphically below. Note that the potential depth limitation is broadly calculated and included on the charts, but this is calculated more accurately under specific conditions later in the report.

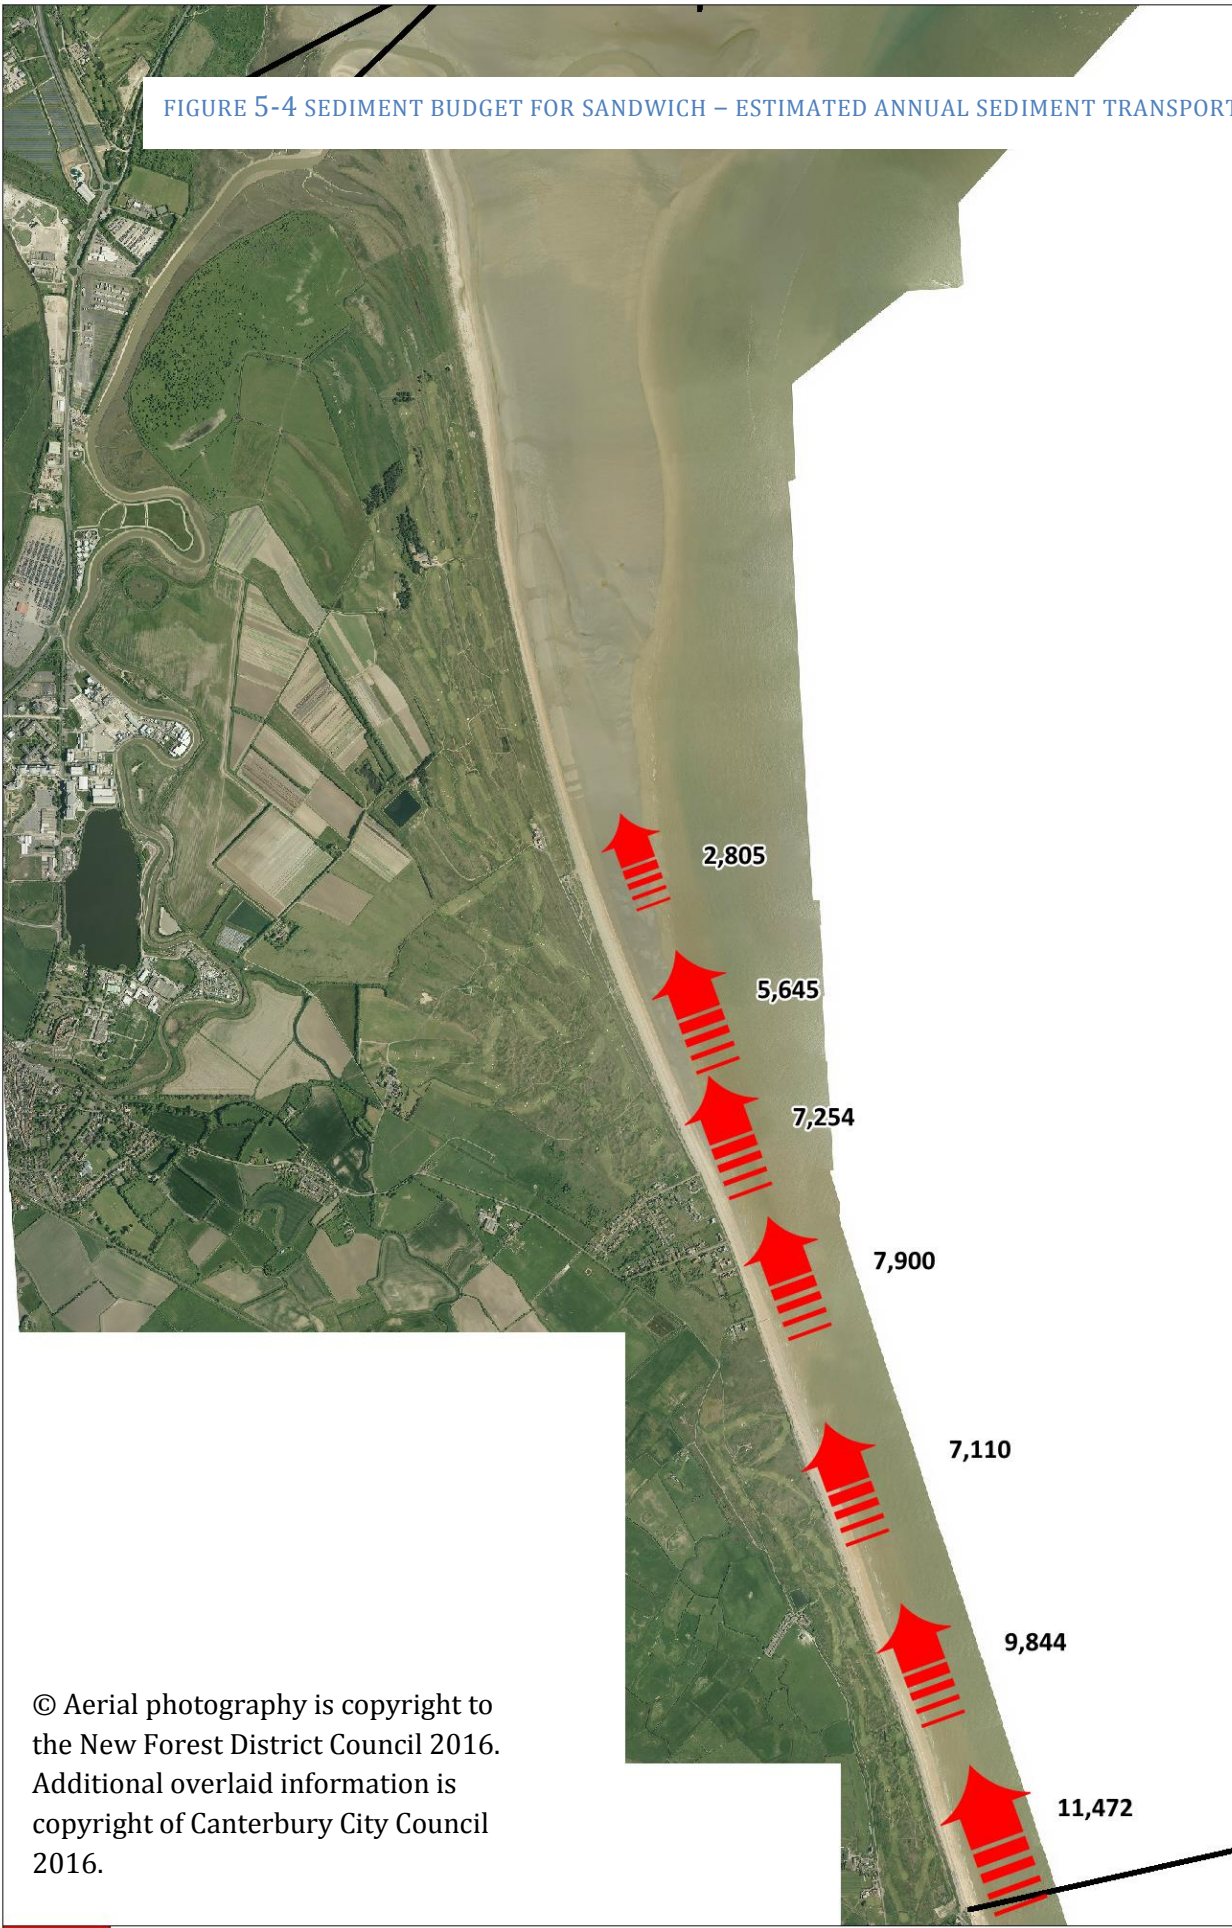
FIGURE 5-4 SEDIMENT BUDGET FOR SANDWICH – ESTIMATED ANNUAL SEDIMENT TRANSPORT

Sediment Budget - Sandwich Estimated annual sediment transport

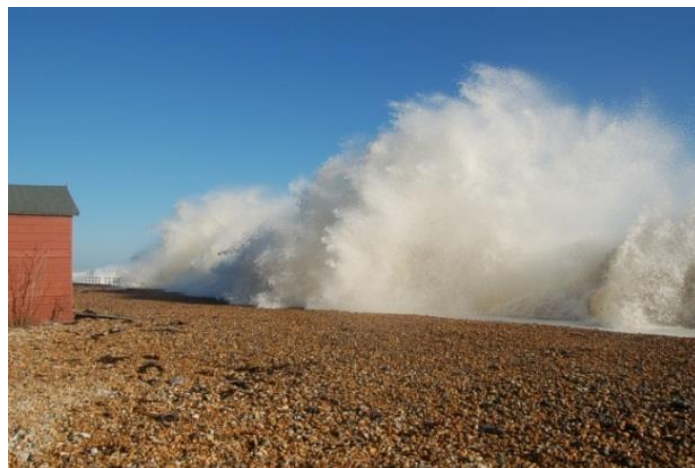
FIGURE 6-2-1 DISSIPATION OF WAVE ENERGY ON A SHINGLE BEACH (KINGSDOWN, 2009)

Shingle beaches are very efficient at dissipating wave energy (Figure 6-2-1). To calculate overtopping rates under different scenarios a methodology was developed and applied consistently to the whole frontage. This is summarised in Figure 6-2-2 and described in the following text.

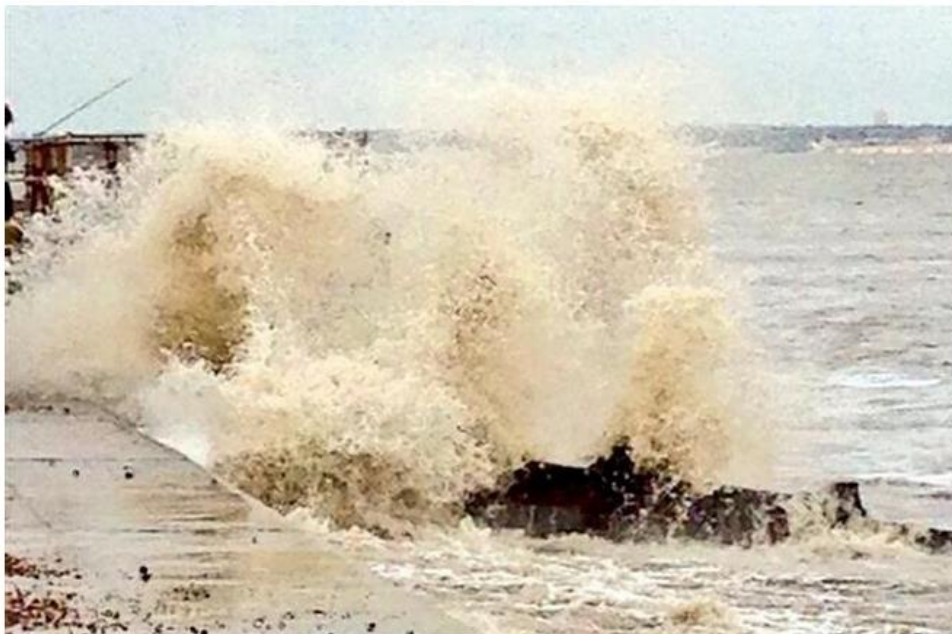
FIGURE 6-2-7 WAVE OVERTOPPING, DEAL (DECEMBER, 2013)

Waves crash against the seafront in a dramatic high tide at Deal beach this afternoon. Picture: Claire Steer

1. Photographic evidence of large overtopping events and retrospective comparison with predicted overtopping (e.g. Figure 6-2-7).

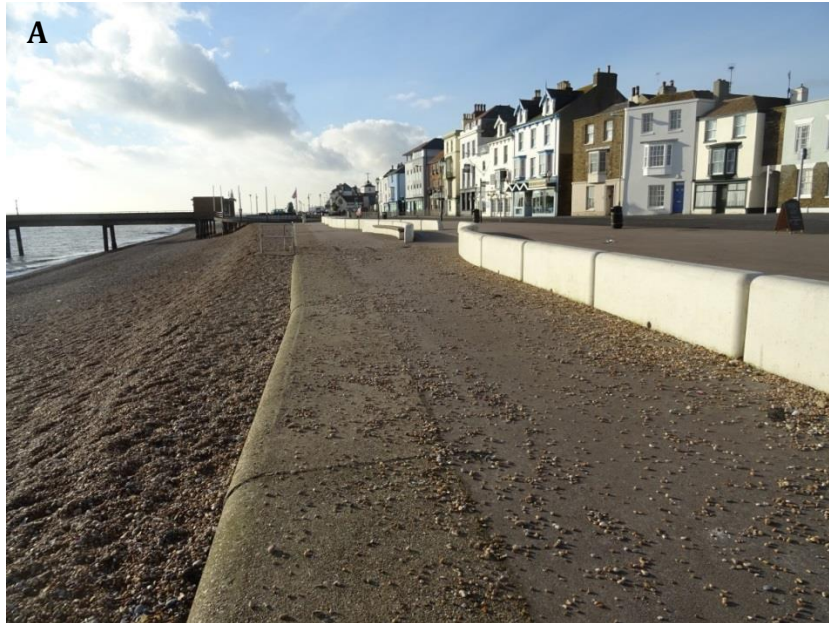
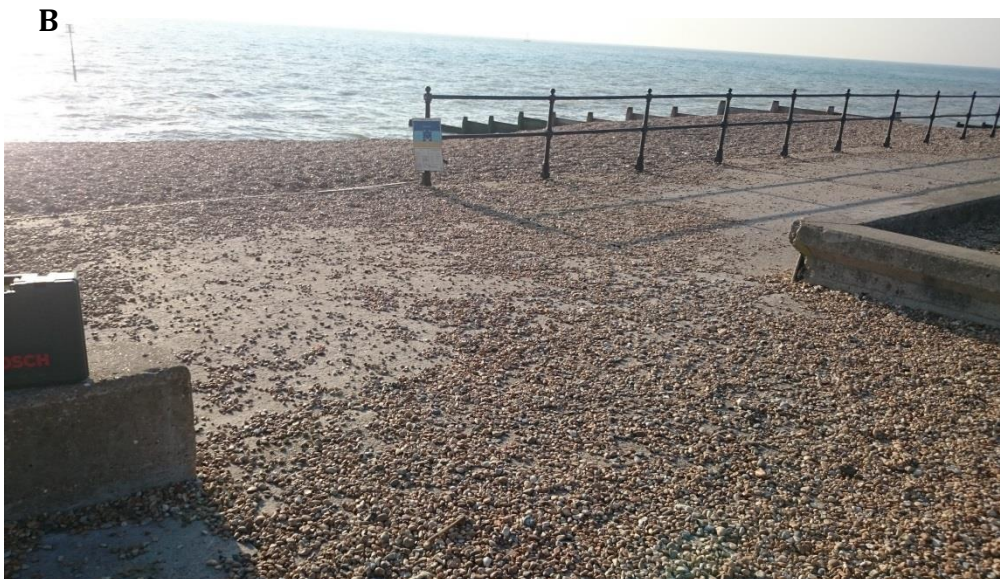
FIGURE 6-2-8 EVIDENCE OF OVERTOPPING IN DEAL (A) ON THE PROMENADE IN CENTRAL DEAL AND (B) AT KINGSDOWN (BOTH PHOTOS 2016)

2. Anecdotal evidence in the form of information that is not well documented or photographed. The prime example of this is shingle on the promenade, which is indicative of small scale overtopping (e.g. Figure 6-2-8). Where management authorities have to periodically clear this it is evident that the defence is subject to minor overtopping on a regular basis. Results can be queried to ensure these events are predicted.

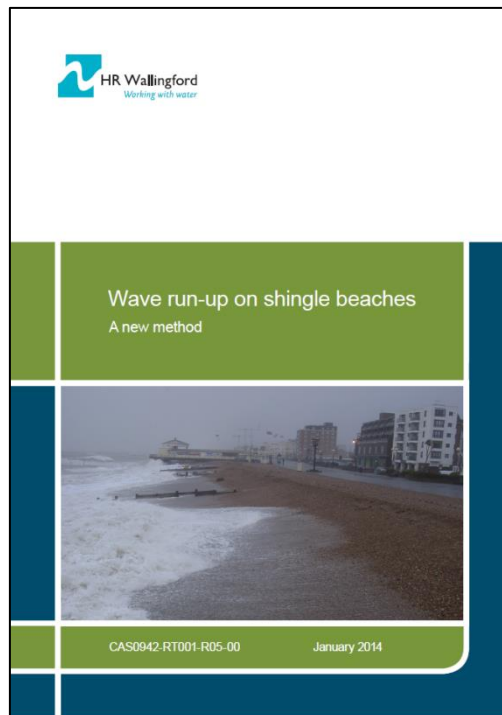
FIGURE 6-2-10 SUB-PROJECT RESEARCH AND DEVELOPMENT OF IMPROVED RUN-UP FORMULA

4. The improved formula presented in Wave run-up on shingle beaches: a new method (HRW, 2014, see Figure 6-2-10) was used in areas that were prone to green water overtopping (No structure and run-up exceeds crest). By running calculations for a number of swell components results could be verified as reasonable and ensure that an underestimate had not been made.

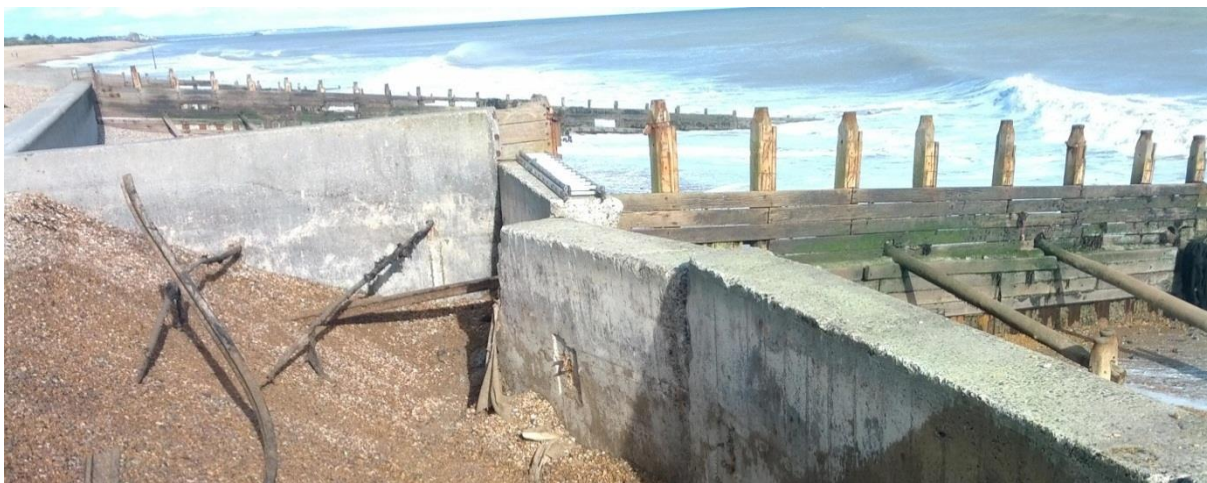
FIGURE 6-2-11 DILAPIDATED GROYNES, LOW BEACH AND SEAWALL FAILURE AT KINGSDOWN (2013)

As beach levels lower due to erosion, draw down in a storm, or failure of groynes that act as controlling structures the seawall becomes increasingly exposed to direct wave attack. In addition to a probable increase in overtopping rates, this significantly increases the risk of seawall failure.

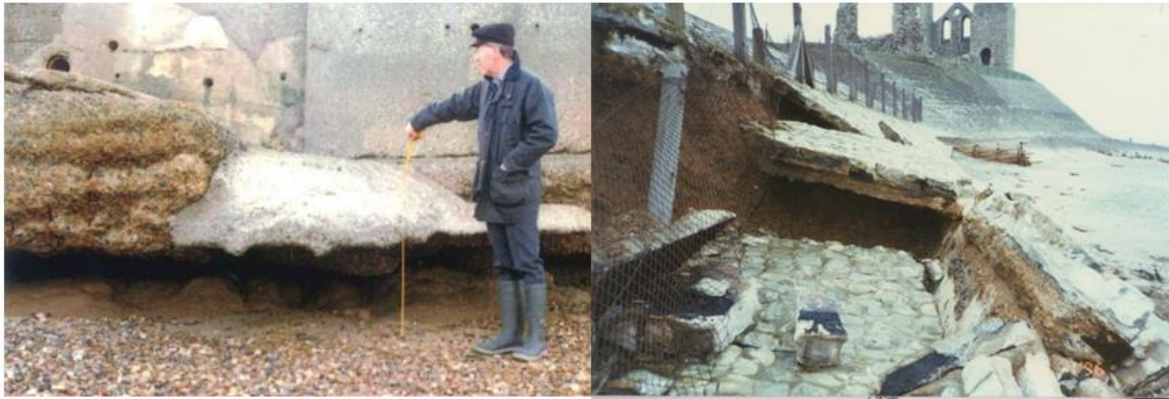
FIGURE 6-2-12 EXAMPLES OF UNDERMINING AT TANKERTON (LEFT) AND RECVLVER (RIGHT)
(BOTH PHOTOS 1999)

Typically, before beach levels get low enough to pose a credible threat to the structure the standard of protection has already become sub-standard due to the increased likelihood and severity of overtopping. There are instances where the structure itself provides a sufficient barrier to overtopping, but often in these cases a beach is required to be maintained in order to protect the structure and prevent undermining.

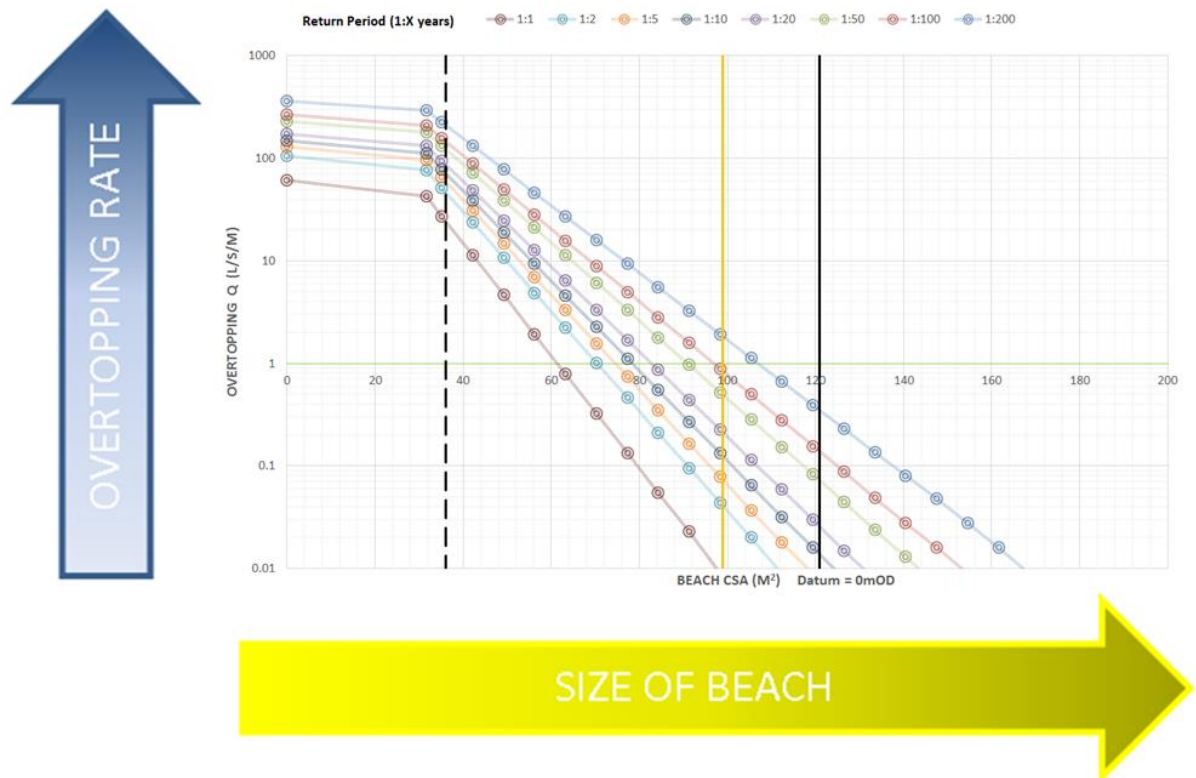
FIGURE 6-3-1 EXAMPLE OF OVERTOPPING RESULTS CHART

In order to visualise the results for each defence section they are presented on a chart (Figure 6-3-1) which compares the predicted overtopping rate with the size of the beach cross sectional area (CSA). This shows the decrease in overtopping for each of the return period conditions (1 to 200 years) as the size of the beach increases. For sections where a rock revetment is present, a single overtopping calculation is performed for overtopping over the revetment.

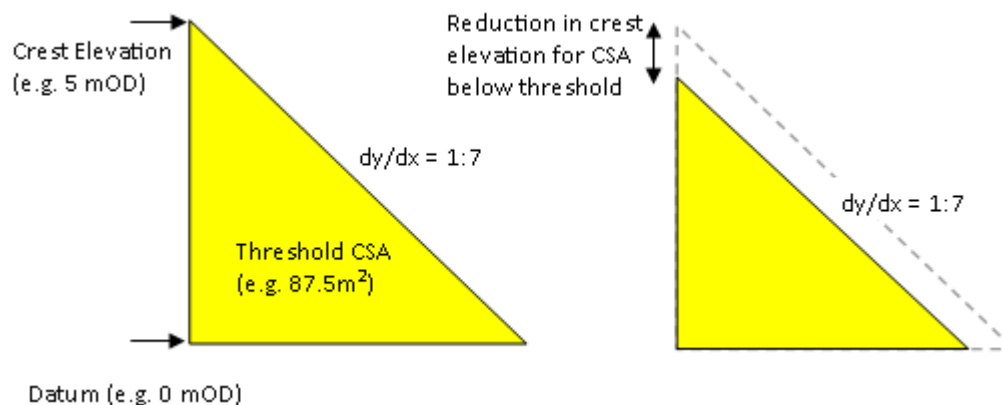
FIGURE 6-3-2 REDUCTION IN CREST HEIGHT FOR PROFILES BELOW A THRESHOLD CSA

Where the beach is the only forward defence (i.e. no hard structure or rock armour) the calculations are based on the beach only and an additional line is plotted (red dashed), showing the minimum CSA at which the modelled crest height can be maintained at a 1:7 slope. The calculations for cross-sectional areas less than this threshold value are based upon a reduced crest height (Figure 6-3-2). This threshold CSA value is denoted by a dashed red line on the graphs.

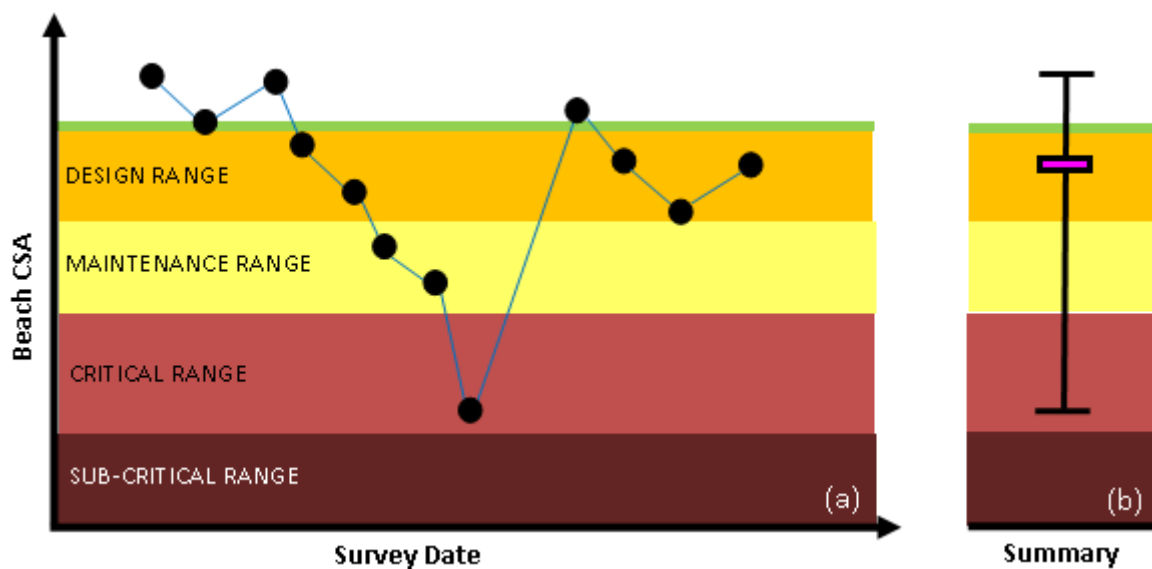
FIGURE 7-2 PRESENTATION OF STANDARD OF PROTECTION AND TRIGGER LEVELS

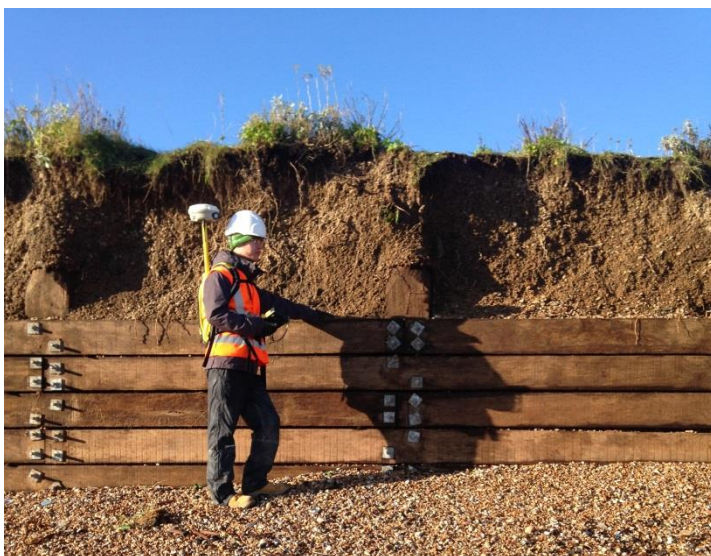
FIGURE 8-1 EXPOSED TIMBER BREASTWORK AND CLIFFING AT WELLINGTON PARADE (JAN 2016)
