Regional Beach Management Plan 2017: Selsey Bill to Climping

Report – ENVIMSE100035/R-01

Final Report, August 2017

Main Report

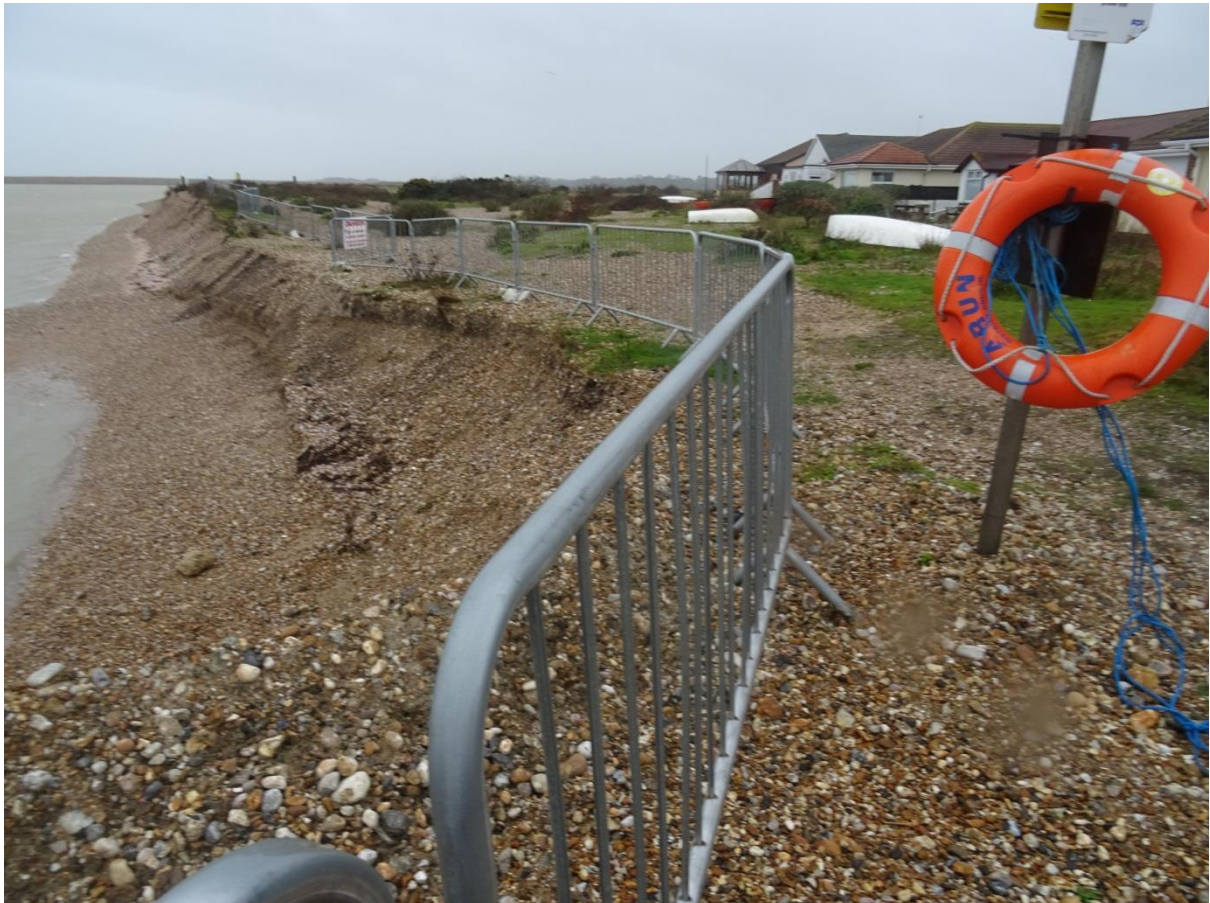
FIGURE 2-1 EROSION OF THE BEACH WEST FRONT ROAD (2016)

Damage to slopes and cliffs, property on top of the slopes and cliffs and damage to property through loss of beach are all reduced by the presence of a shingle beach (Figure 2-1). Prior to the breach of the Church Norton spit, there was a risk of erosion at Pagham Harbour, there are also risks at Pagham to Aldwick, Elmer and Climping. There have been no properties lost to the sea in recent history (Appendix C).

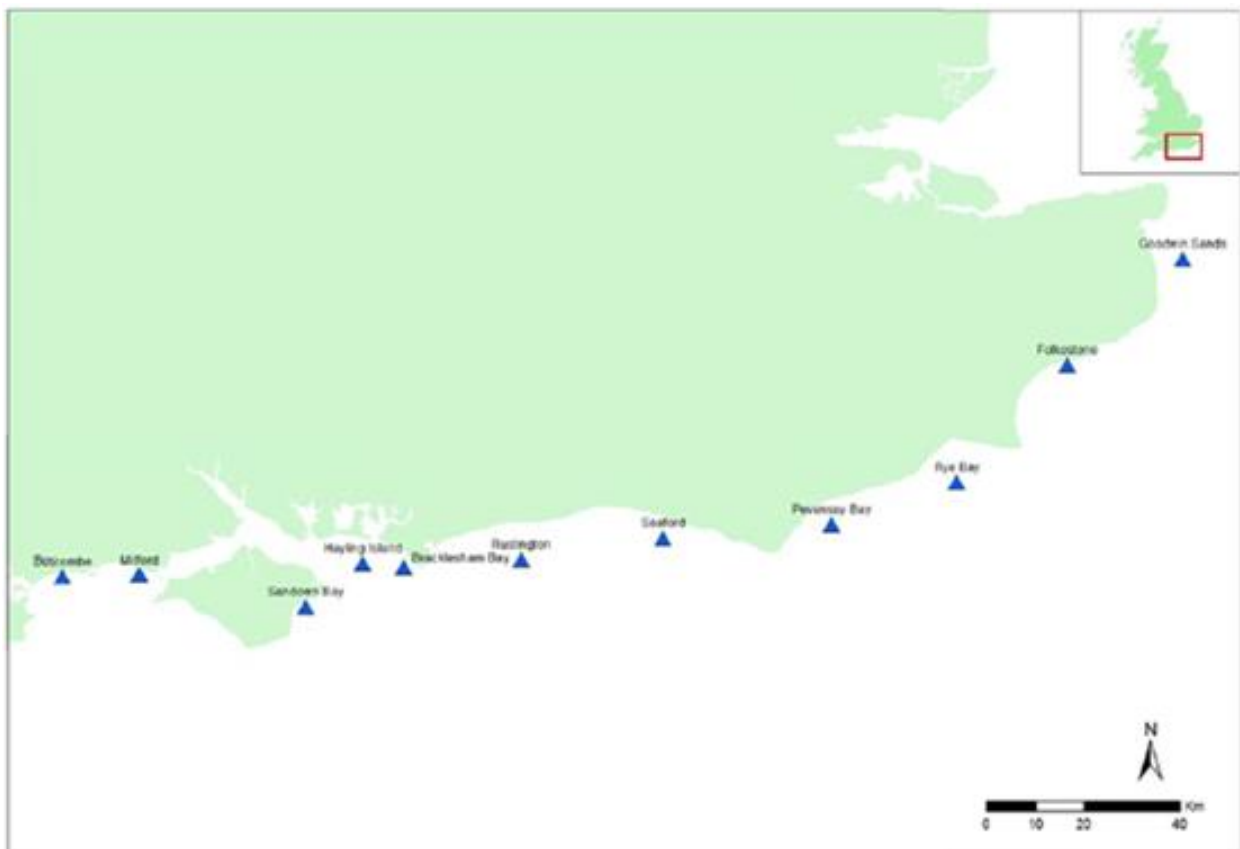
FIGURE 3-2 LOCATION OF WAVE BUOYS ON THE SOUTH EAST COAST

As part of the Regional Coastal Monitoring Programme a network of wave buoys has been deployed around the coast since 2003.

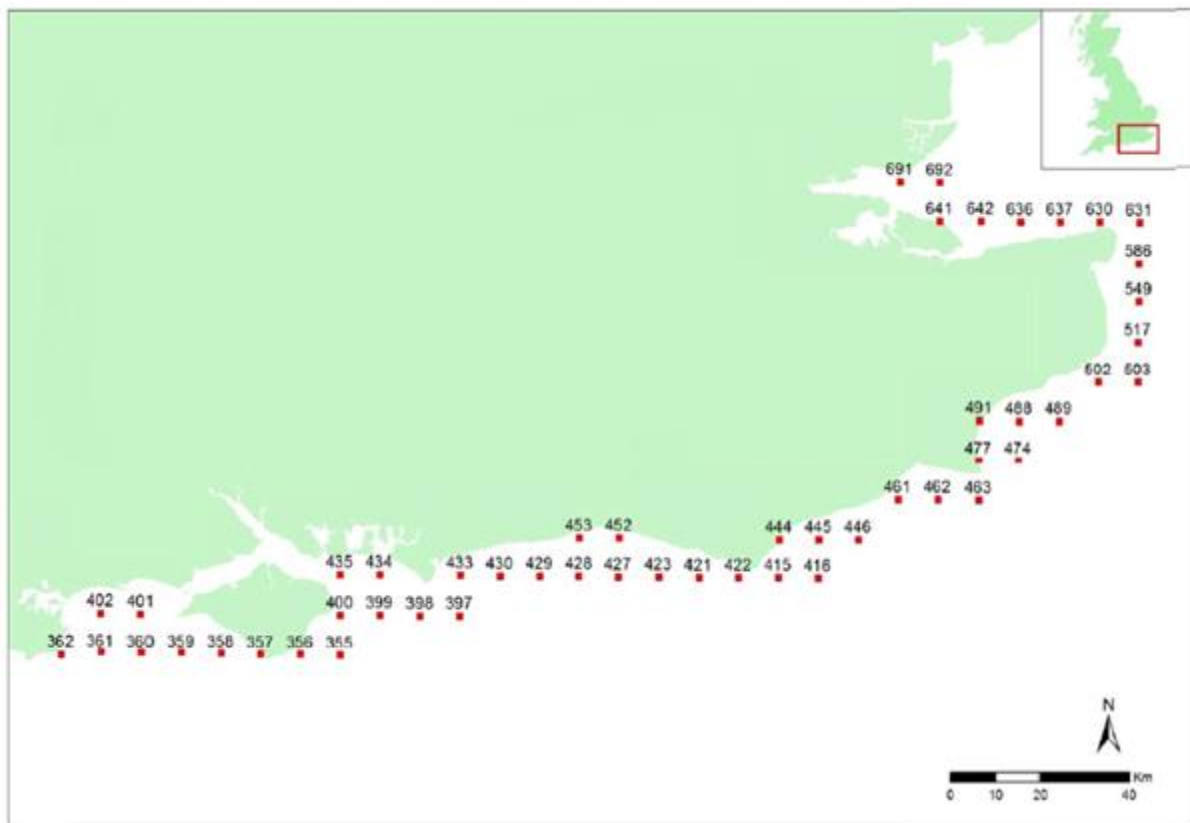
FIGURE 3-4 LOCATION OF MET OFFICE HINDCAST POINTS

Using thirty-three years of Met Office Hindcast data for 52 nearshore locations at ~5km intervals (Figure 3.4) the Joint Return Probability for Beach Management study (Mason, 2014), calculated extreme return periods for each of these points.

Significant wave height return periods for Met Office points M0433, M0430 and M0398 are included for reference in Table 3-2.

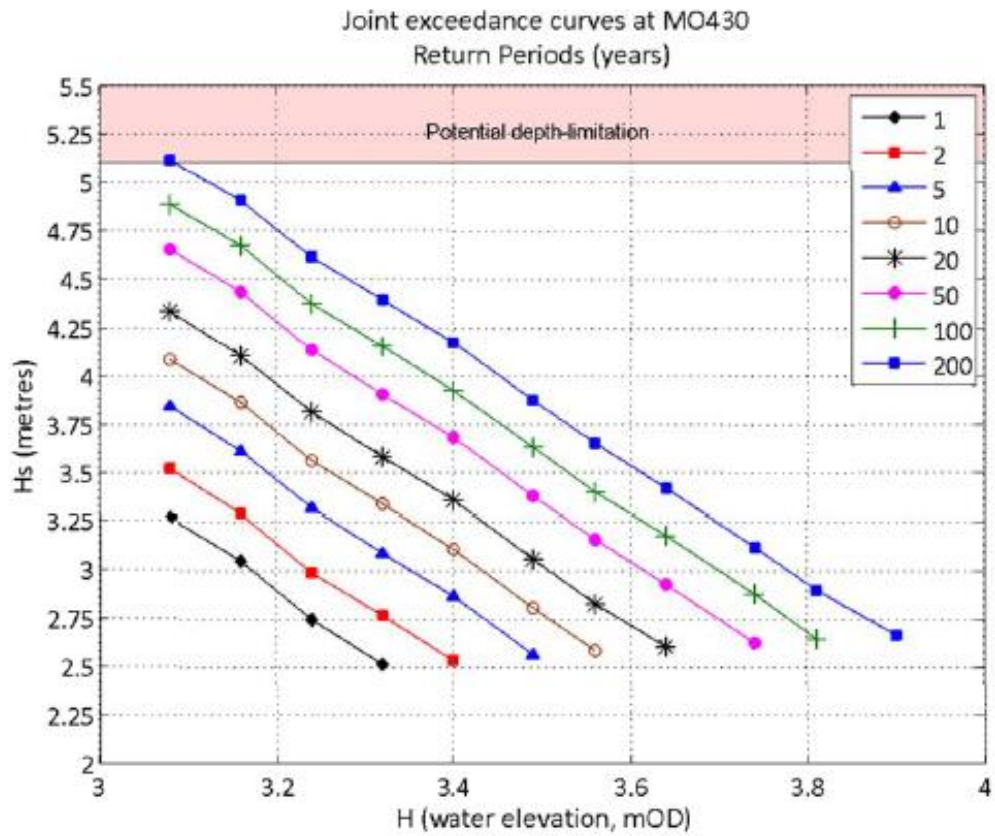
FIGURE 3-7 JOINT PROBABILITY EXCEEDANCE CURVES AT MO430 AND MO433, RETURN PERIOD (YEARS).

Results for Met office points M0398, M0433 and M0430 are presented graphically below. Note that the potential depth limitation is broadly calculated and included on the charts, but this is calculated more accurately under specific conditions later in the report.

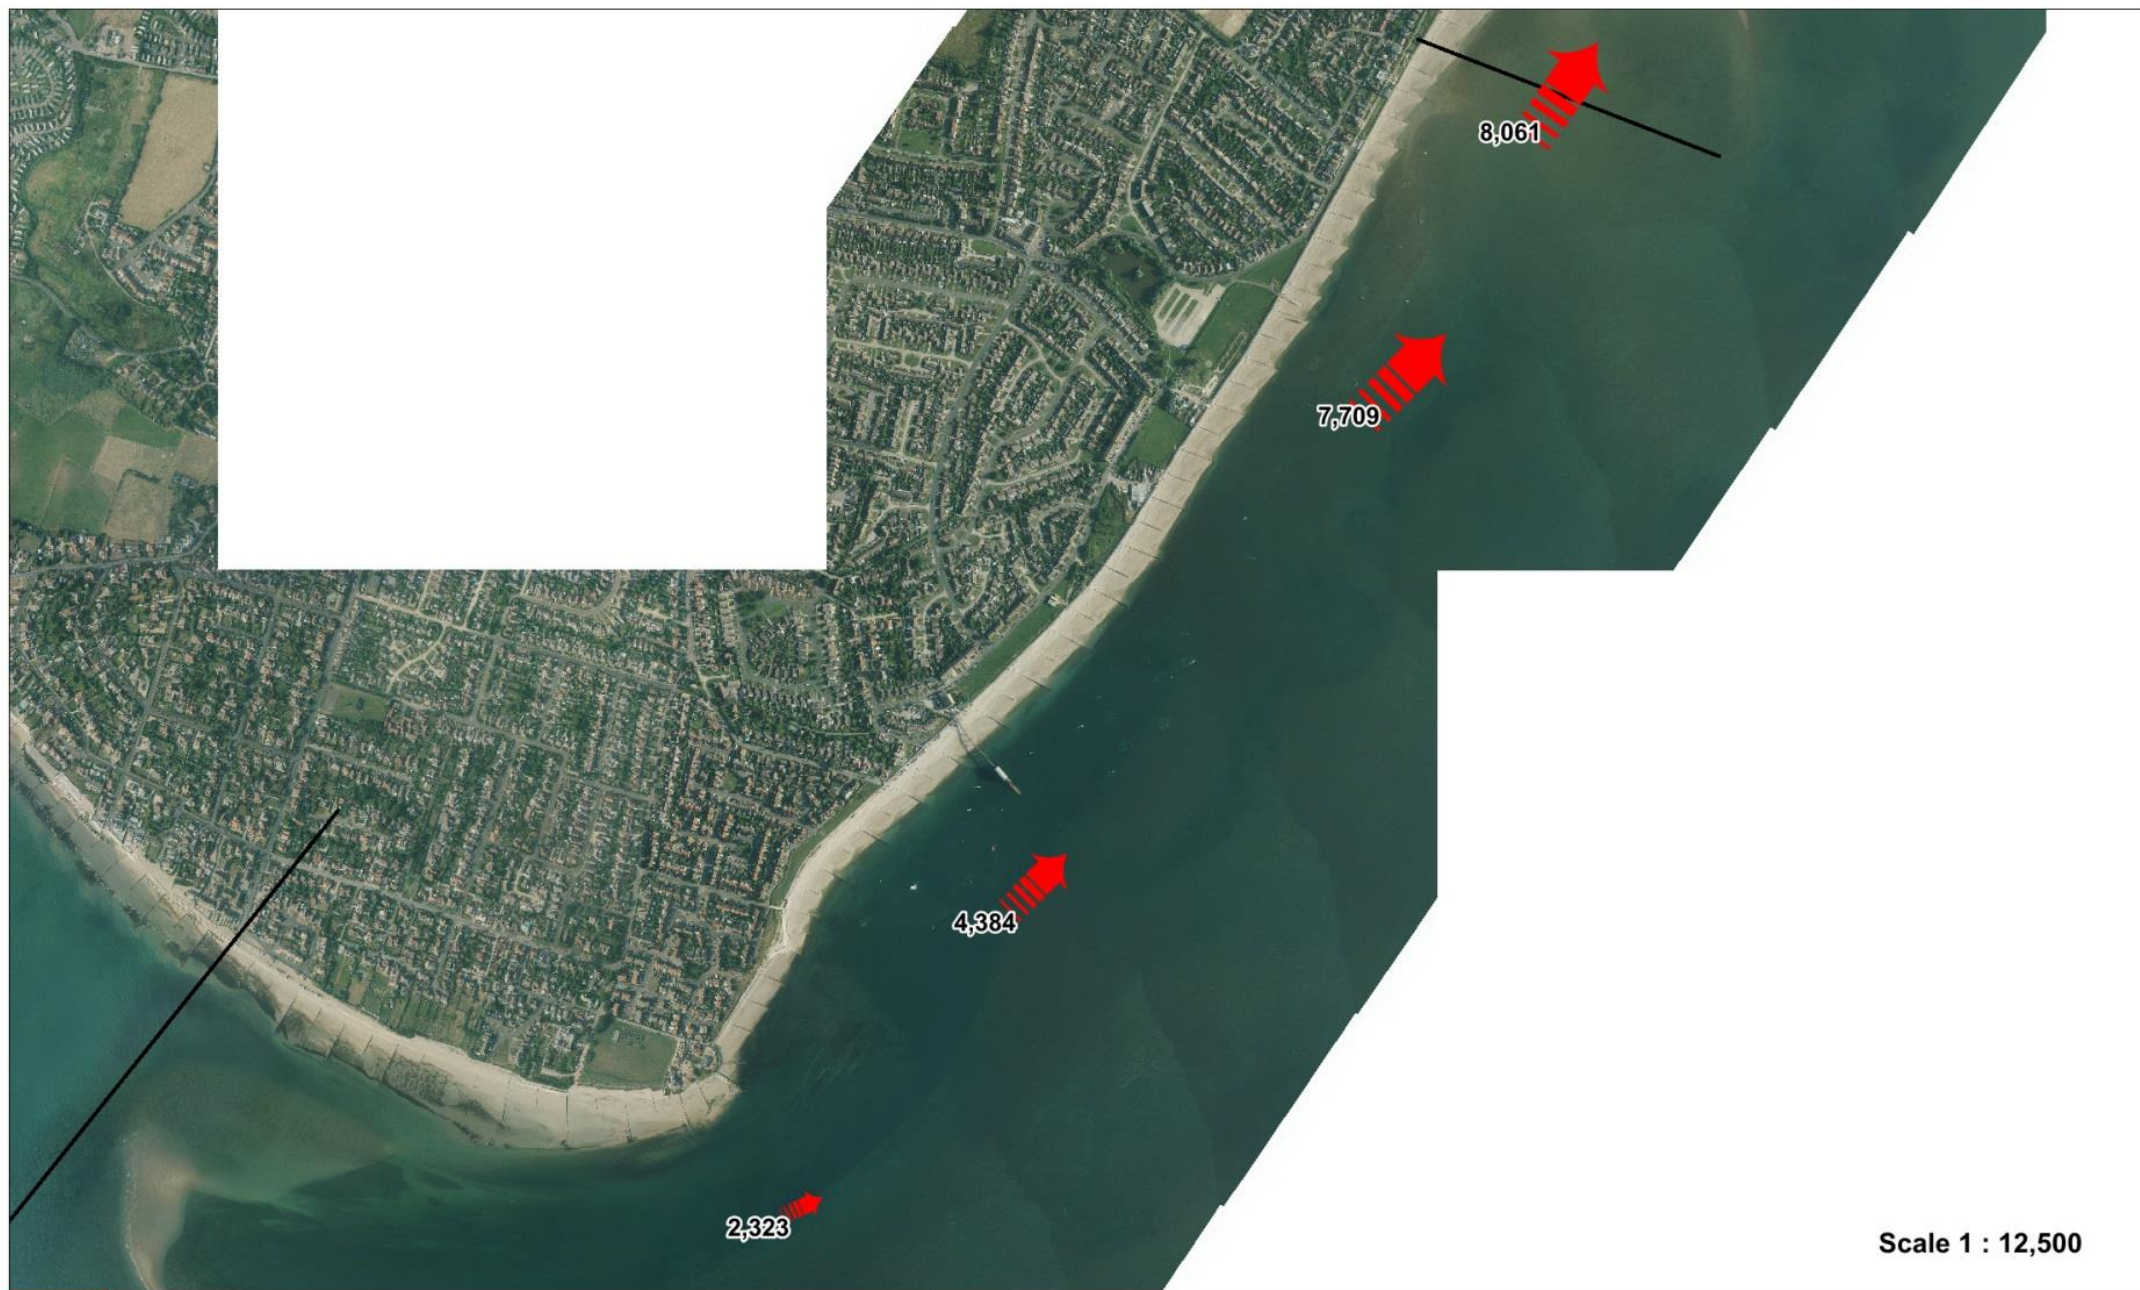
FIGURE 5-3 SEDIMENT TRANSPORT RATES – SELSEY BILL
 Estimated annual sediment transport in cubic meters.
 — Unit boundaries

Changes and rates shown on the plate are calculated based on 2007 and 2017 data and thus mask significant annual differences. The sediment budget presented should be used and interpreted with great care.

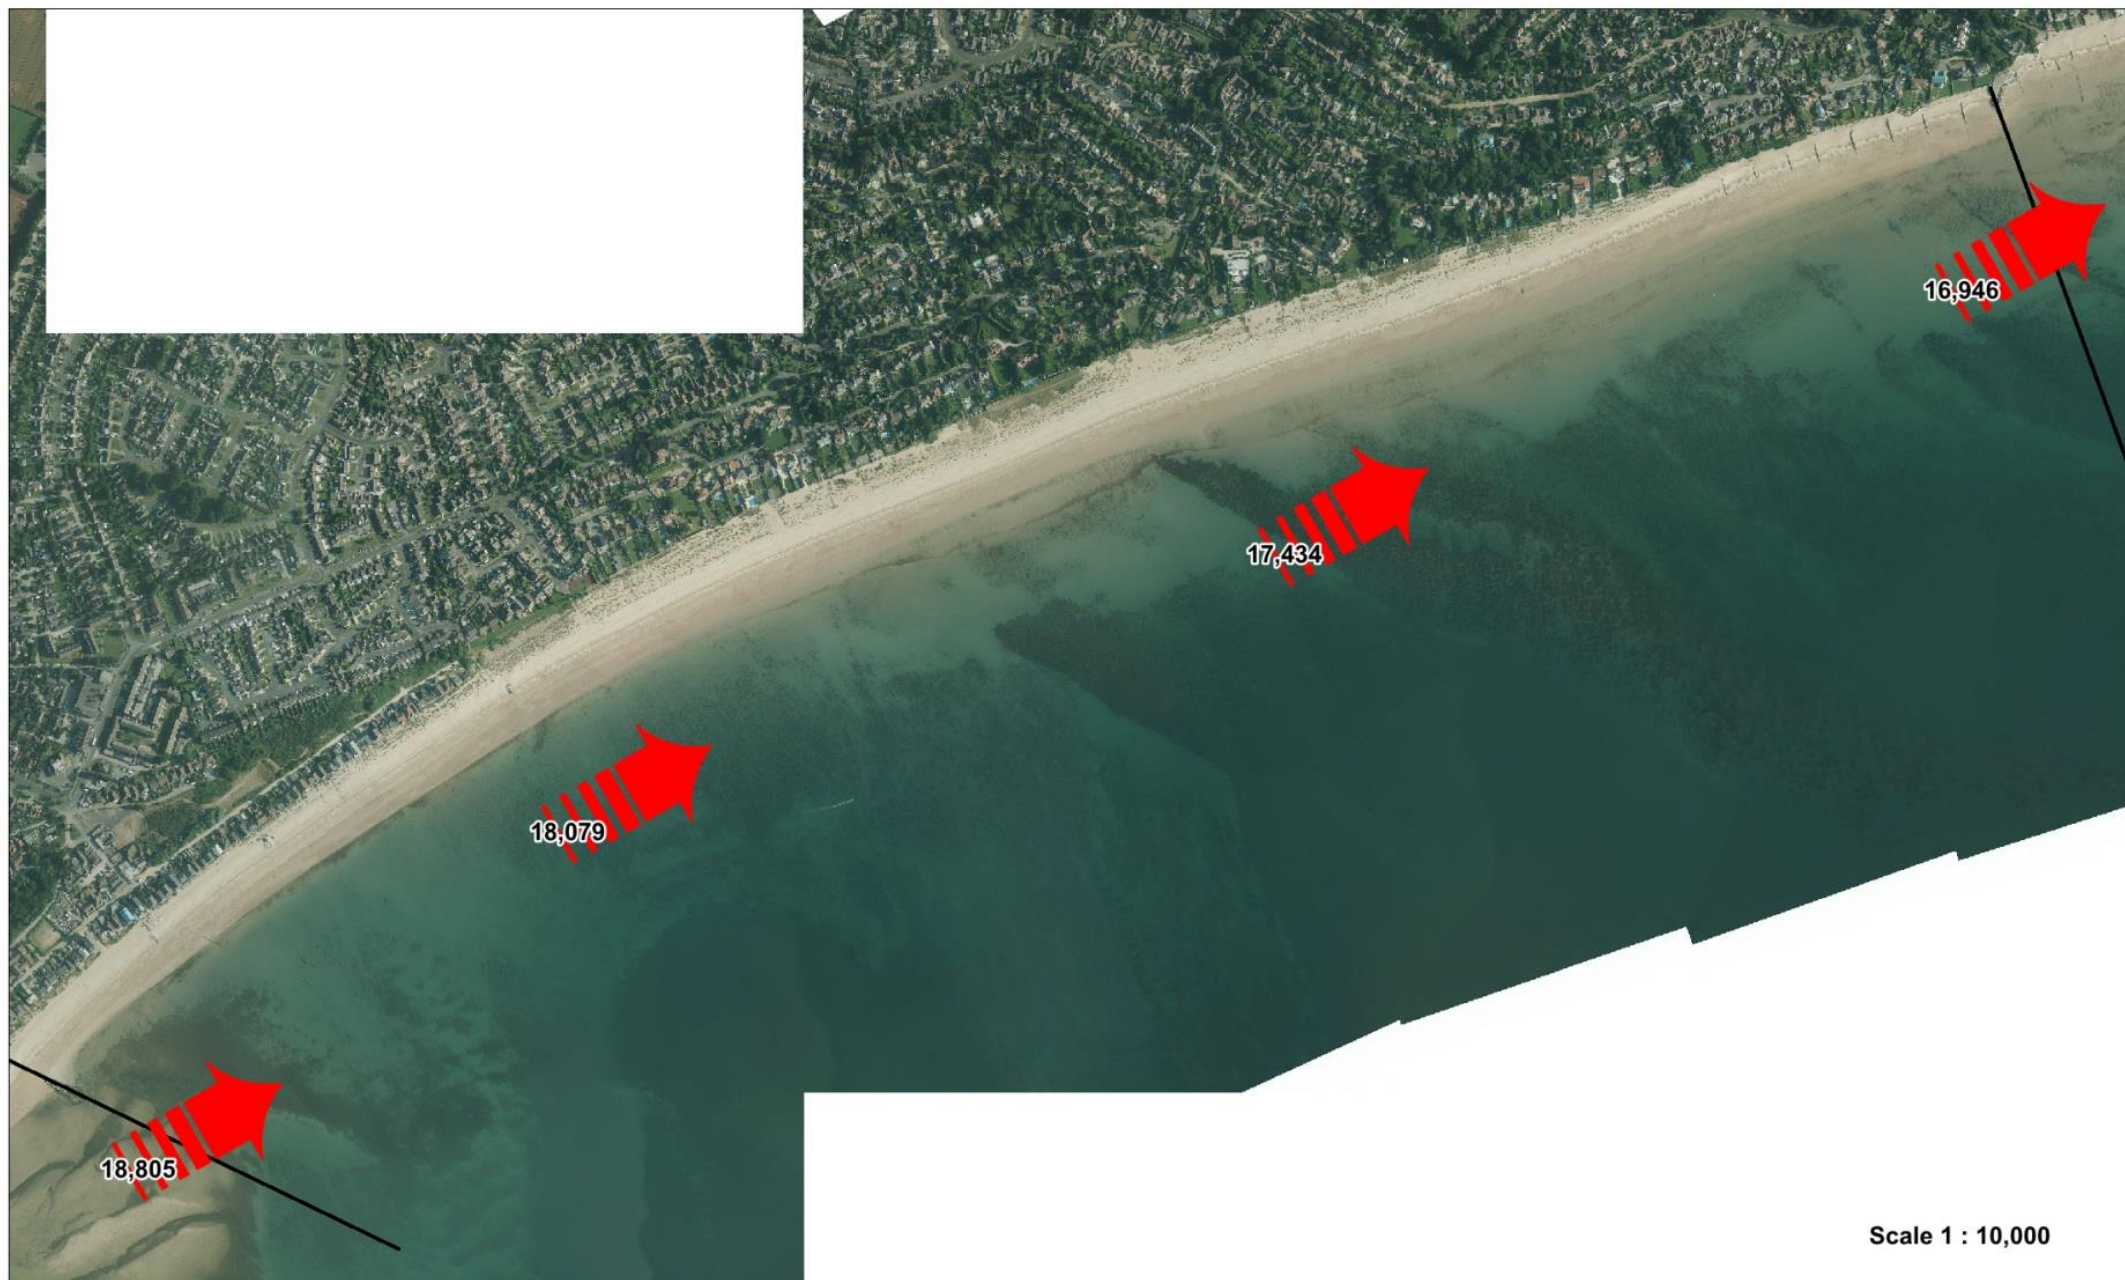
FIGURE 5-5 SEDIMENT TRANSPORT RATES – PAGHAM TO
ALDWICK

Estimated annual sediment transport in cubic meters.

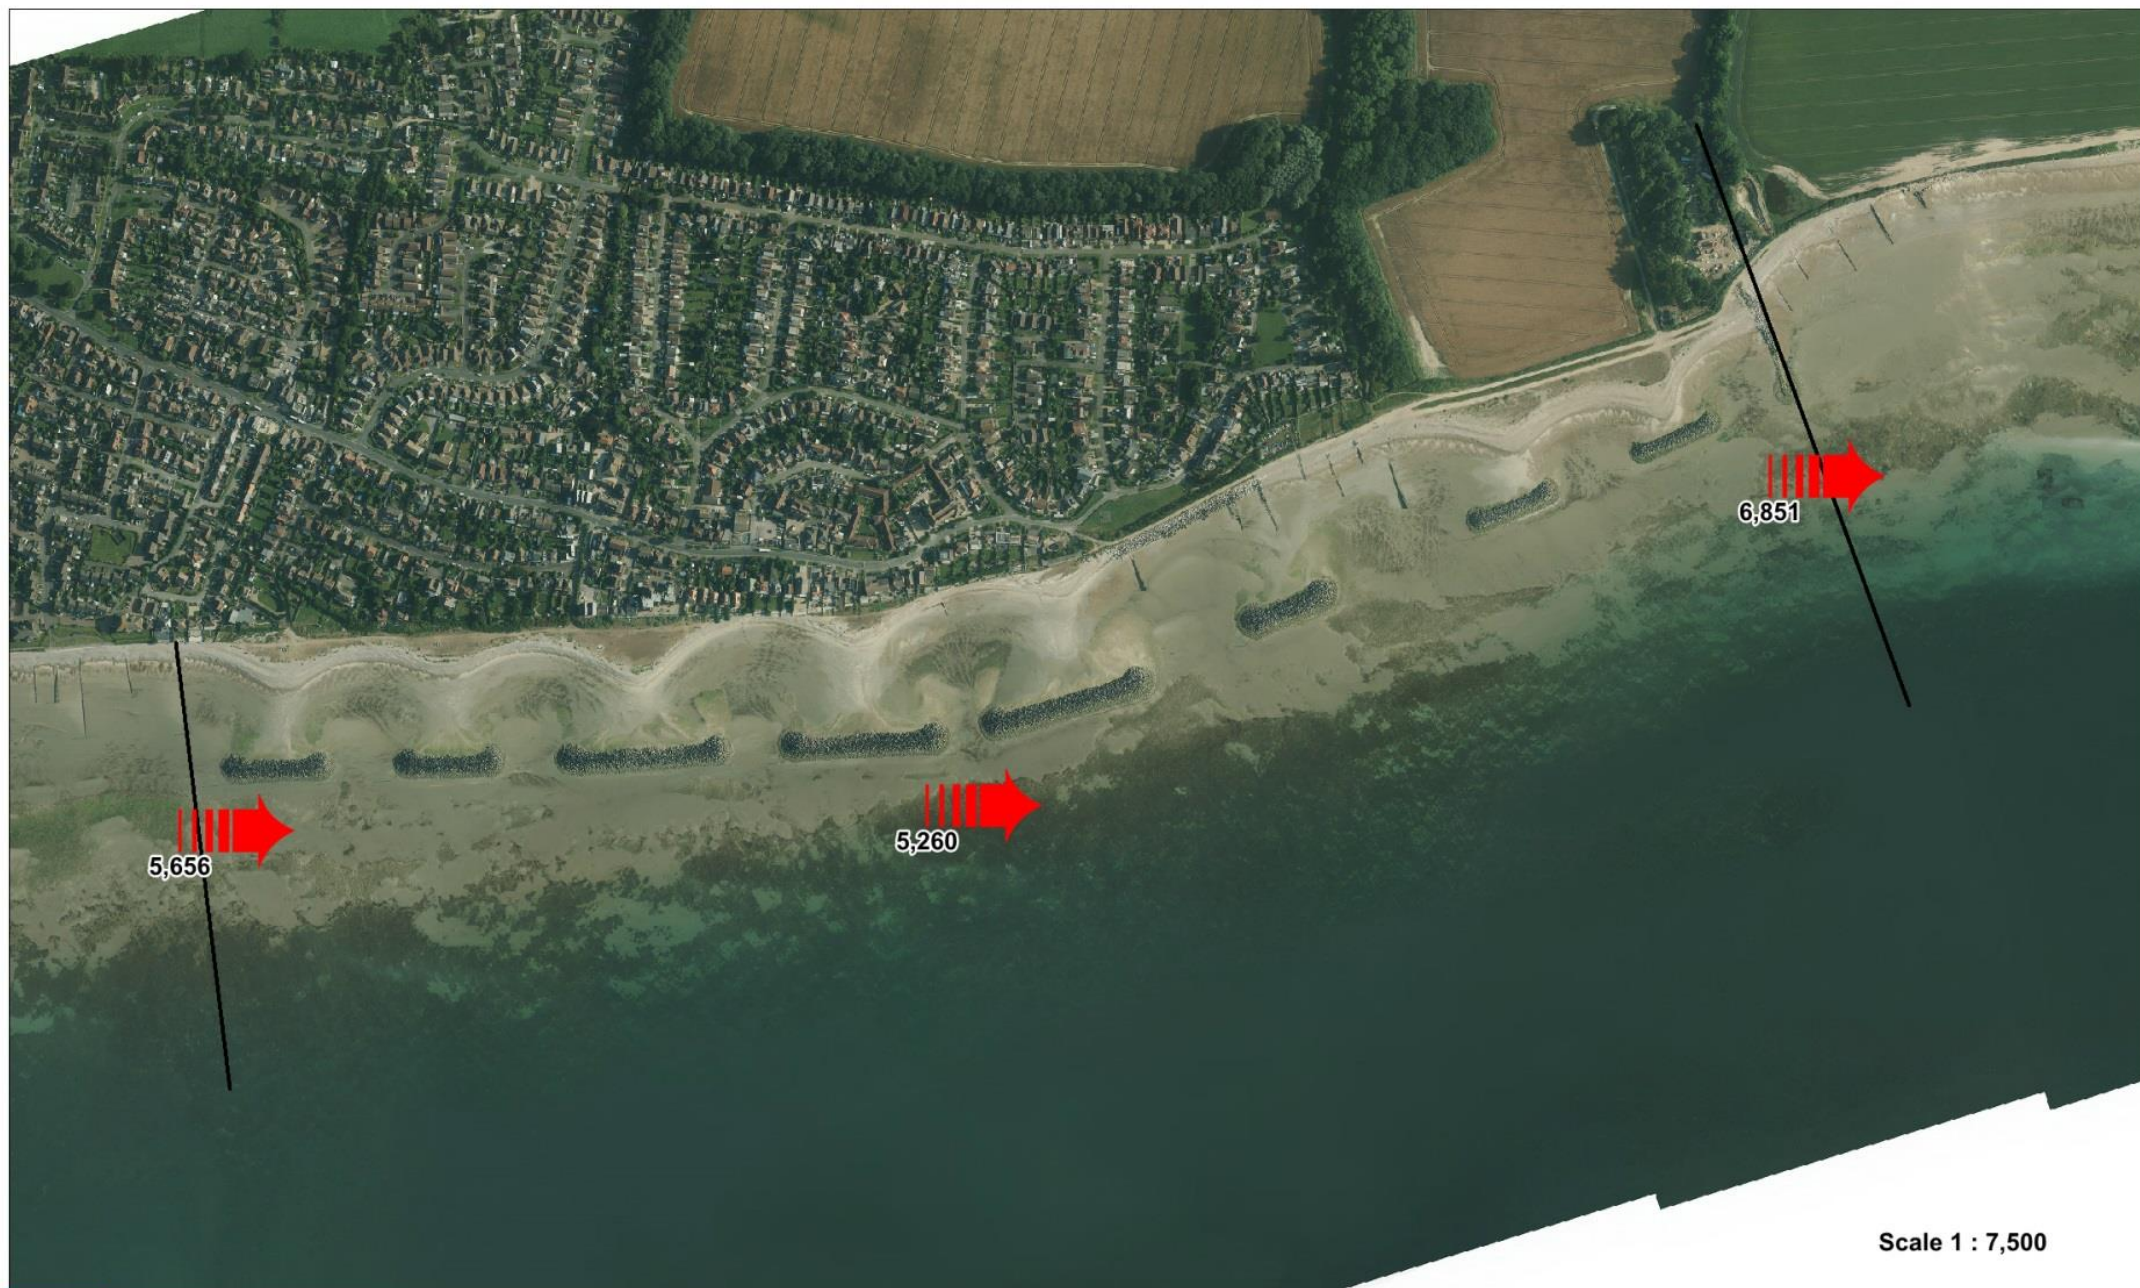
FIGURE 5-7 SEDIMENT TRANSPORT RATES – ELMER

Estimated annual sediment transport in cubic meters.

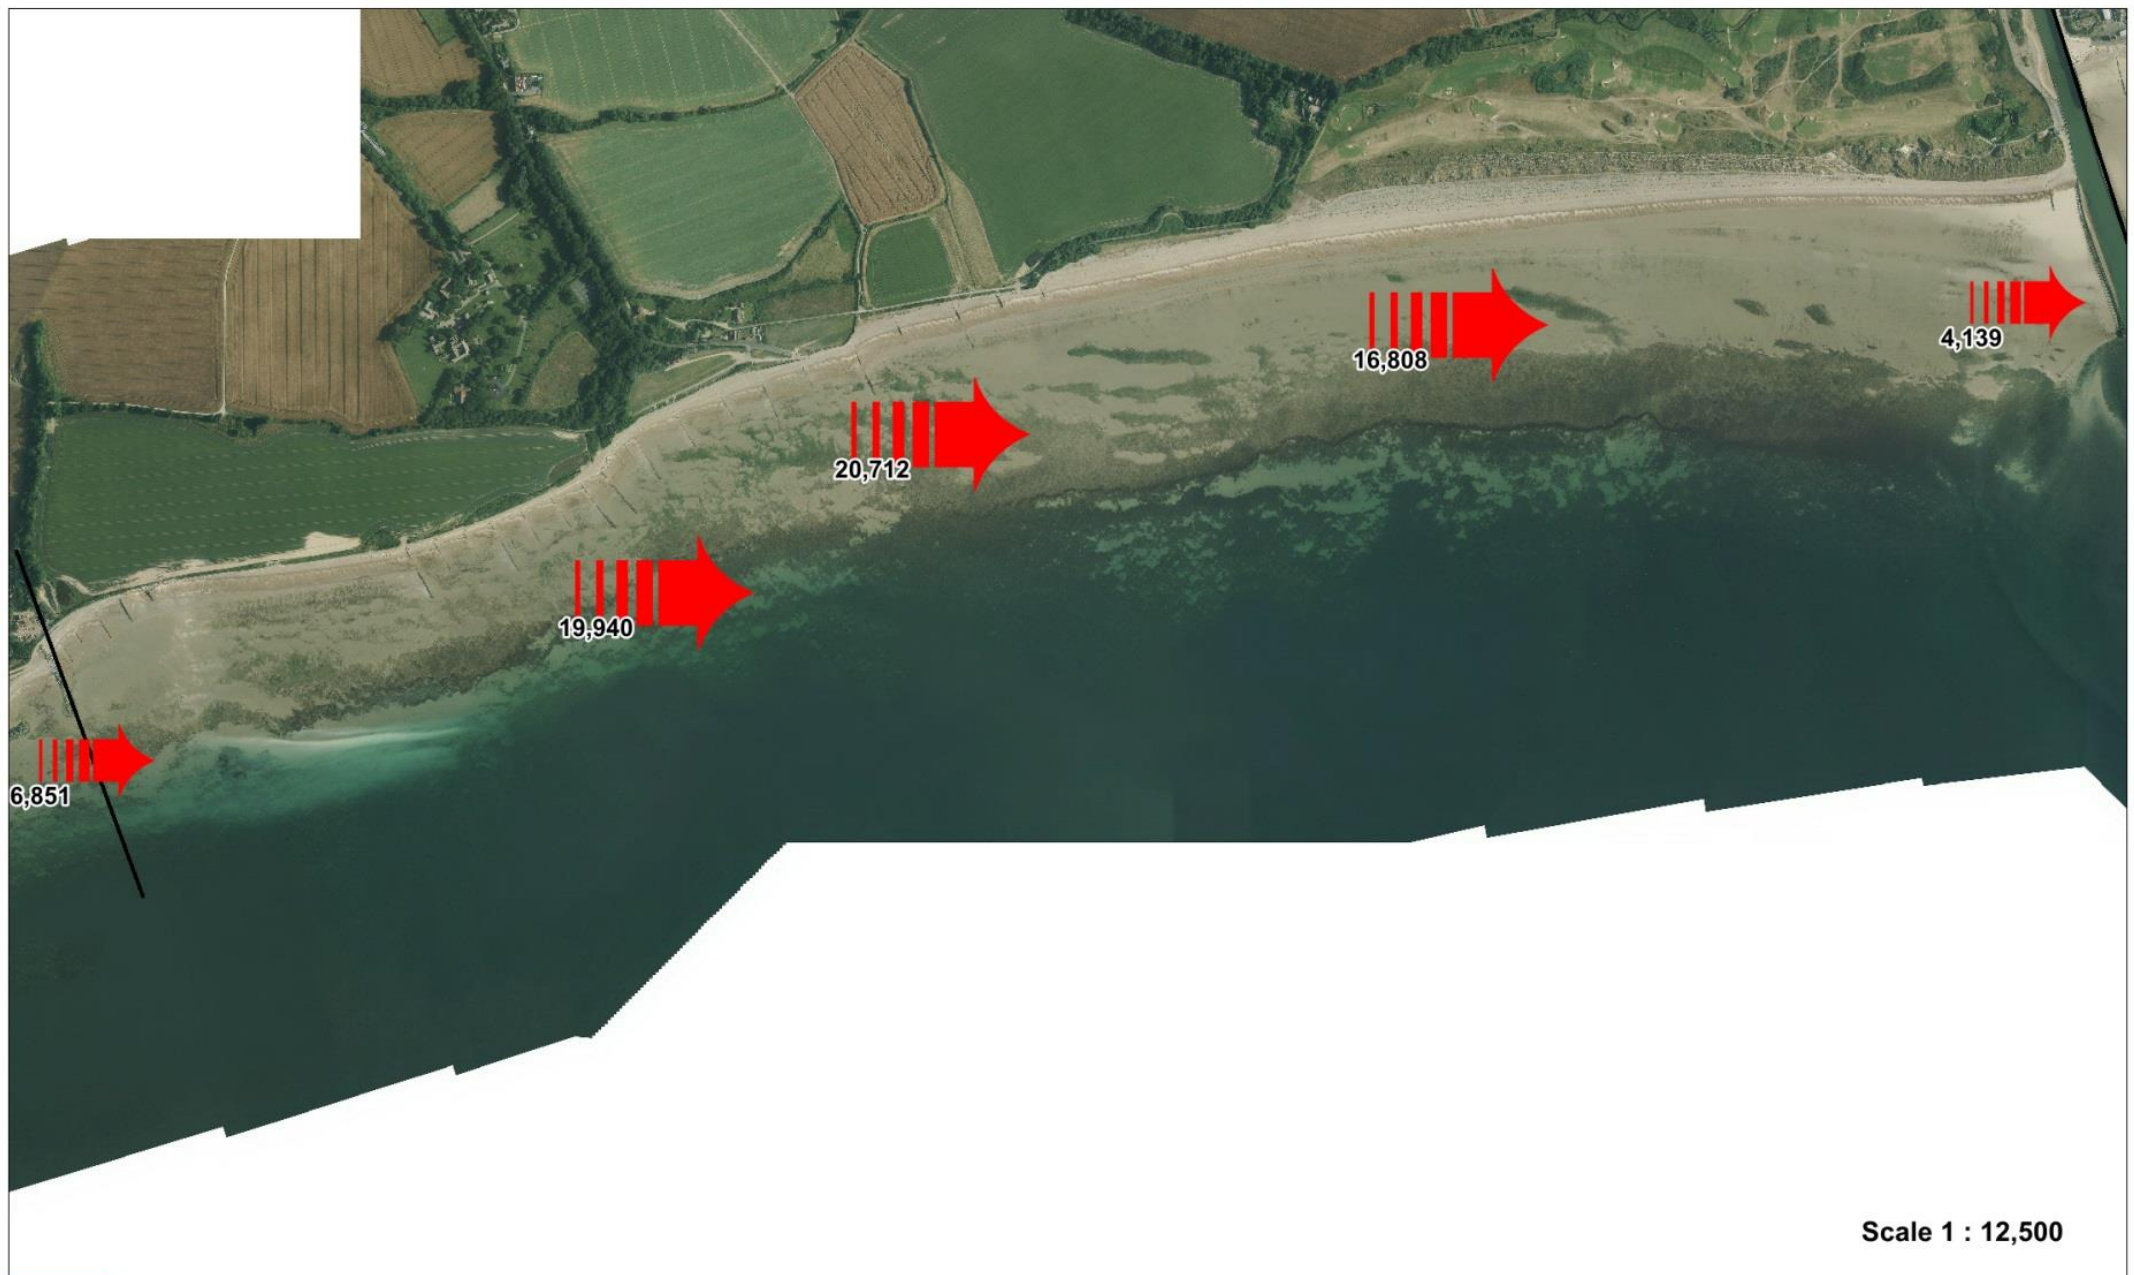
FIGURE 5-8 SEDIMENT TRANSPORT RATES – CLIMPING

Estimated annual sediment transport in cubic meters.

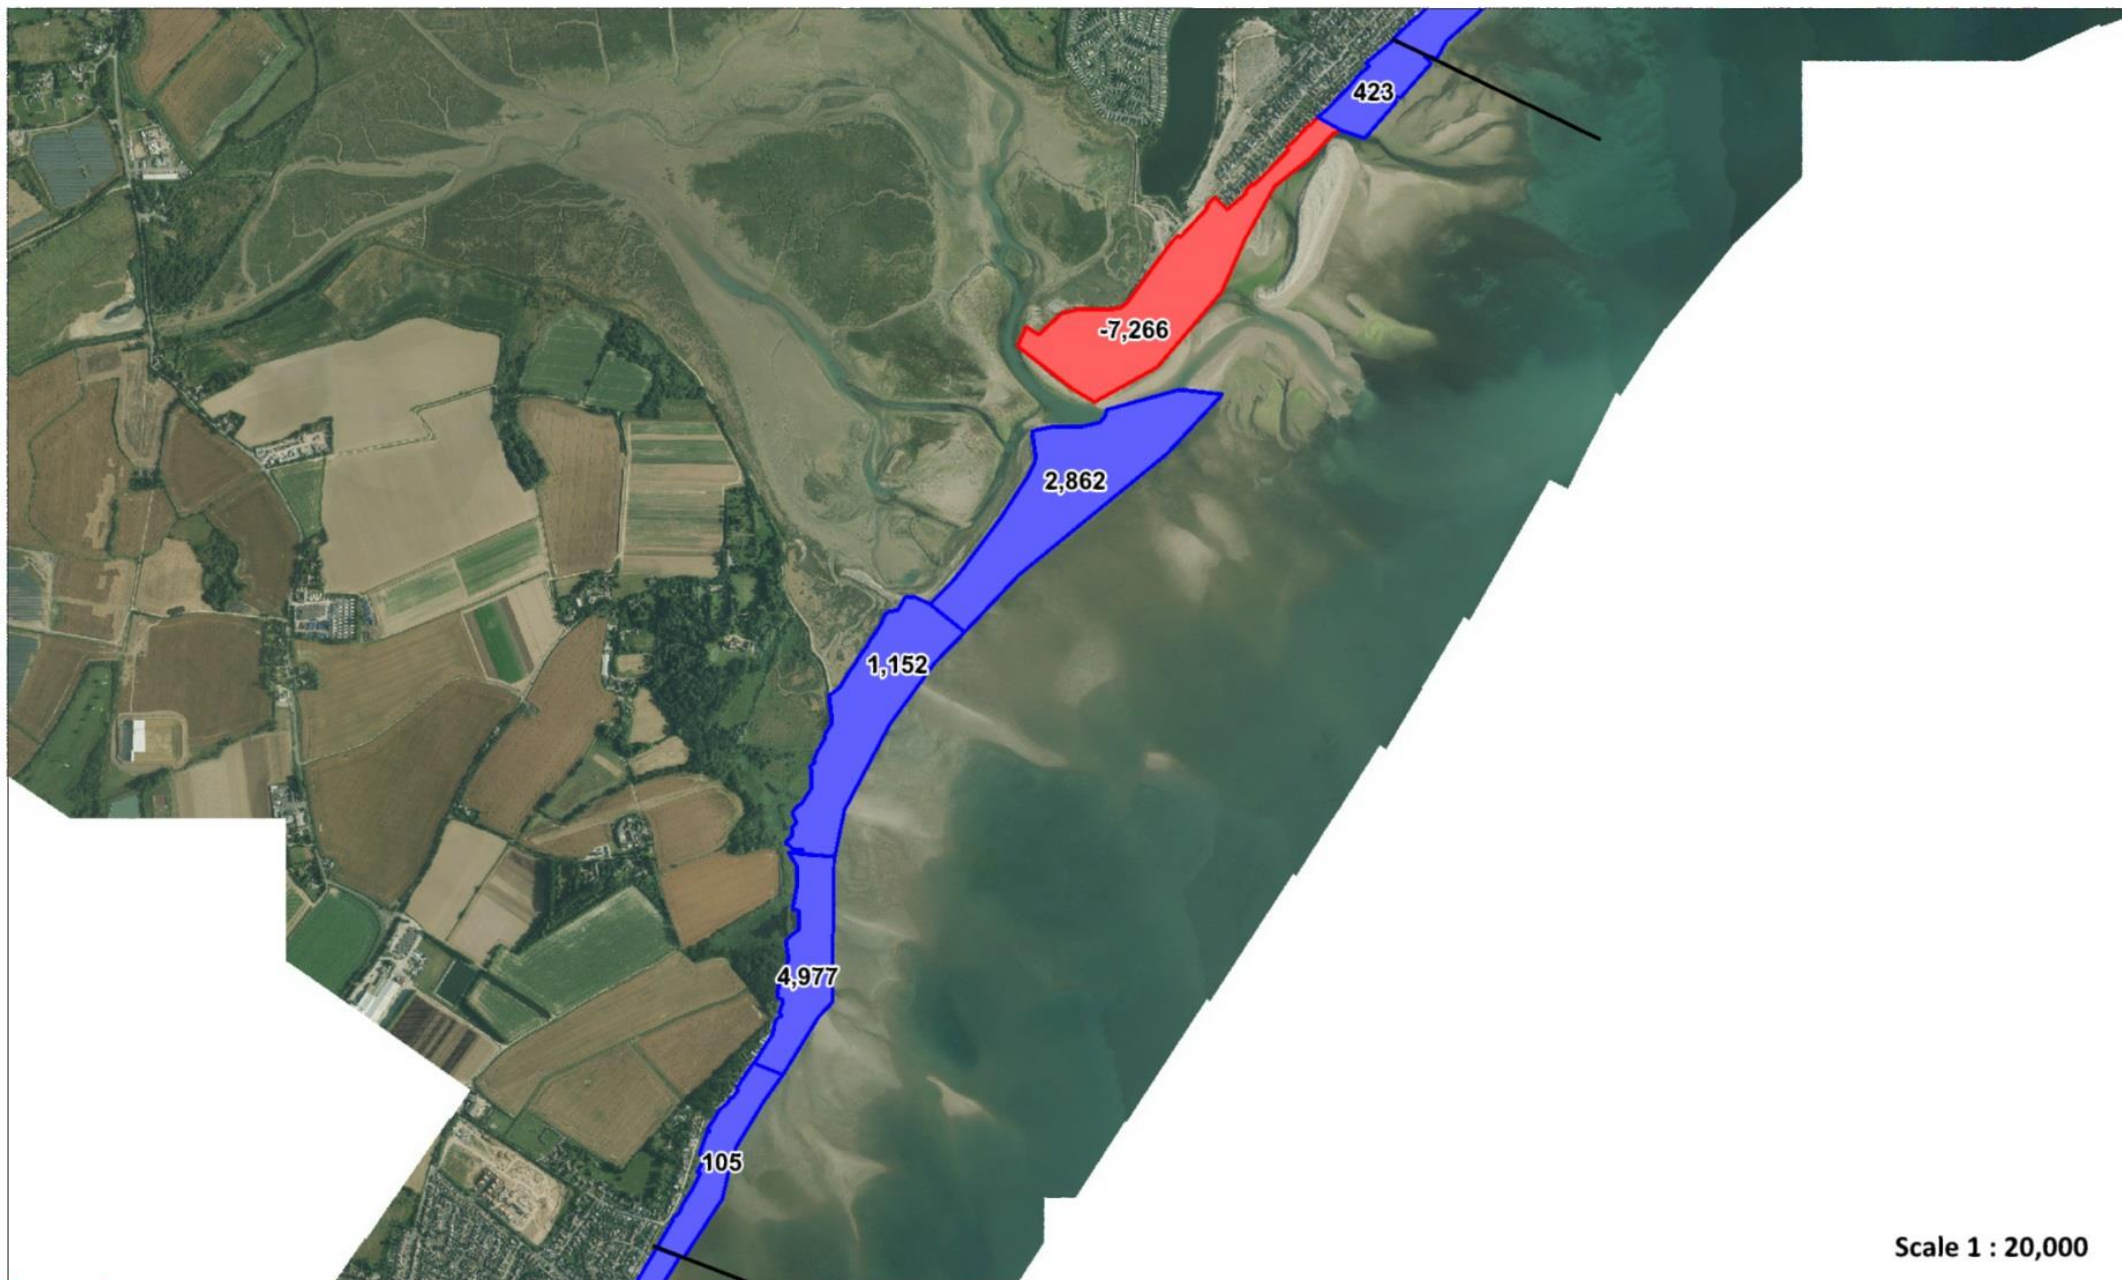
FIGURE 5-10 NET ANNUAL EROSION/ACCRETION – PAGHAM HARBOUR

The net accretion/erosion rate.
(Influence of beach recycling and replenishment discounted)

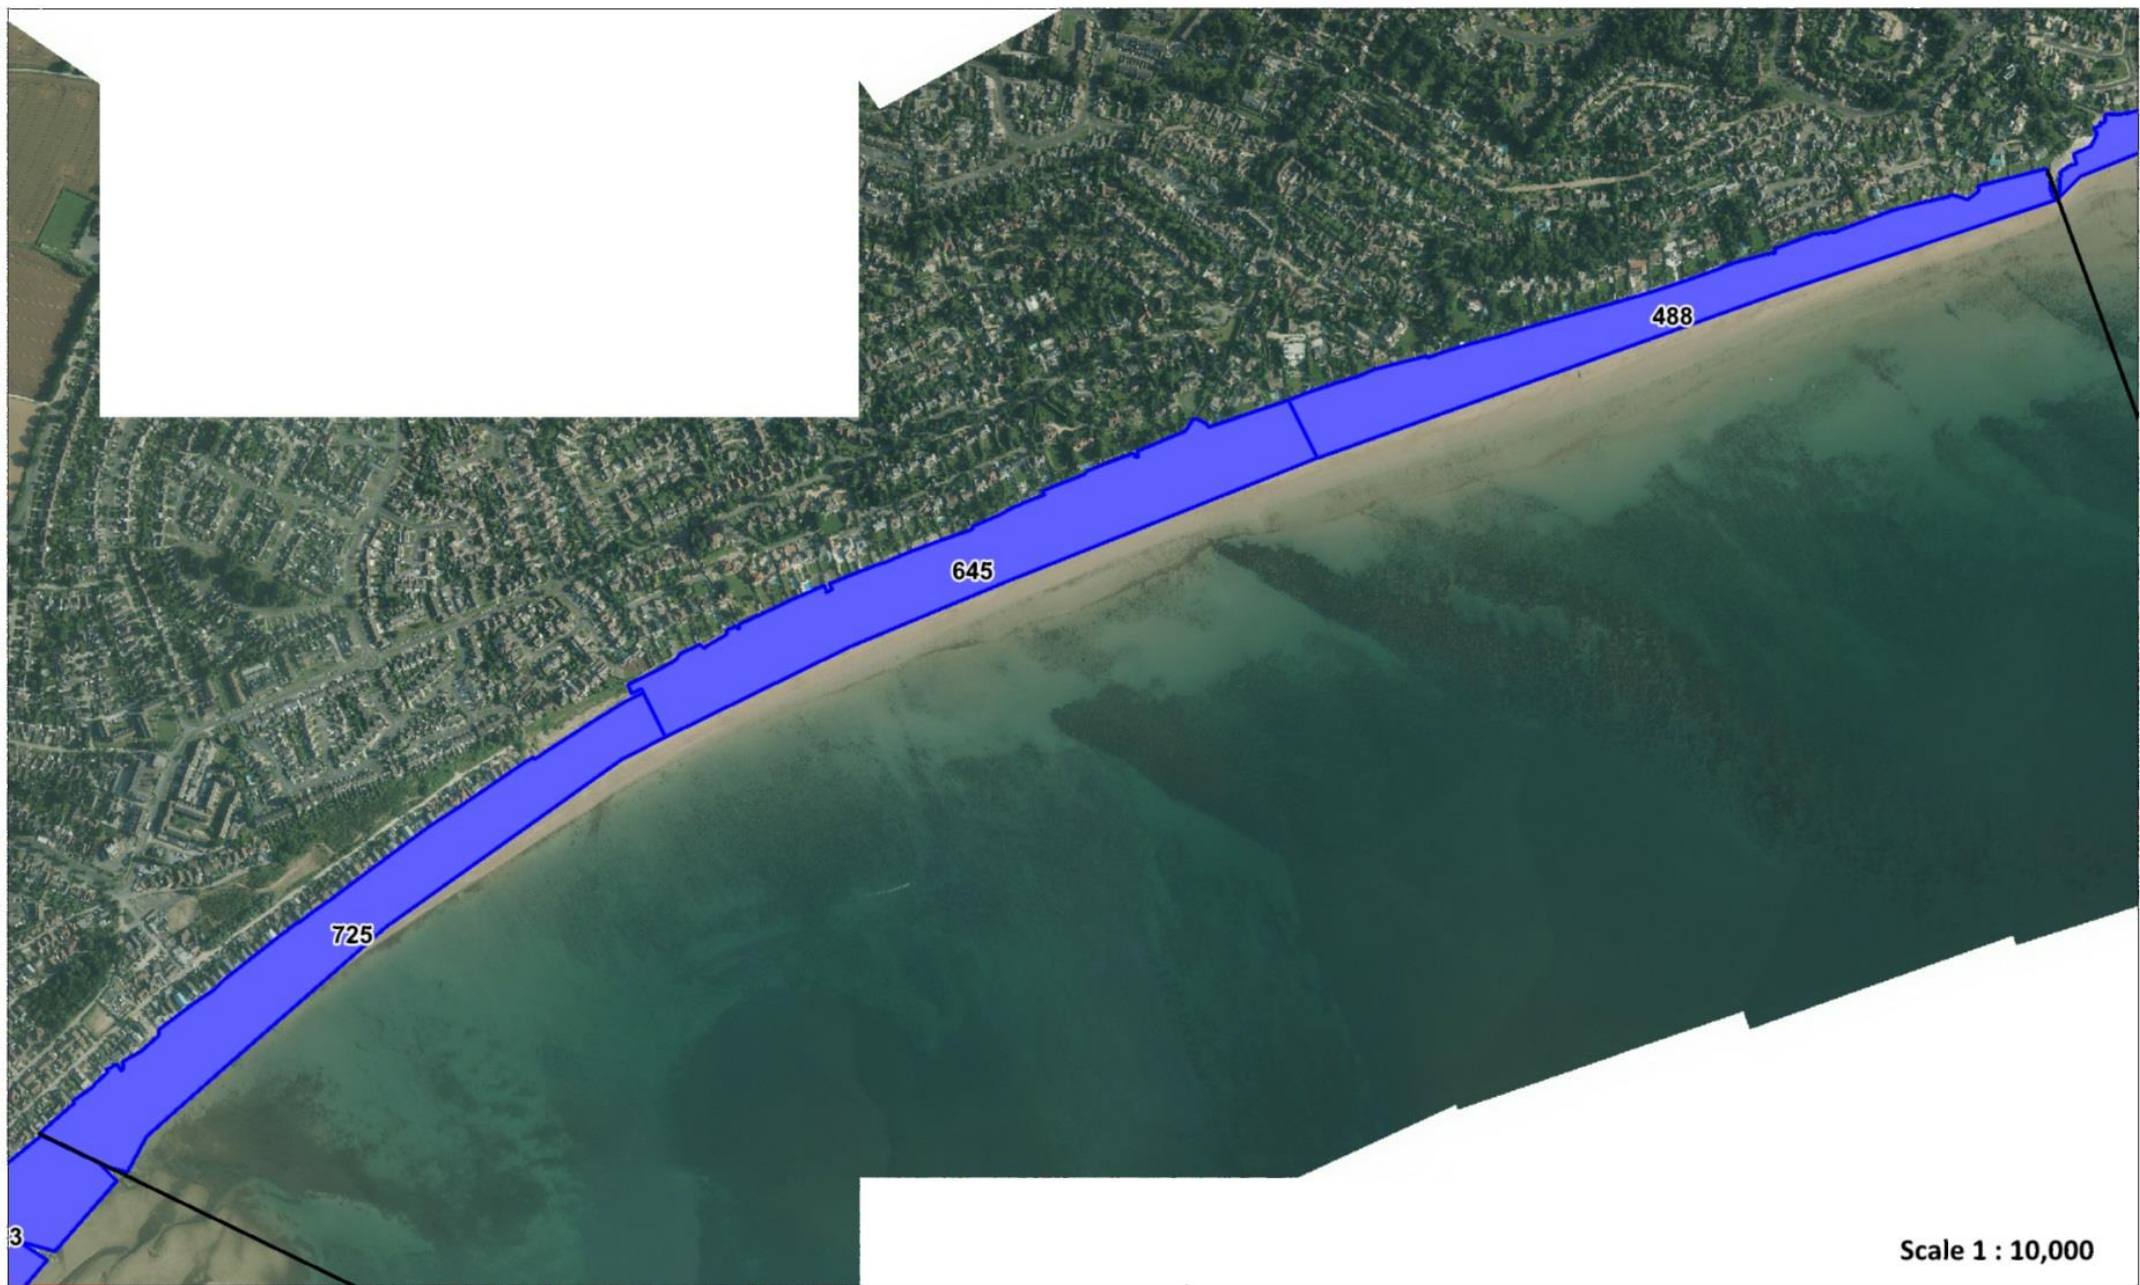
FIGURE 5-11 NET ANNUAL EROSION/ACCRETION – PAGHAM TO ALDWICK

The net accretion/erosion rate.
(Influence of beach recycling and replenishment discounted)

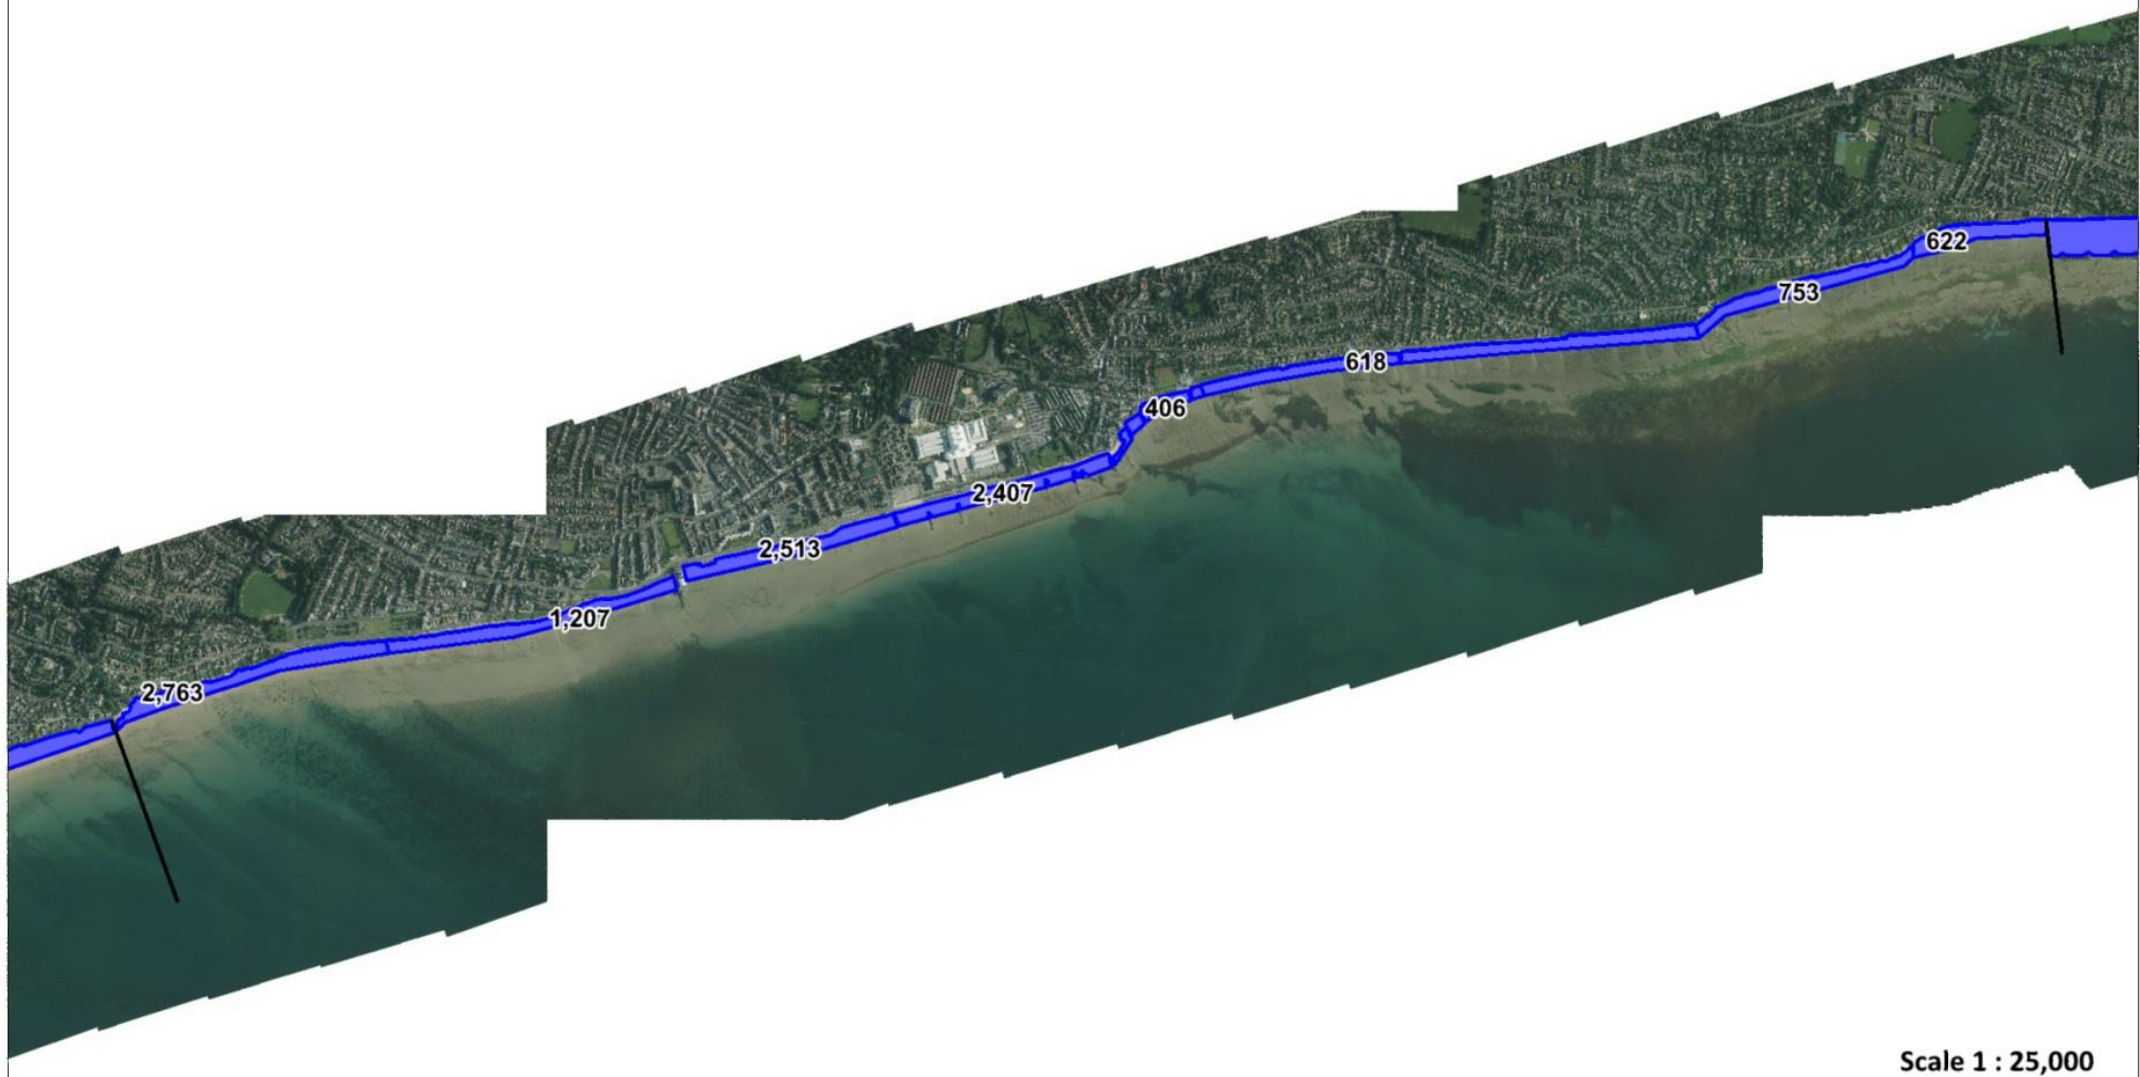
FIGURE 5-12 NET ANNUAL EROSION/ACCRETION – BOGNOR REGIS

The net accretion/erosion rate.
(Influence of beach recycling and replenishment discounted)
