Regional Beach Management Plan 2017: Selsey Bill to Climping

Report – ENVIMSE100035/R-01

Final Report, August 2017

Main Report

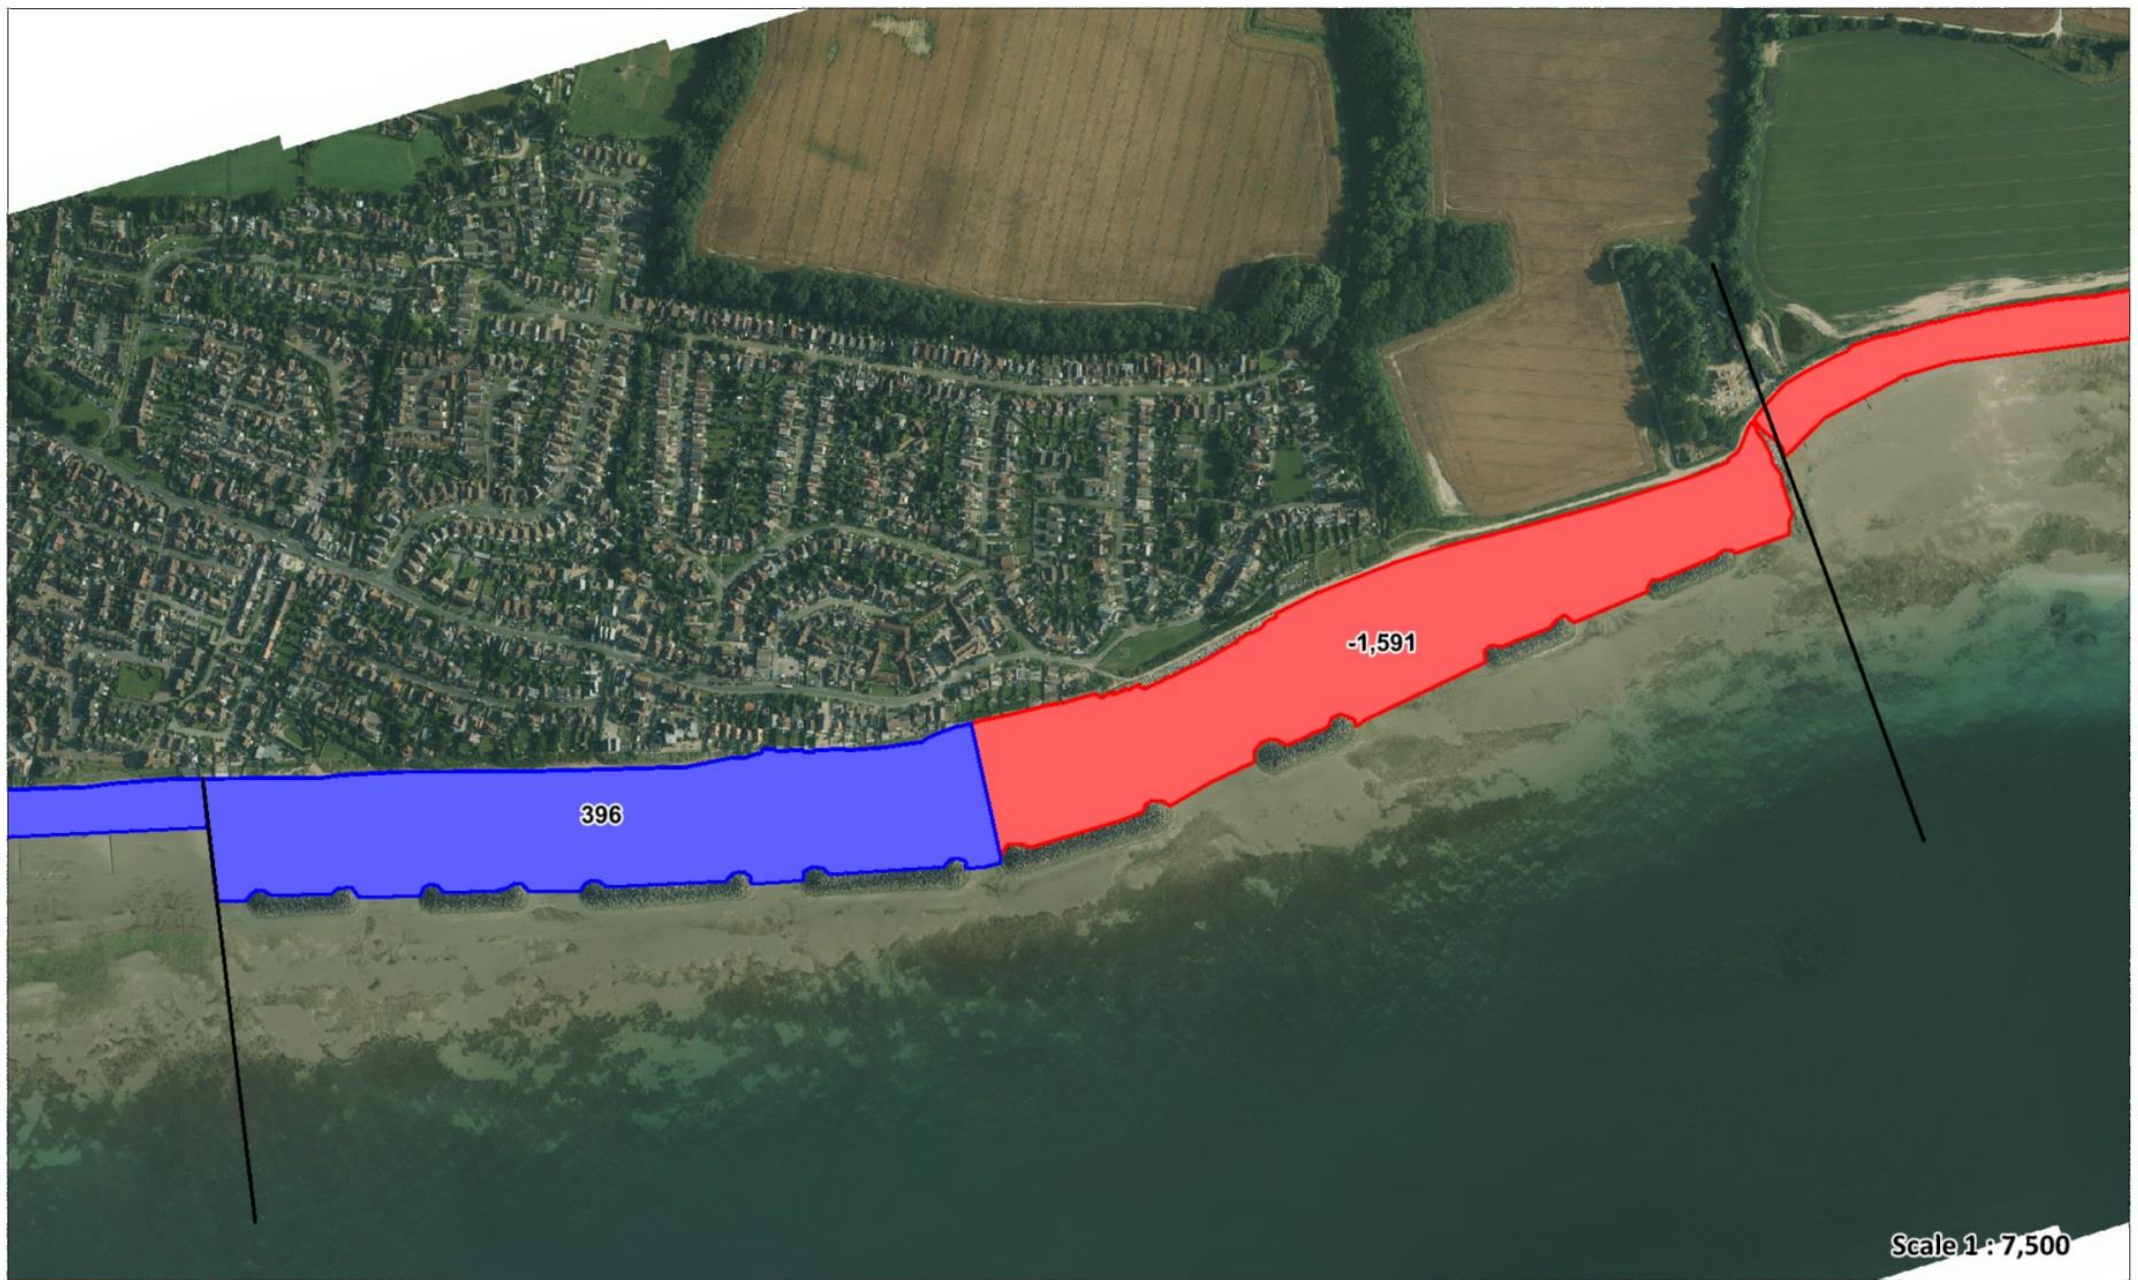
FIGURE 5-13 NET ANNUAL EROSION/ACCRETION – ELMER

The net accretion/erosion rate.
(Influence of beach recycling and replenishment discounted)

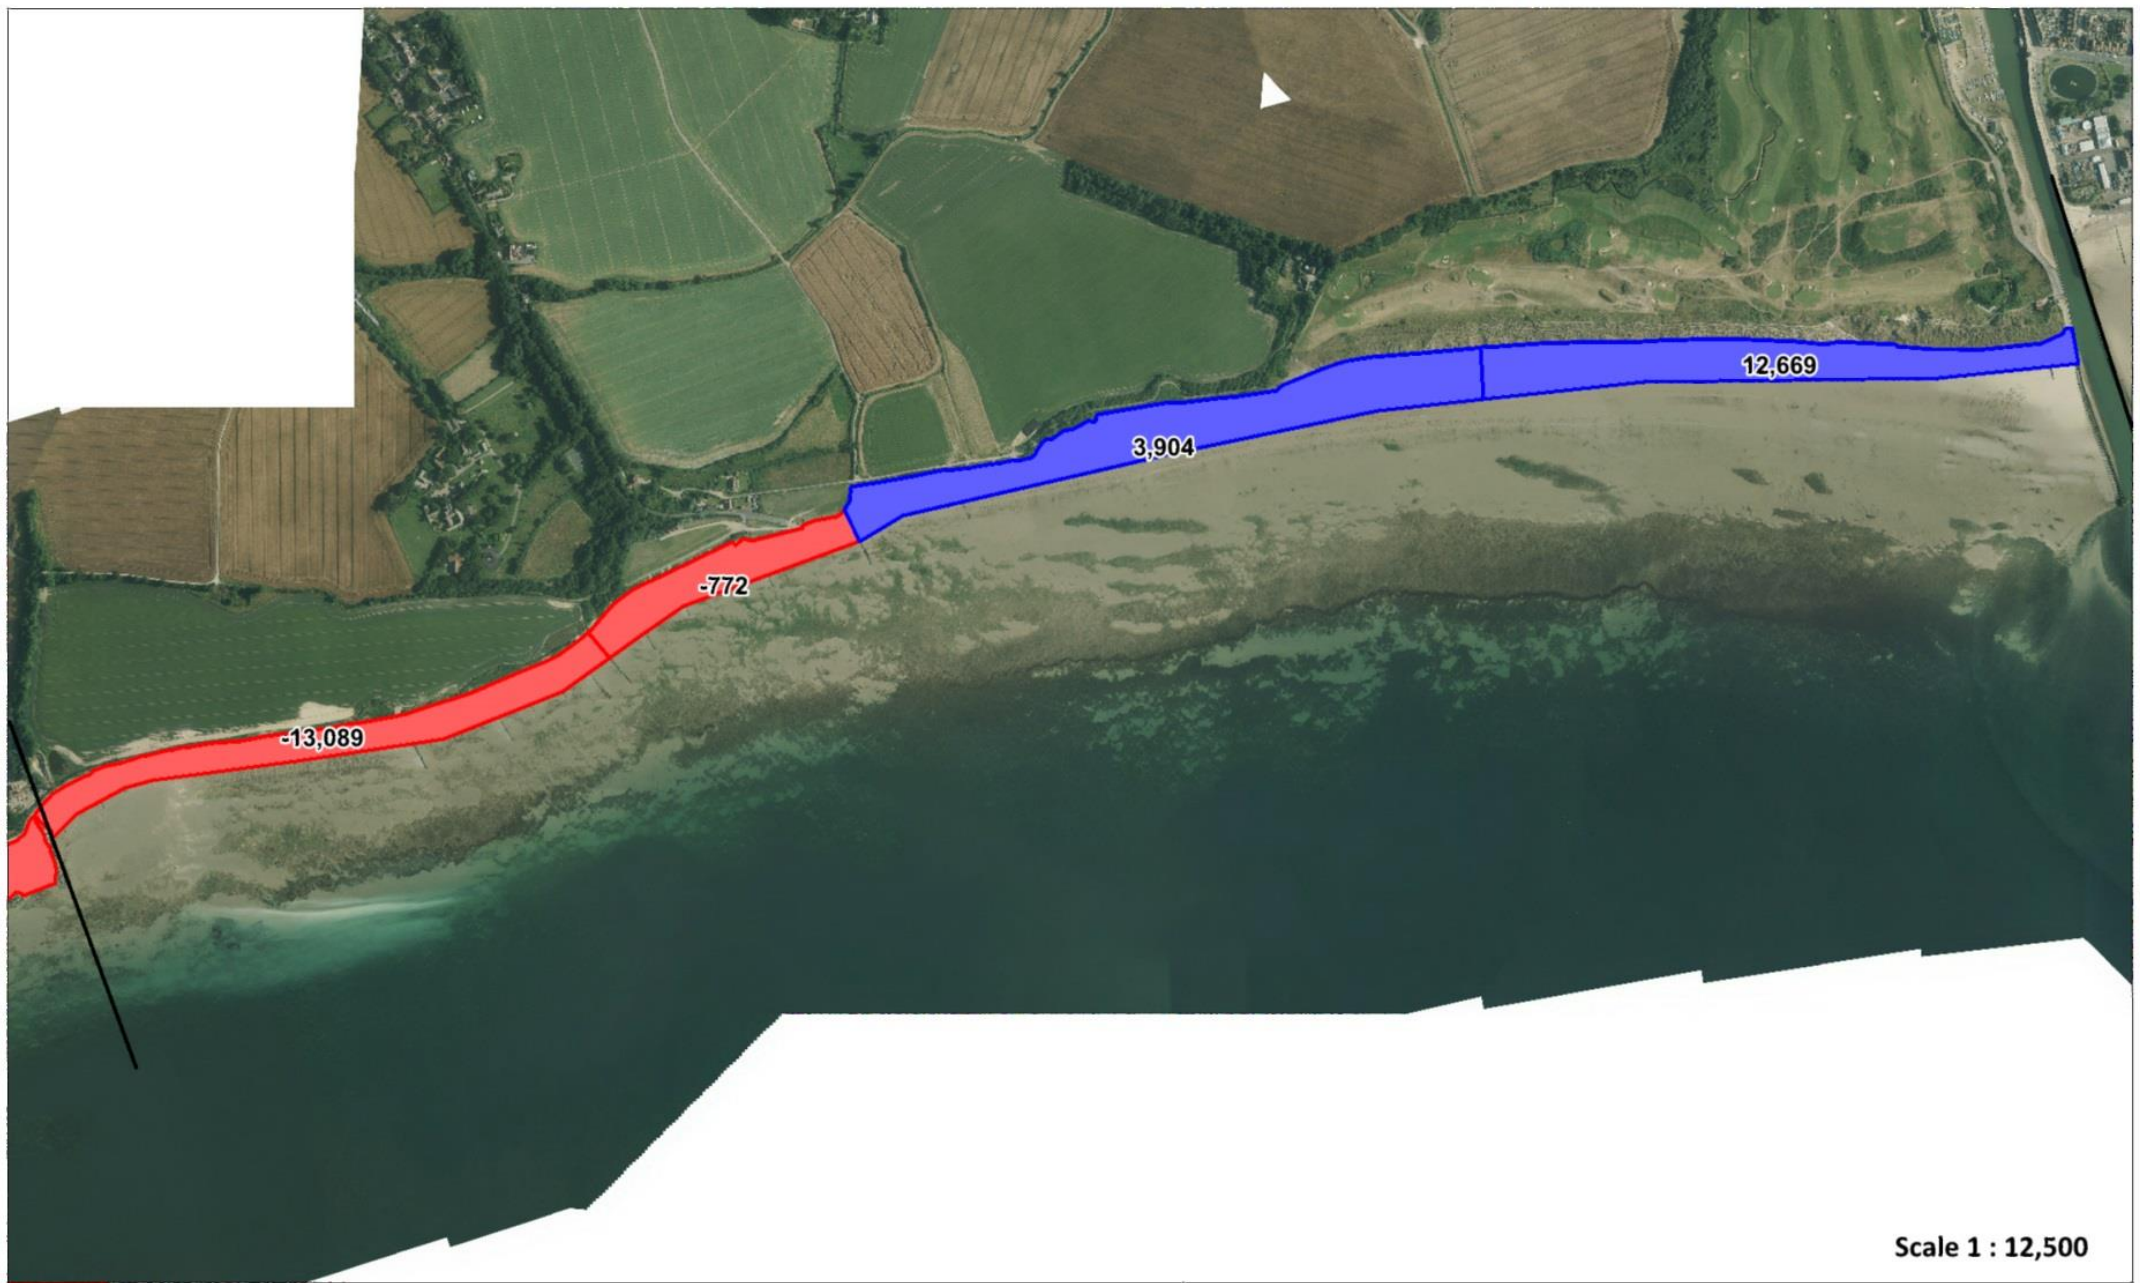
FIGURE 5-14 NET ANNUAL EROSION/ACCRETION – CLIMPING

The net accretion/erosion rate.
(Influence of beach recycling and replenishment discounted)

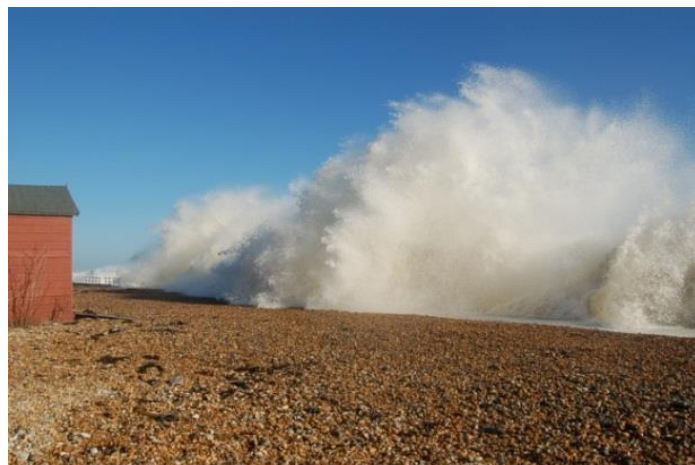
FIGURE 6-2-1 DISSIPATION OF WAVE ENERGY ON A SHINGLE BEACH (KINGSDOWN, 2009)

Shingle beaches are very efficient at dissipating wave energy (Figure 6-2-1). To calculate overtopping rates under different scenarios a methodology was developed and applied consistently to the whole frontage. This is summarised in Figure 6-2-2 and described in the following text.

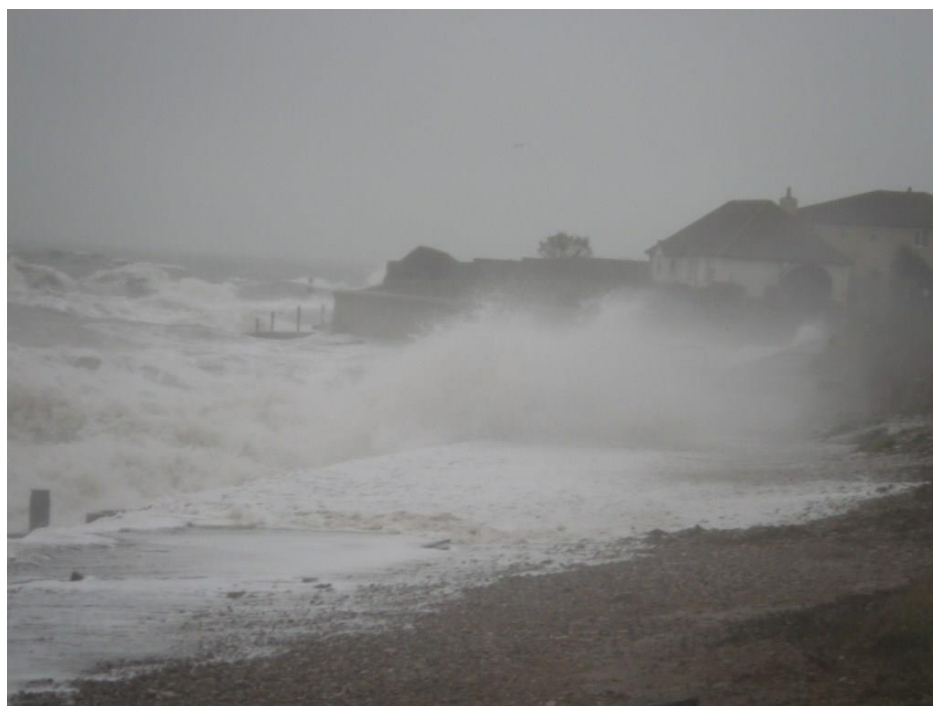
FIGURE 6-2-7 WAVE OVERTOPPING, SELSEY BILL (DECEMBER, 2012). PHOTO CREDIT CHICHESTER DISTRICT COUNCIL

1. Photographic evidence of large overtopping events and retrospective comparison with predicted overtopping (e.g. Figure 6-2-7).

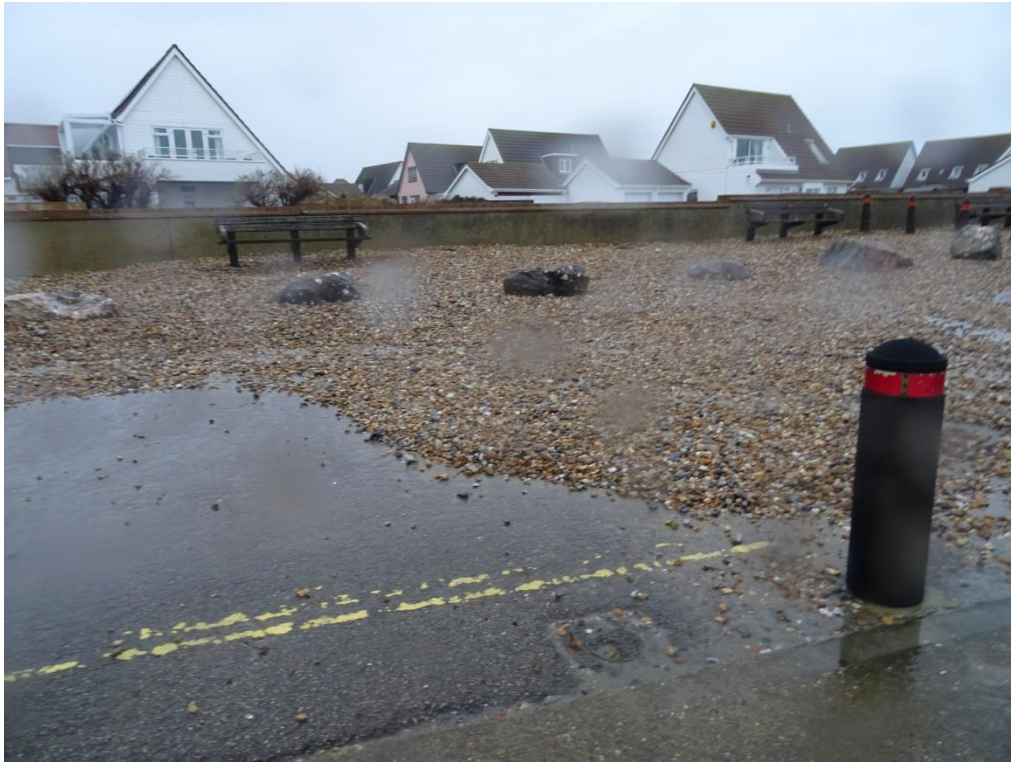
FIGURE 6-2-8 EVIDENCE OF OVERTOPPING ON TO THE PROMENADE, SELSEY (2016)

2. Anecdotal evidence in the form of information that is not well documented or photographed. The prime example of this is shingle on the promenade, which is indicative of small scale overtopping (e.g. Figure 6-2-8). Where management authorities have to periodically clear this it is evident that the defence is subject to minor overtopping on a regular basis. Results can be queried to ensure these events are predicted.

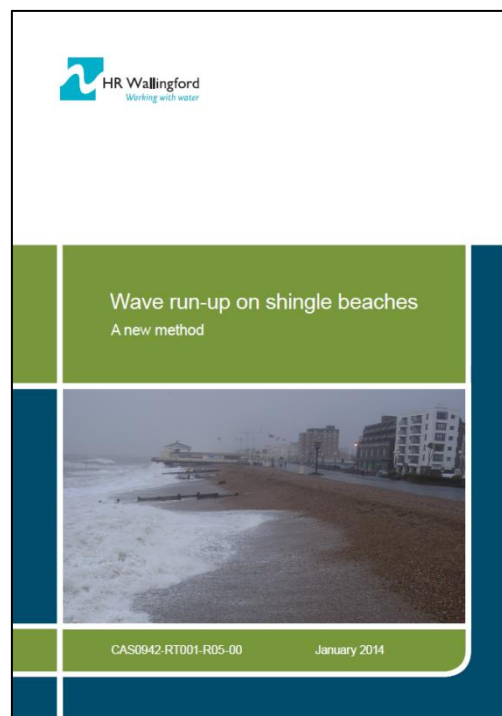
FIGURE 6-2-10 SUB-PROJECT RESEARCH AND DEVELOPMENT OF IMPROVED RUN-UP FORMULA

4. The improved formula presented in Wave run-up on shingle beaches: a new method (HRW, 2014, see Figure 6-2-10) was used in areas that were prone to green water overtopping (No structure and run-up exceeds crest). By running calculations for a number of swell components results could be verified as reasonable and ensure that an underestimate had not been made.

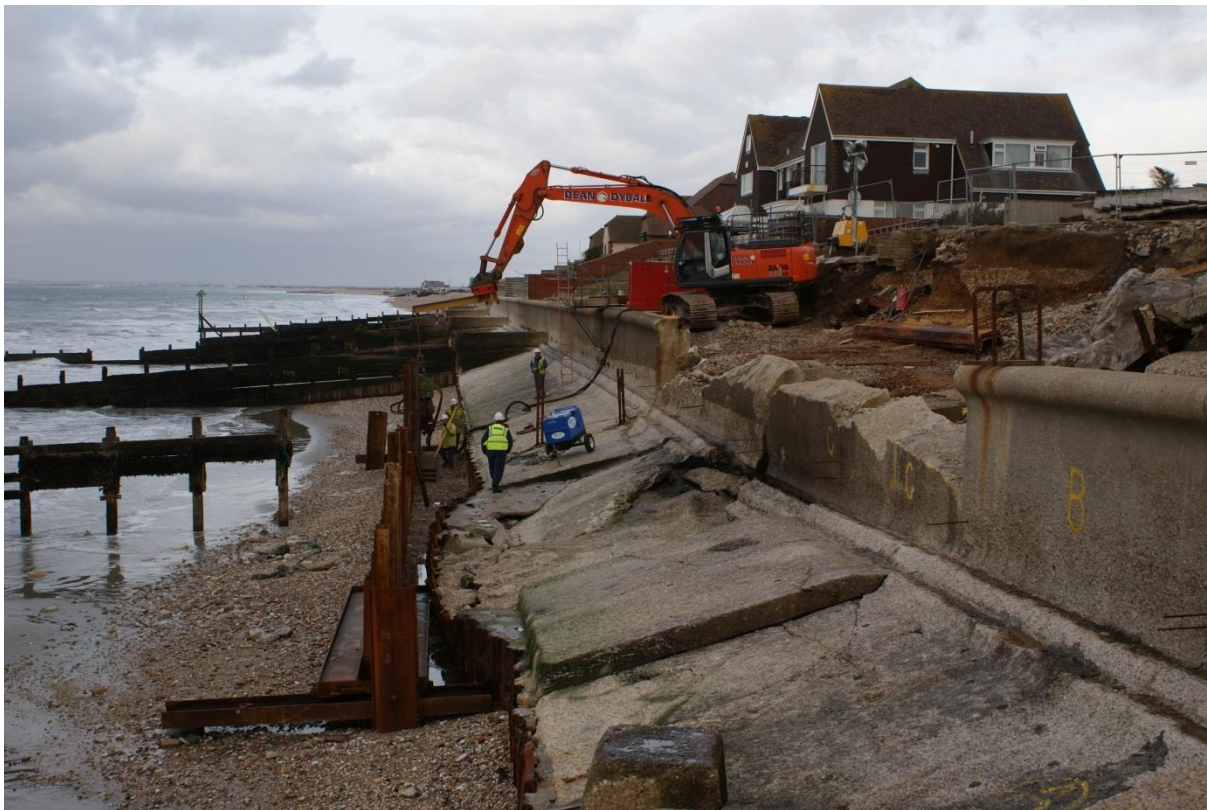
FIGURE 6-2-11 DILAPIDATED GROYNES, LOW BEACH AND SEAWALL FAILURE AT SELSEY (2008)

As beach levels lower due to erosion, draw down in a storm, or failure of groynes that act as controlling structures the seawall becomes increasingly exposed to direct wave attack. In addition to a probable increase in overtopping rates, this significantly increases the risk of seawall failure.

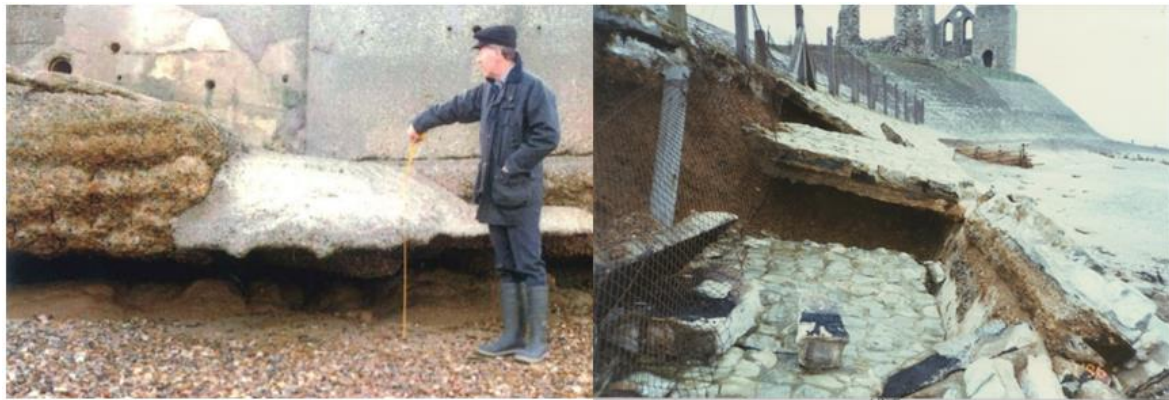
FIGURE 6-2-12 EXAMPLES OF UNDERMINING AT TANKERTON (LEFT) AND RECVLVER (RIGHT)
(BOTH PHOTOS 1999)

Typically, before beach levels get low enough to pose a credible threat to the structure the standard of protection has already become sub-standard due to the increased likelihood and severity of overtopping. There are instances where the structure itself provides a sufficient barrier to overtopping, but often in these cases a beach is required to be maintained in order to protect the structure and prevent undermining.

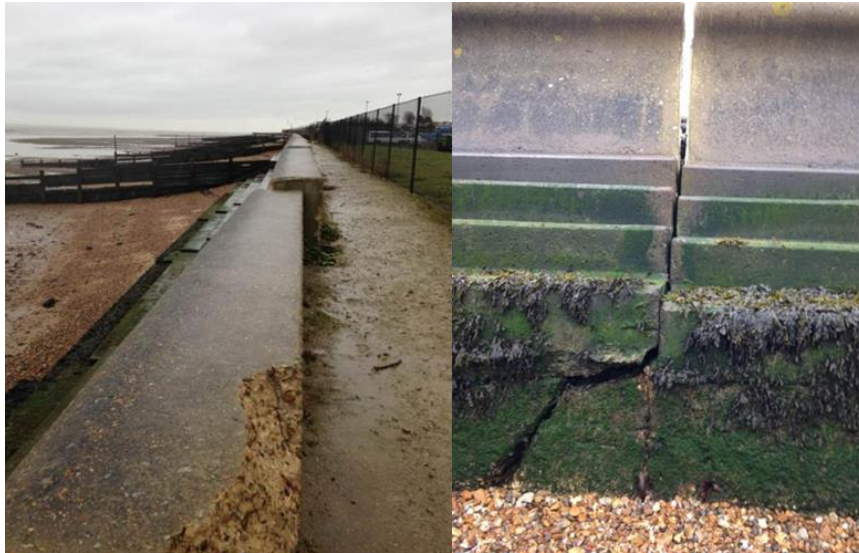
FIGURE 6-2-13 FAILURE OF A SEAWALL AT ALL HALLOWS DUE TO SLIDING/TOPPLING OF DEFENCE SECTIONS (2015)

For coastal management authorities should undertake regular asset condition inspections in order to assess the need for any maintenance. Historically these may have been picked up by NFCDD inspections. It is anticipated that this will shortly be replaced by AIMS, but in the interim each coast protection authority should conduct their own regular coastal asset inspections.

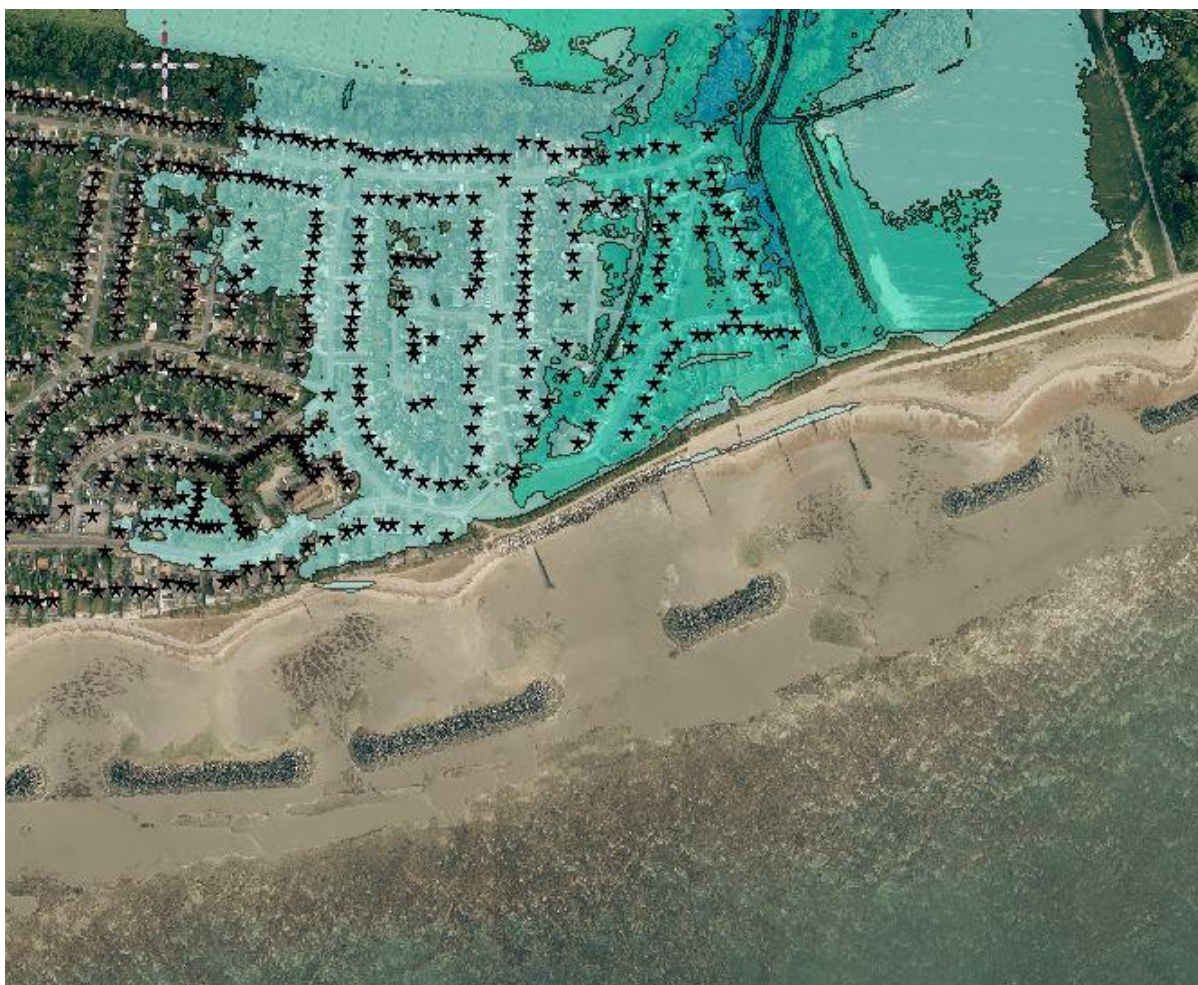
FIGURE 6-2-15 EXAMPLE OF PROPERTIES (STARS) WITHIN THE 1:200 YEAR EXTREME WATER LEVEL PLANAR FLOODPLAIN (ELMER)

In order to calculate the properties at risk from a 1:200 year event (4.5mOD) a planar still water level flood map was created using LiDAR data (most recent dataset, 2015) and combined with the Ordnance Survey's AddressBase property layer (Figure 6-2-15). There are three large flood plains within the study area: Pagham Harbour (c.740ha), Bognor Regis (c.1707ha) and the Adur River (c.378ha – Climping side of the river only), and a smaller basin at Selsey recreation ground (c.32ha).
