Hastings Borough Council
Coastal Adaptation Pathfinder
June 2010

Department of Development and Planning
Transportation and Engineering Division

Hastings Borough Council Coastal Adaptation Pathfinder 2010

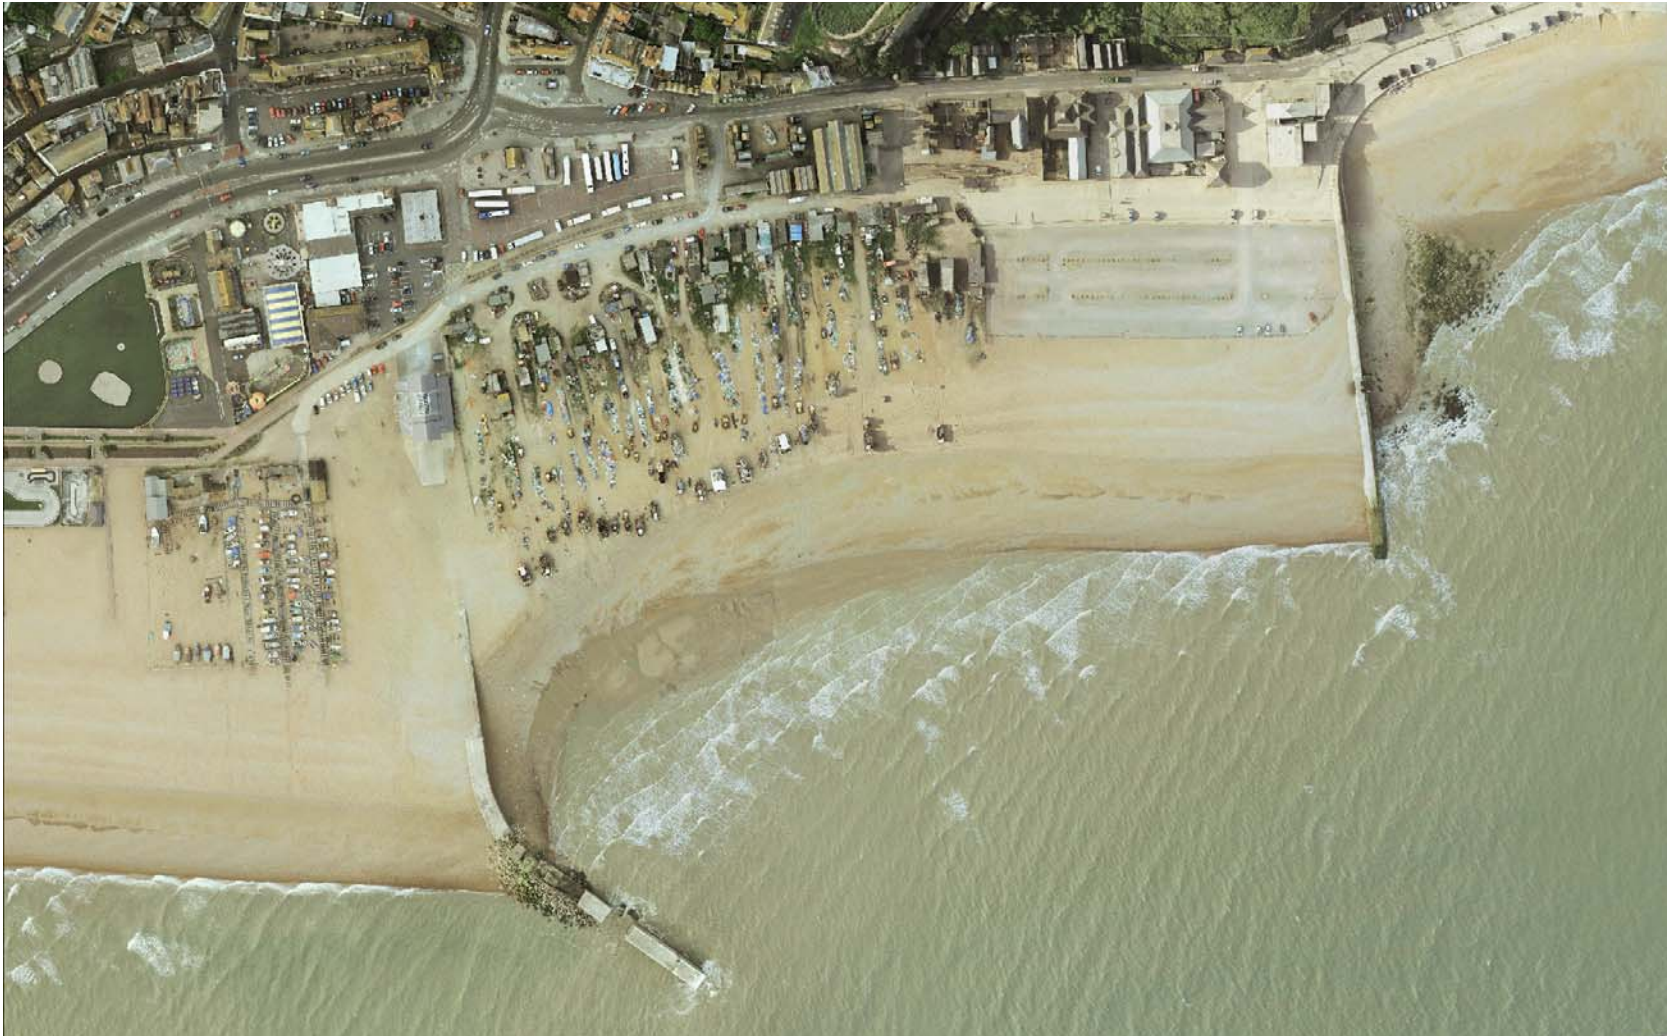
Figure 2.3: Hastings Harbour Aerial (2008)

Although the beach has noticeably increased in width naturally through accreting shingle over the years, the fishing fleet is strongly evident in all the aerial photographs with what appears to be a similar number of vessels.

As part of the Environment Agency's Aerial Beach Management Survey (ABMS) the entire Sussex coastline has been photographed on an annual basis since the late 1970s. Aerial photographs from 2008, 2000, 1990 and 1980 are displayed in Figures 2.3-2.6.

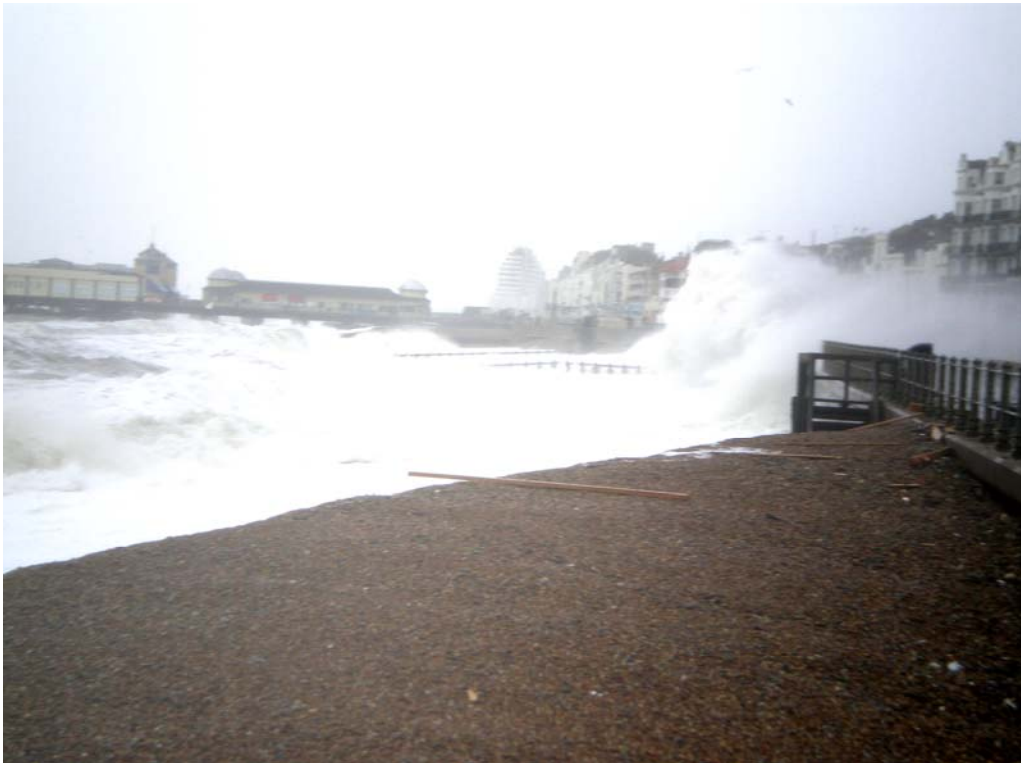
Figure 3.1: Impact of a Recent Storm Event at Hastings Prior to Remedial Works in 2009

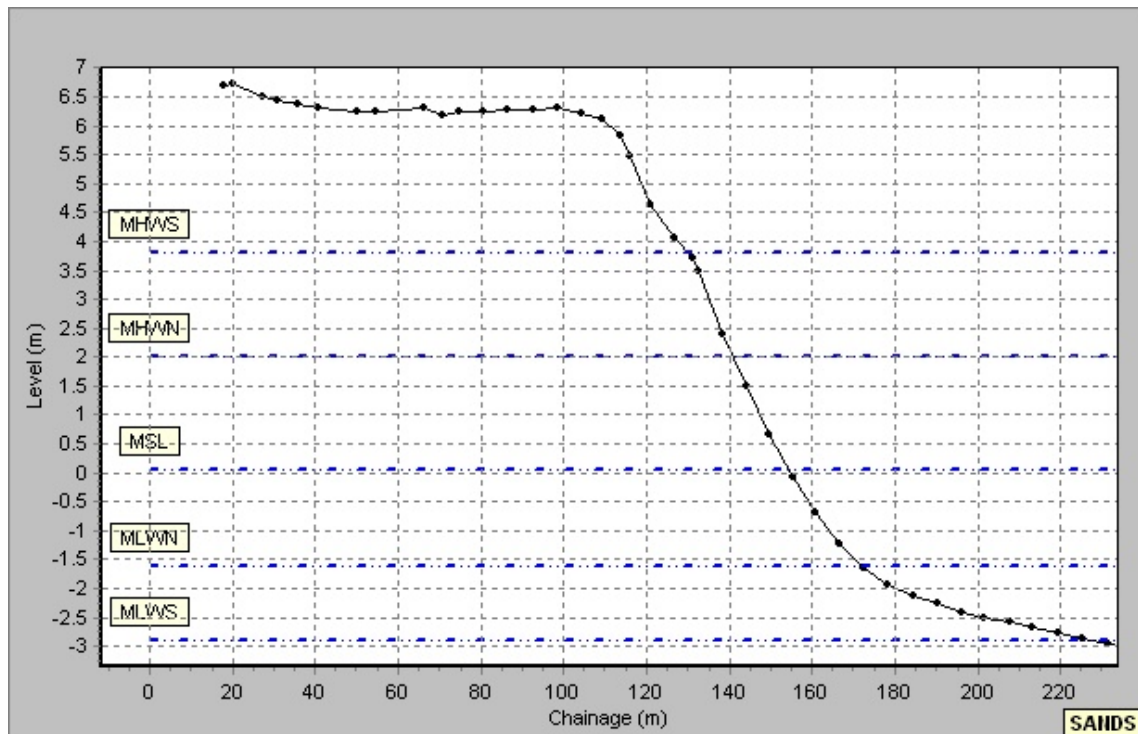
For illustrative purposes these levels are shown in contrast to a profile at the western end of the harbour beach (Figure 3.2). At present the beach crest is over two metres higher than the mean high water spring tide level providing a good standard of protection to the fleet and hinterland.

Figure 3.2: Tidal levels Superimposed on a Profile Surveyed in Spring 2010 at the Western End of the Harbour Beach

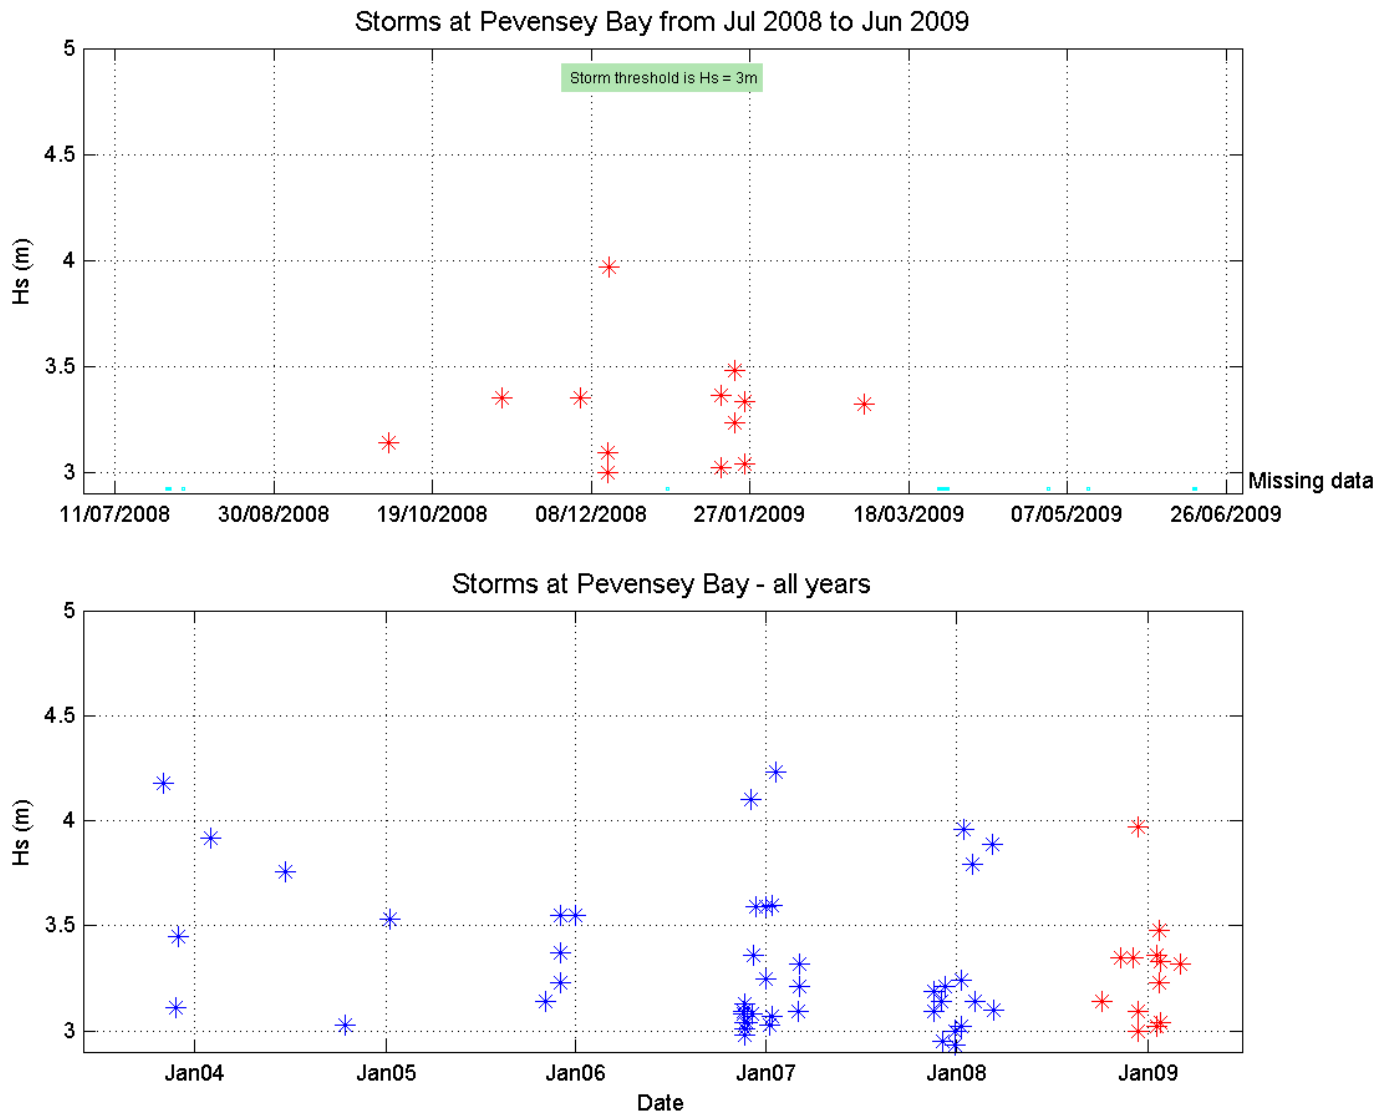
Figure 3.4: Incidence of storms during (a) most recent reporting period and (b) since deployment

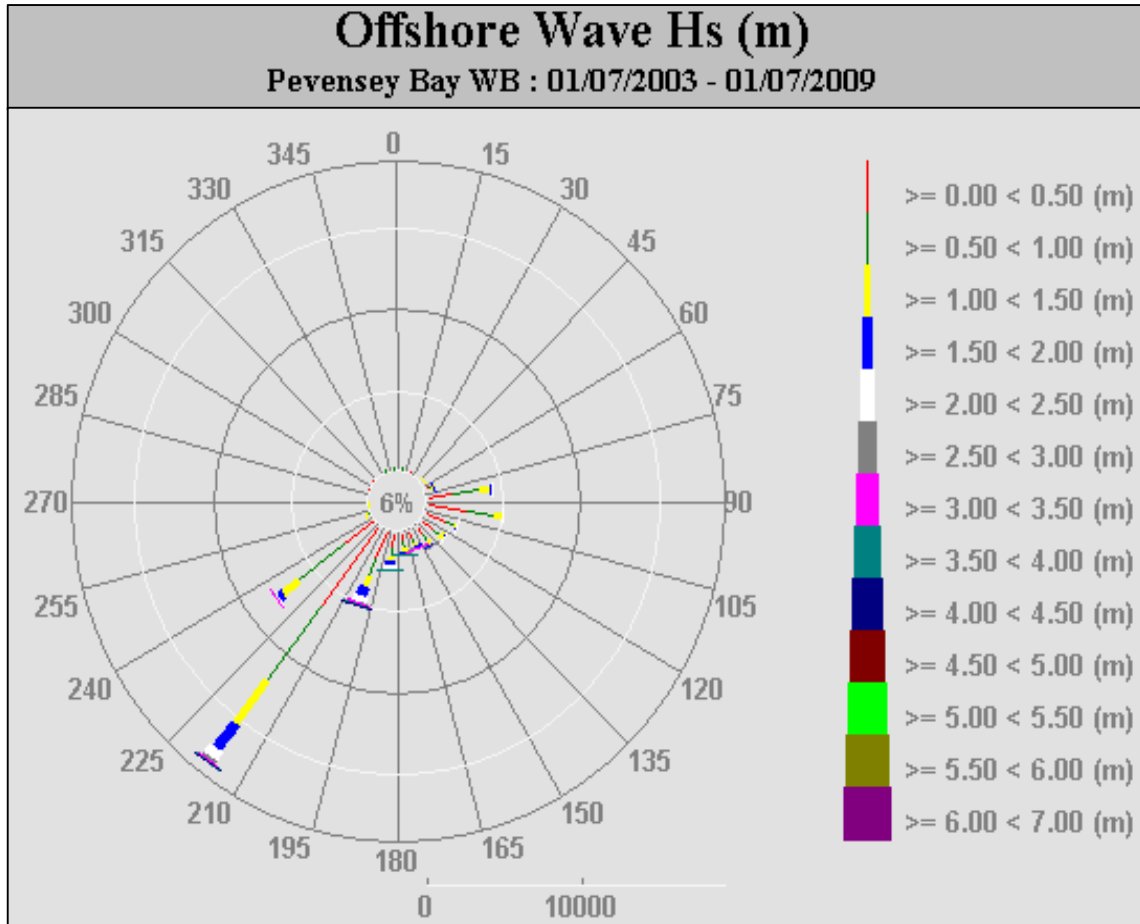
Directional analysis of the Pevensey Bay data (Figure 3.5) demonstrates the predominance of south westerly waves, not only for large storm events but also for more regular waves. Although shingle and sand moves both east and west dependant on the current wave direction, this characteristic drives the net easterly sediment transport.

Figure 3.5: Percentage of occurrence of Direction vs. Offshore Wave Height (Hs) for July 2003 to July 2009

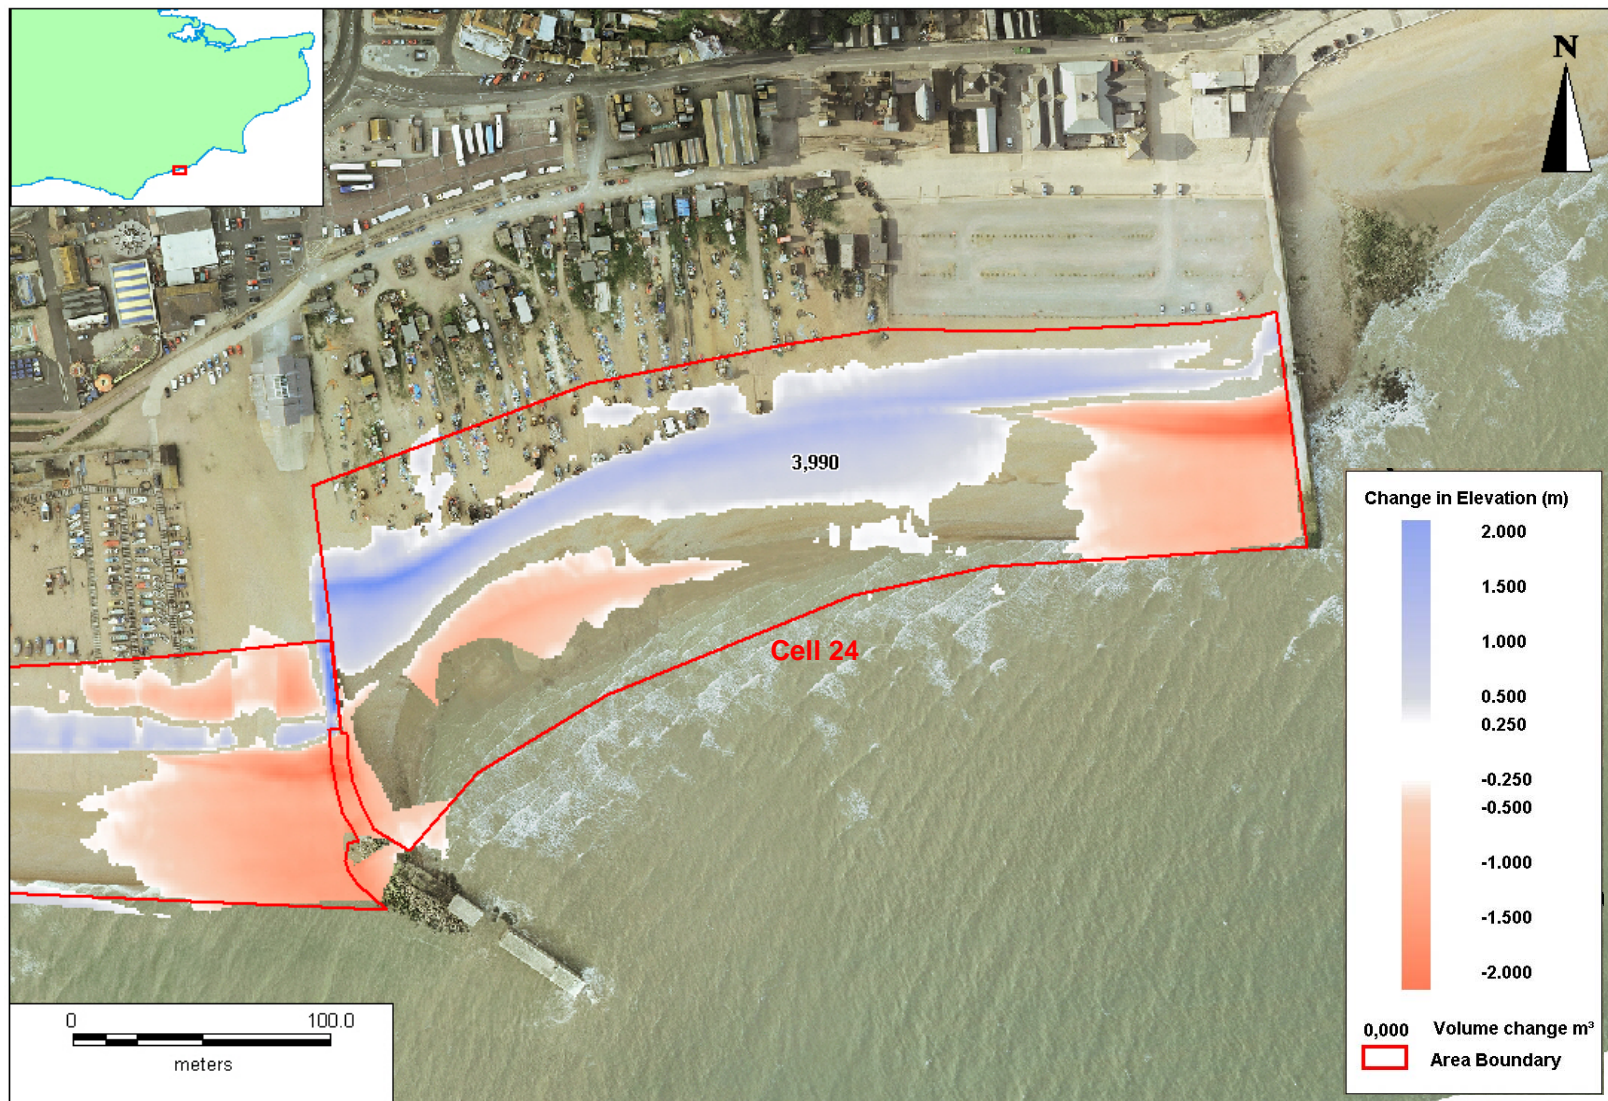
Sections of beach highlighted in red represent erosion that has occurred between 2003 and 2010, and the areas highlighted blue indicate accretion. Whilst these figures show an overall change in beach volume within each discrete section, it should be recognised that the data is based on the BMP survey, which is undertaken once each year. It is therefore only a snapshot of one moment in time, and the particular dynamics of each frontage need to be taken into account. This ensures that the information shown in the difference models represents the net change rather than capturing a particular extreme variation caused by a large event.

Figure 4.1: Difference Model 2003-2010: Hastings Harbour

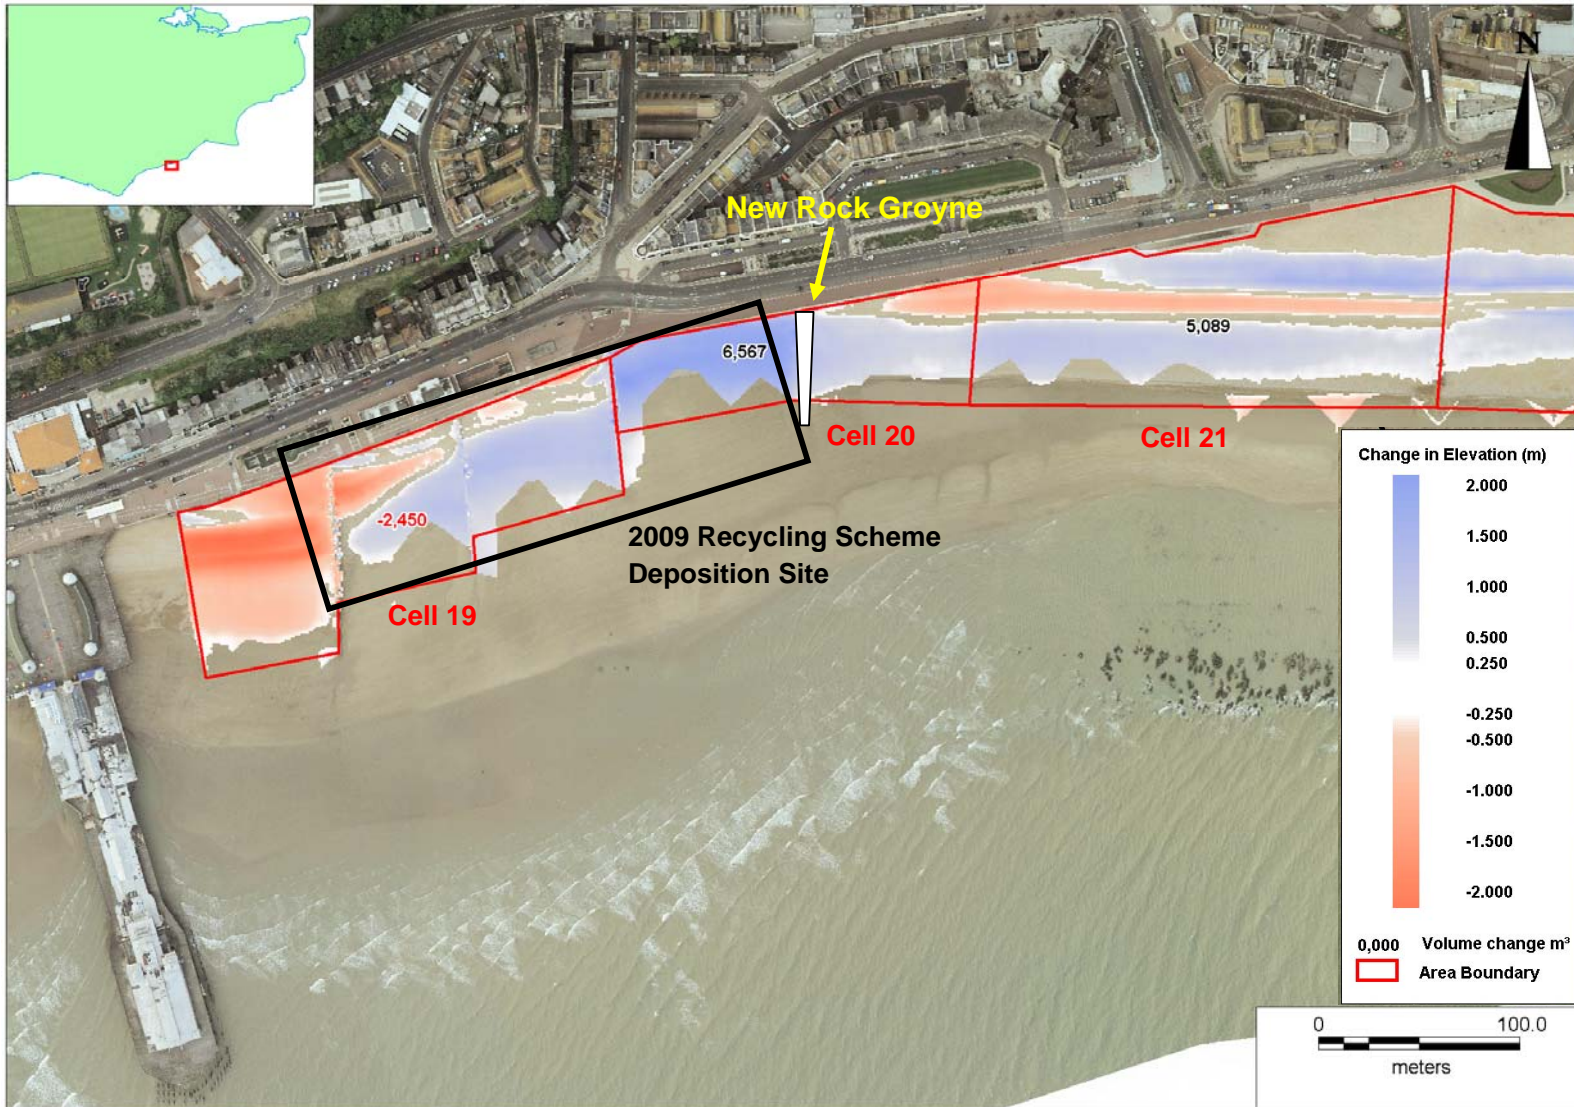
Figure 4.3: Difference Model 2003-2010: White Rock to Marine Parade

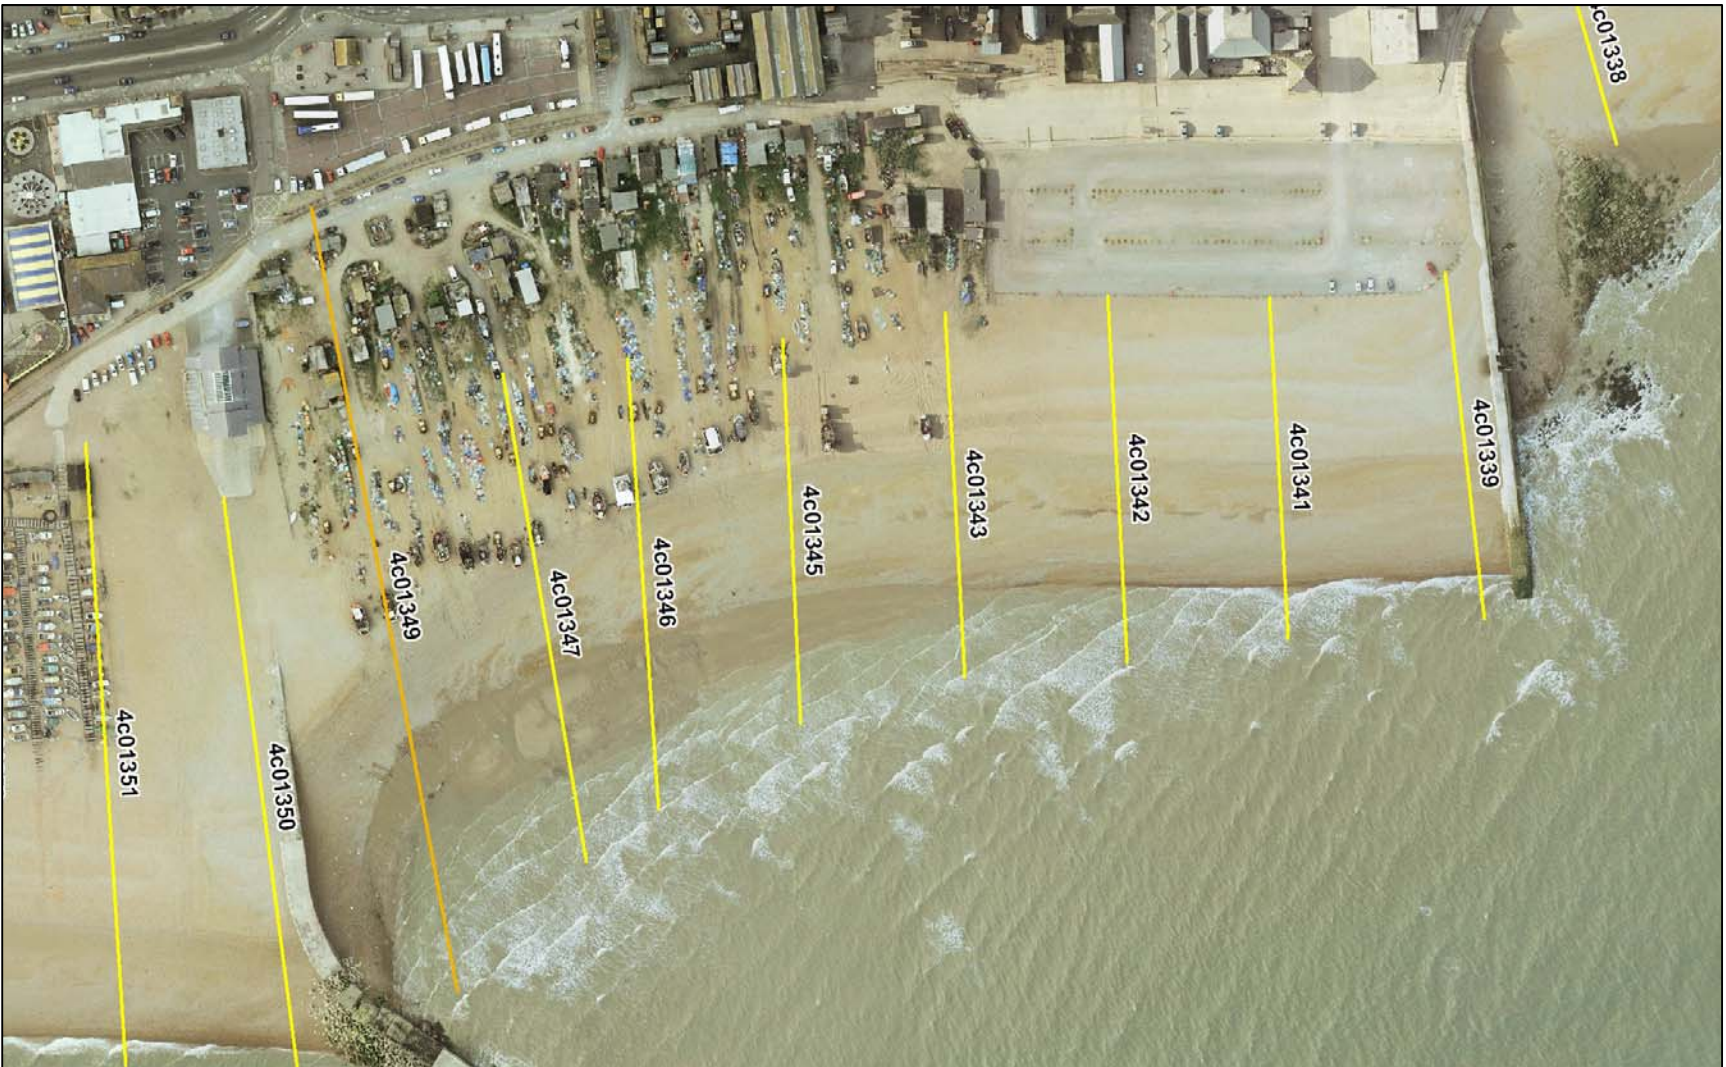
The analysis of a number of cross shore profiles was carried out as part of this study, in order to identify evolution trends along the study area. Figure 4.4 shows the full set of beach profiles available in the study area.

Figure 4.4: Beach Profile Locations within the Hastings Harbour Beach

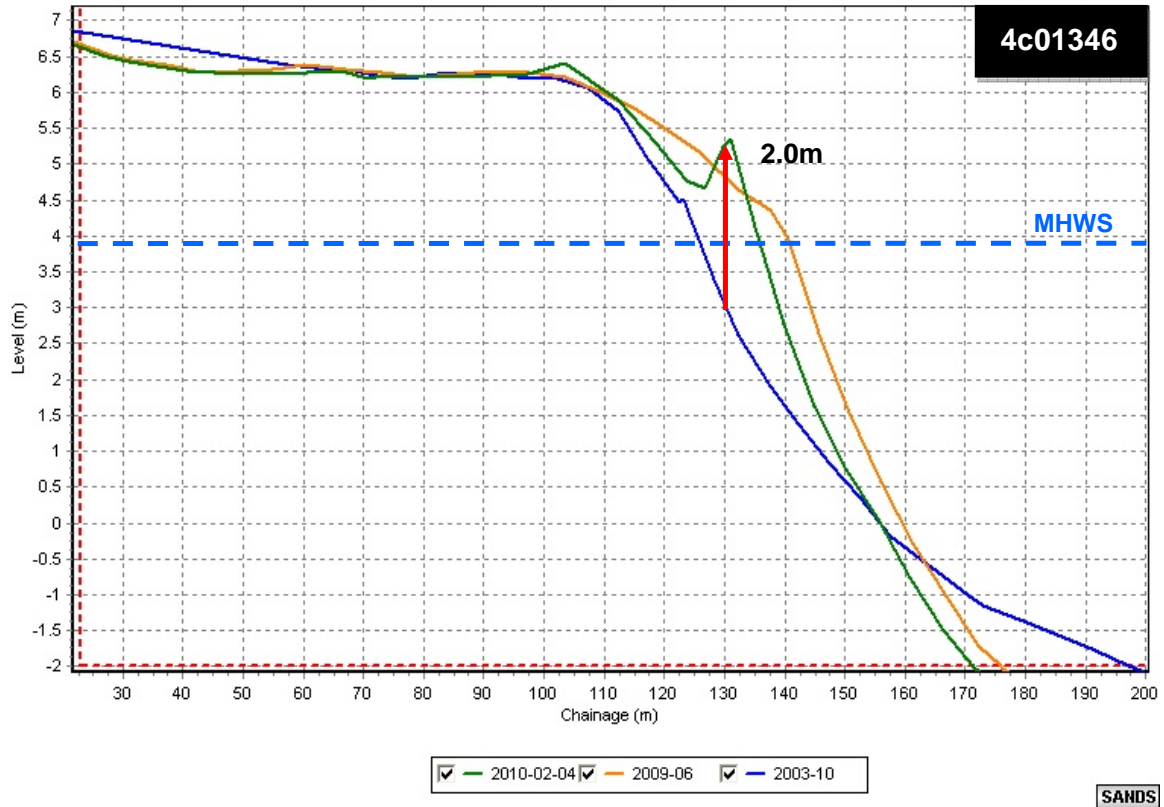
Figure 4.5: Profile 4c01346

Due to the large increase in material, the change in sediment size and profile gradient has made it more difficult to launch the boats. Profile 4c01349 (Figure 4.5), in the west of this section, illustrates where the beach sediment has been distributed. The majority of the beach face has increased in elevation, and a large berm 2.0m in height has been formed. Profile 4c01347 (Figure 4.6) clearly illustrates the steepening of the beach face between 2003 (gradient of 1:10) and 2009 (1:5).

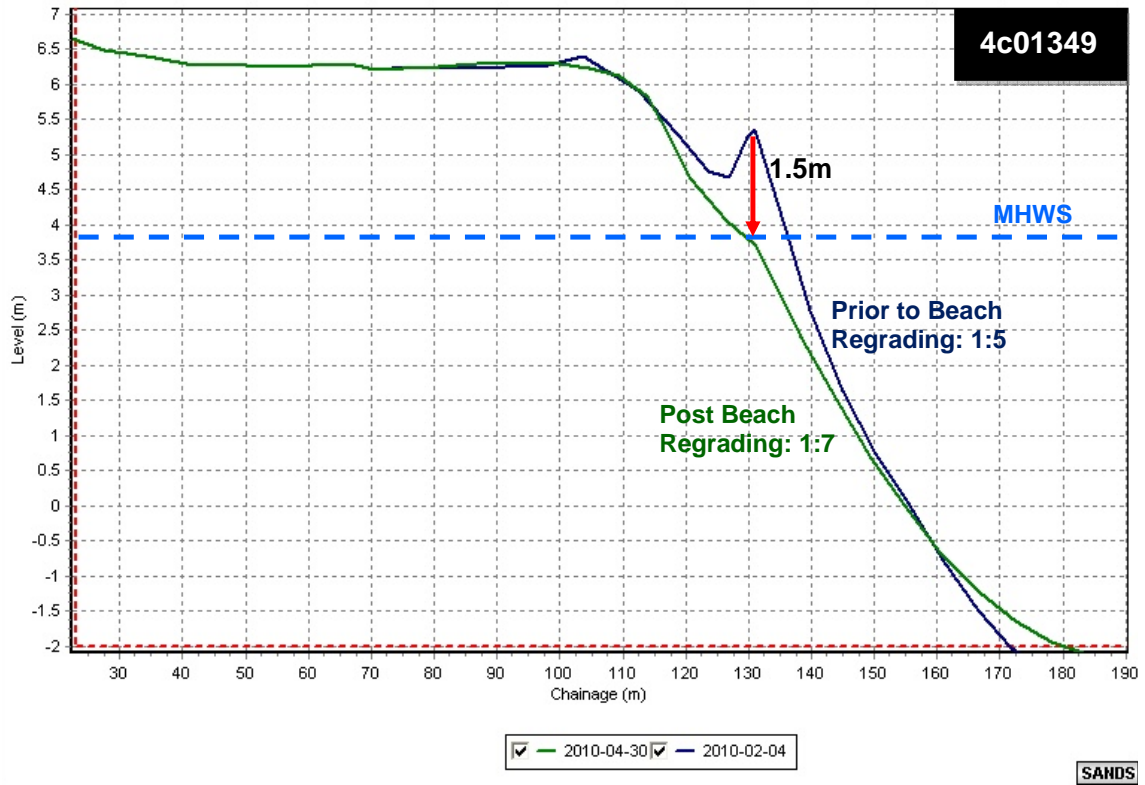
Figure 4.7: Profile 4c01349

Following the April 2010 regrading scheme, the crest has lowered by 1.5m within the harbour beach with a gentler slope of 1:7 on the beach face (Figure 4.7).

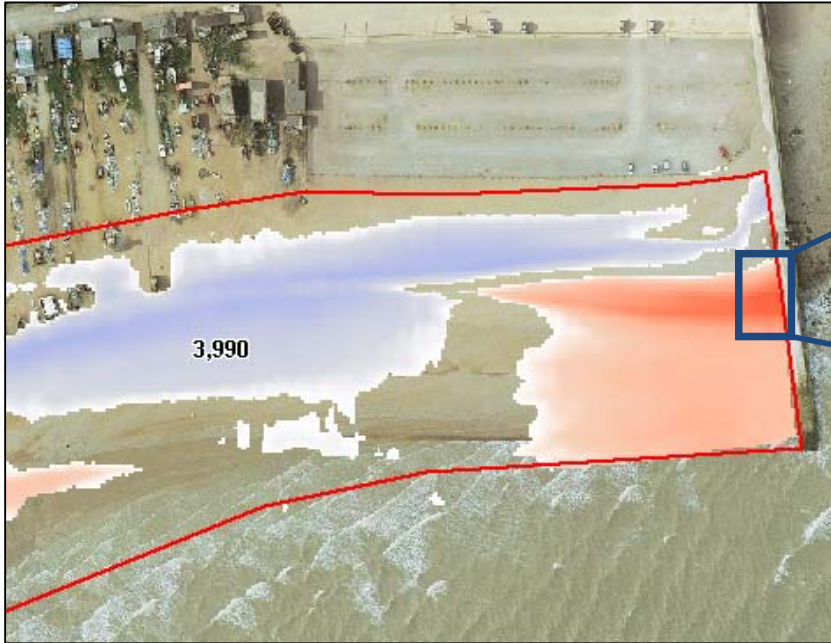
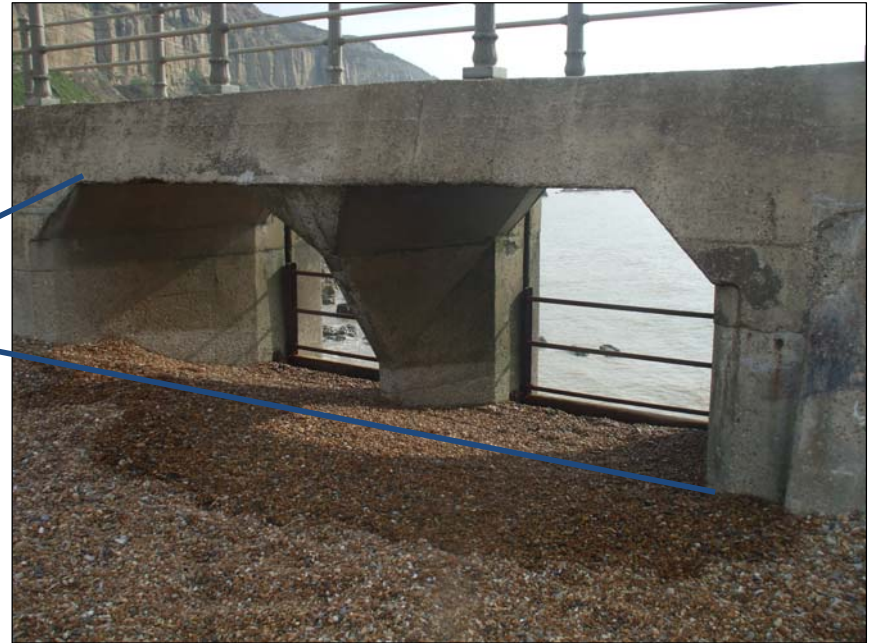
Figure 5.2: Open Sluice Gate inside the Harbour Beach

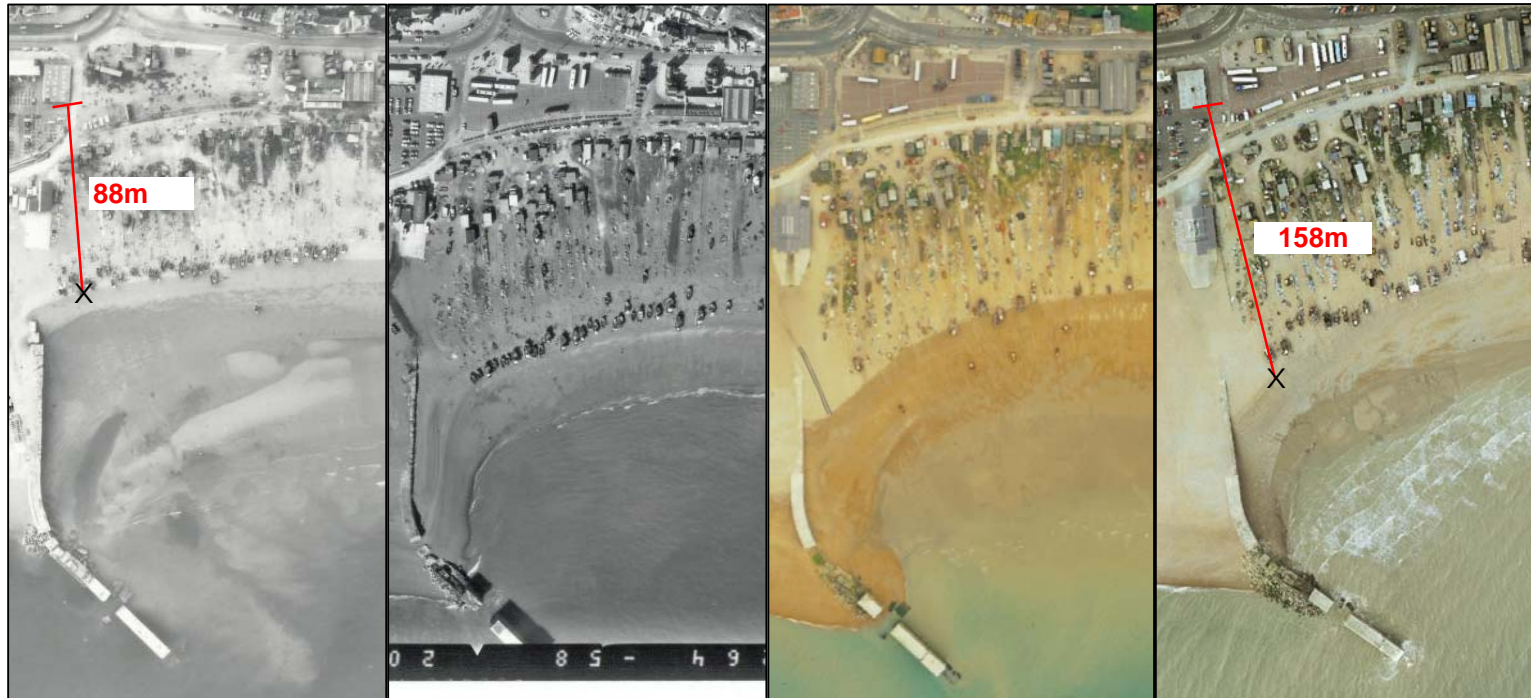
Figure 5.3: Beach Width Changes from 1980-2008. The distance between the front of a building beside the coach park and the beach crest has been measured for both the 1980 and 2008 aerials in order to see how far the beach has advanced over that time period.

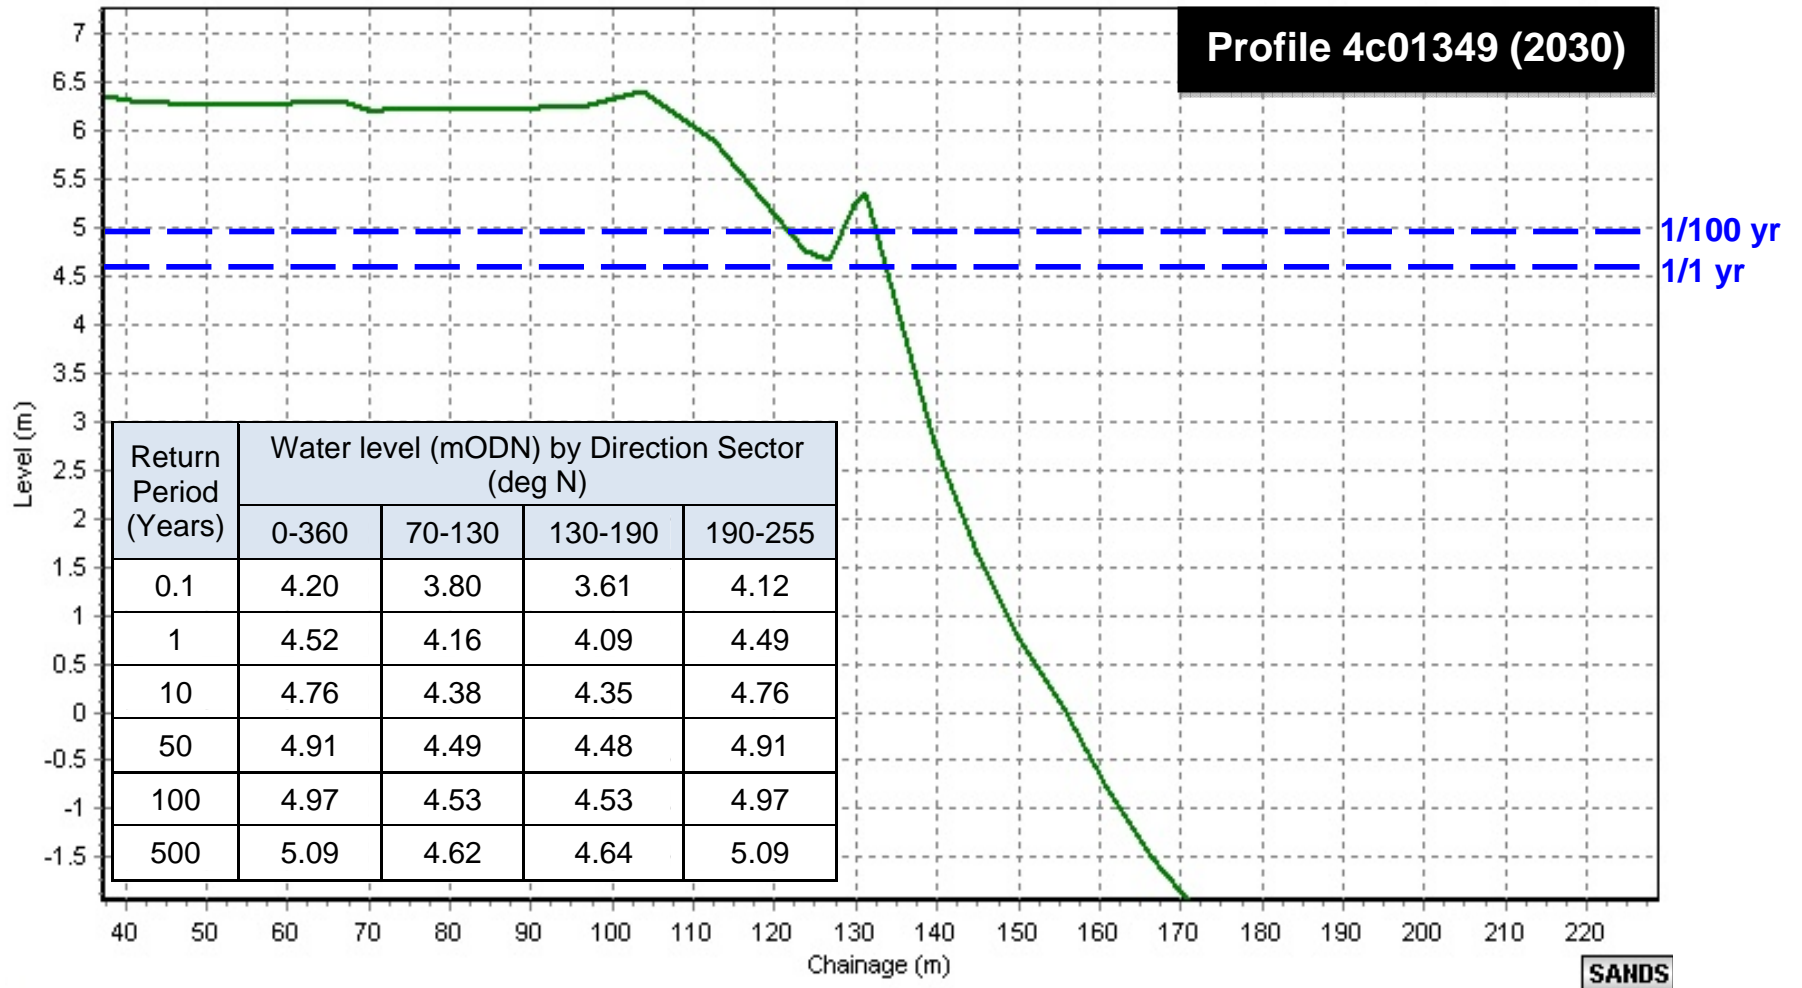
To put these changes into context the levels and anticipated return periods for extreme water levels have been updated and graphically illustrated against a recent profile survey at the western end of the harbour beach (Figures 6.1-6.3).

Figure 6.1: Predicted Sea Level Rise Extreme Water Levels for 2030

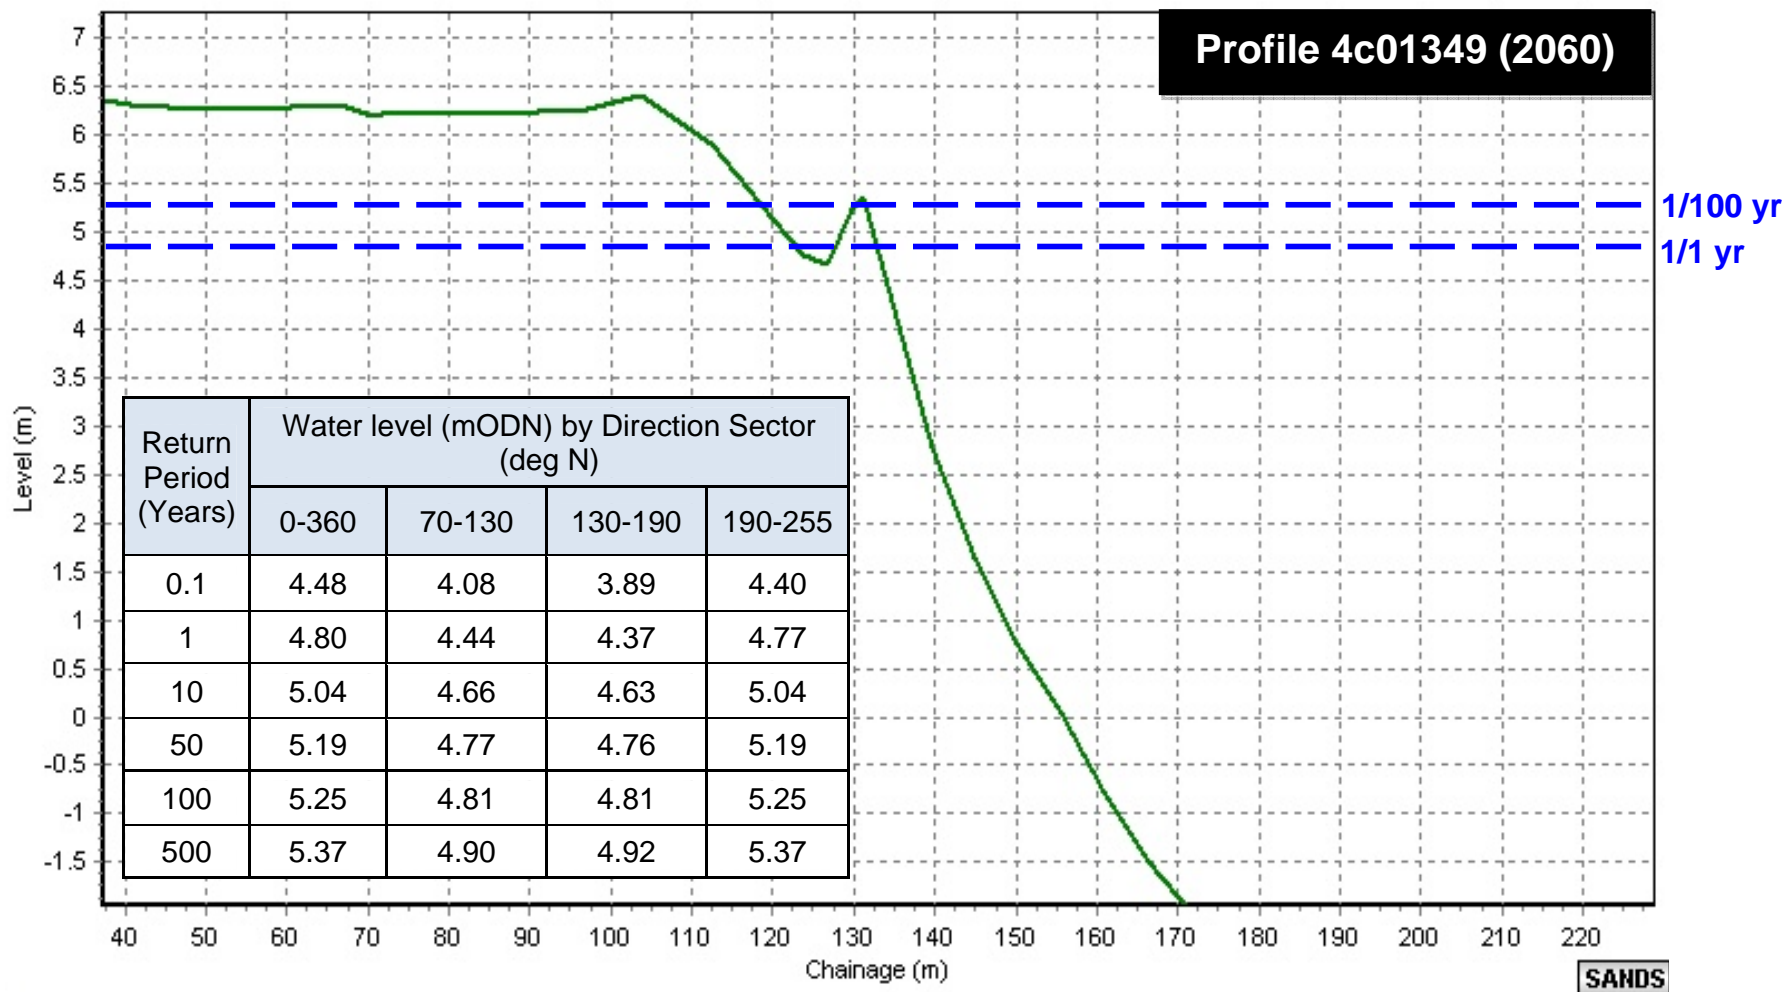
Figure 6.2: Predicted Sea Level Rise Extreme Water Levels for 2060

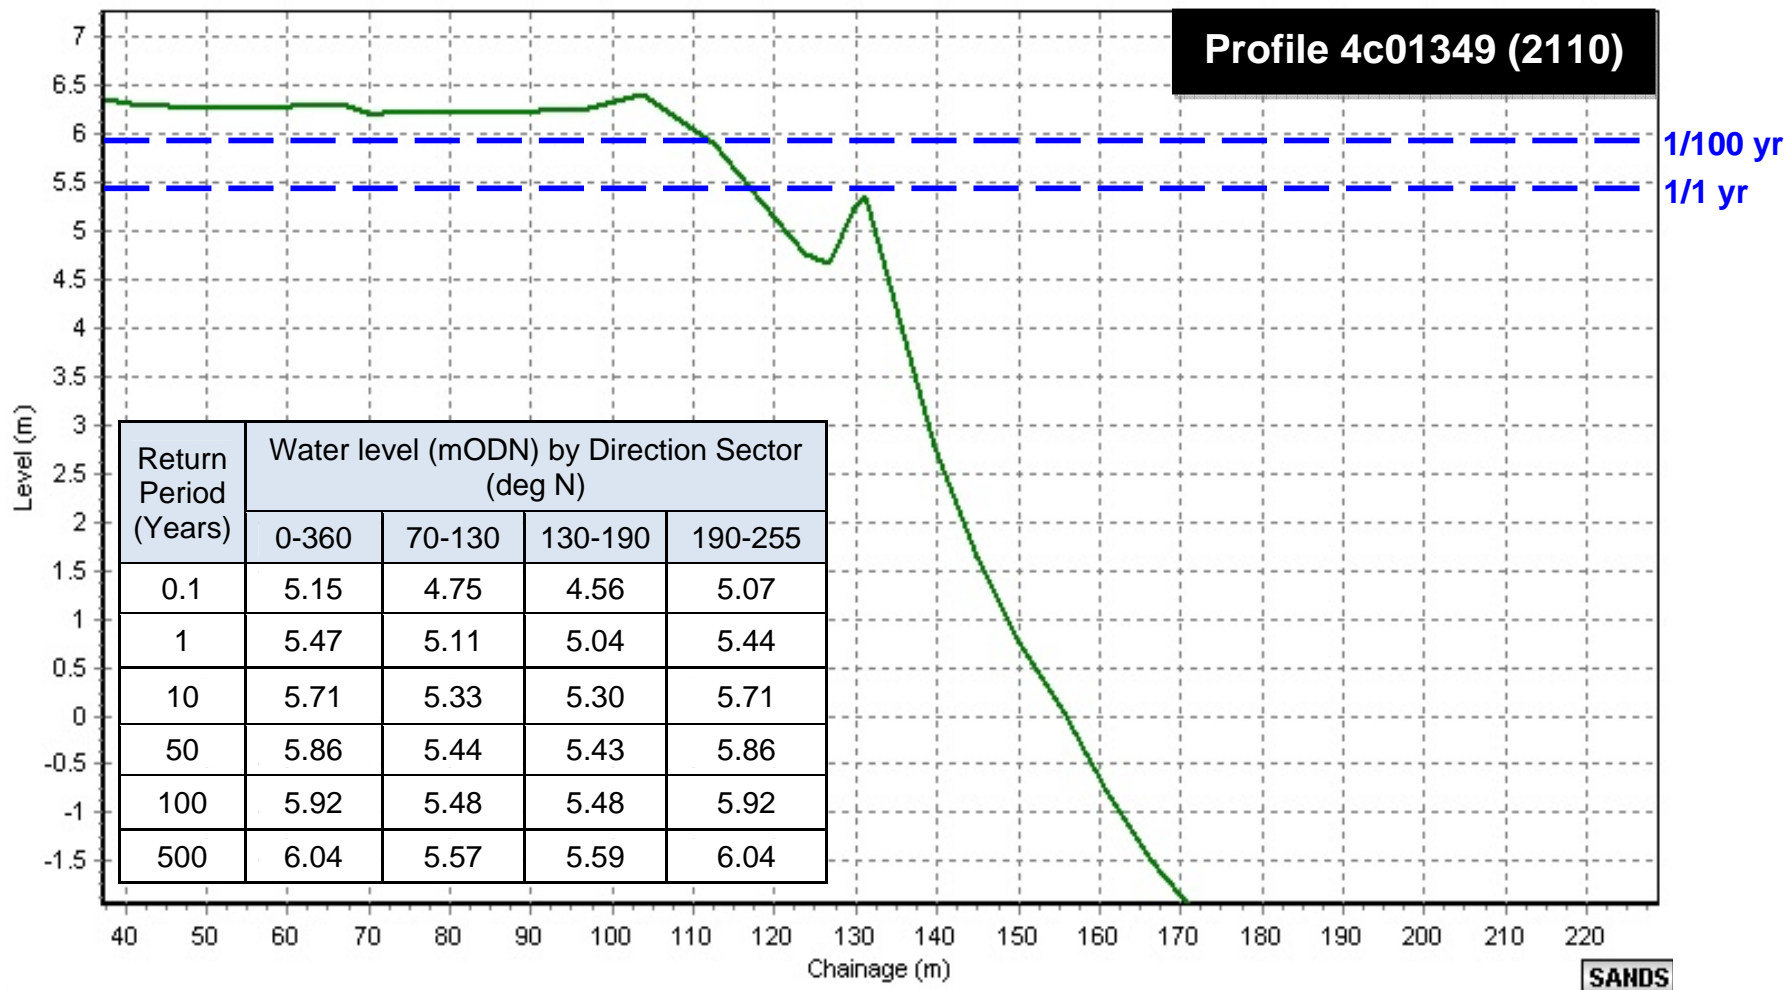
Figure 6.3: Predicted Sea Level Rise Extreme Water Levels for 2110
