Hastings Borough Council
Coastal Adaptation Pathfinder
June 2010

Department of Development and Planning
Transportation and Engineering Division

Hastings Borough Council Coastal Adaptation Pathfinder 2010

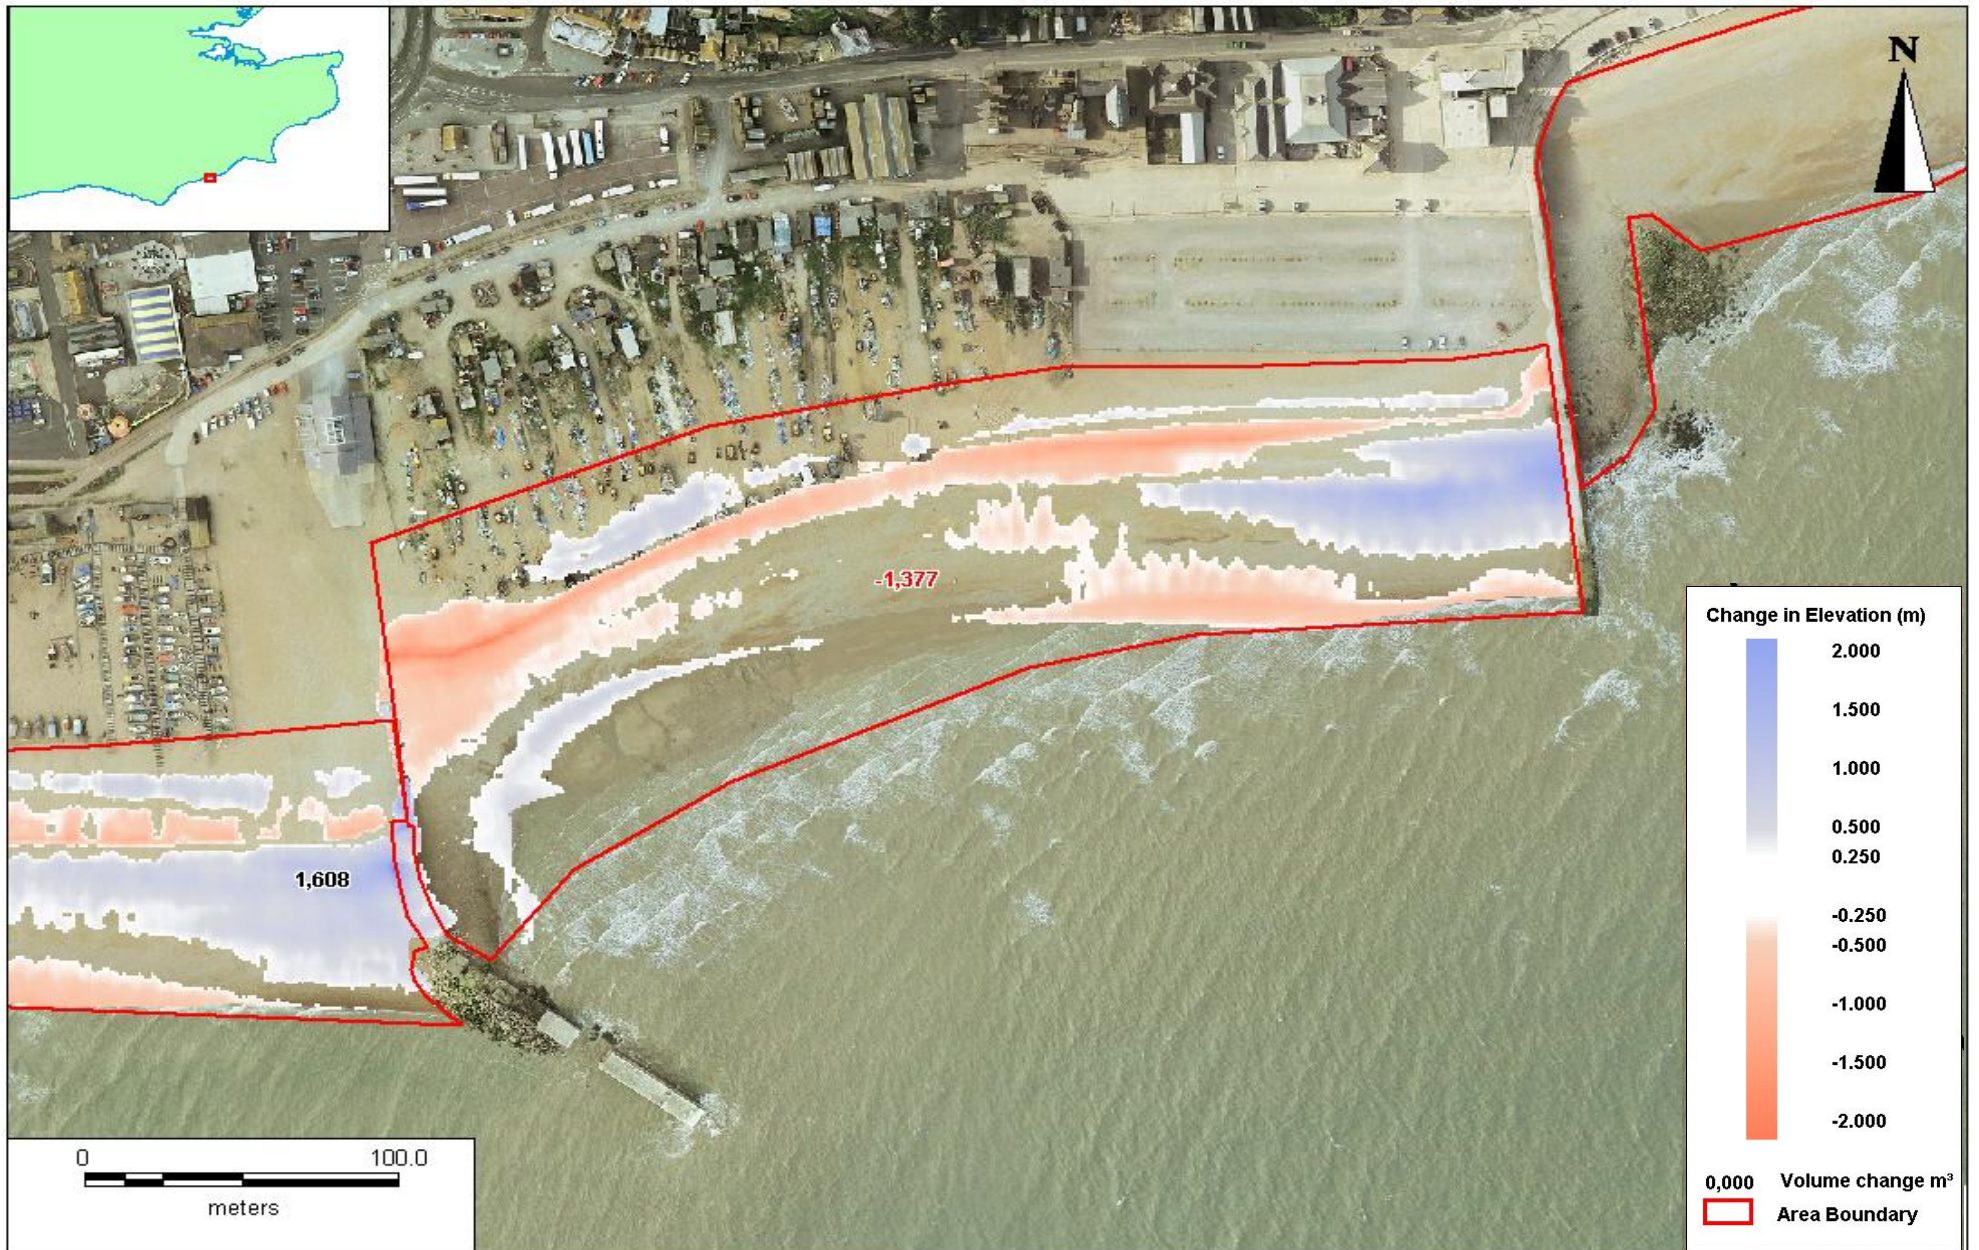
Beach Management Plan Site – Difference Model February 2010-April 2010 (post-beach regrading): Hastings Harbour

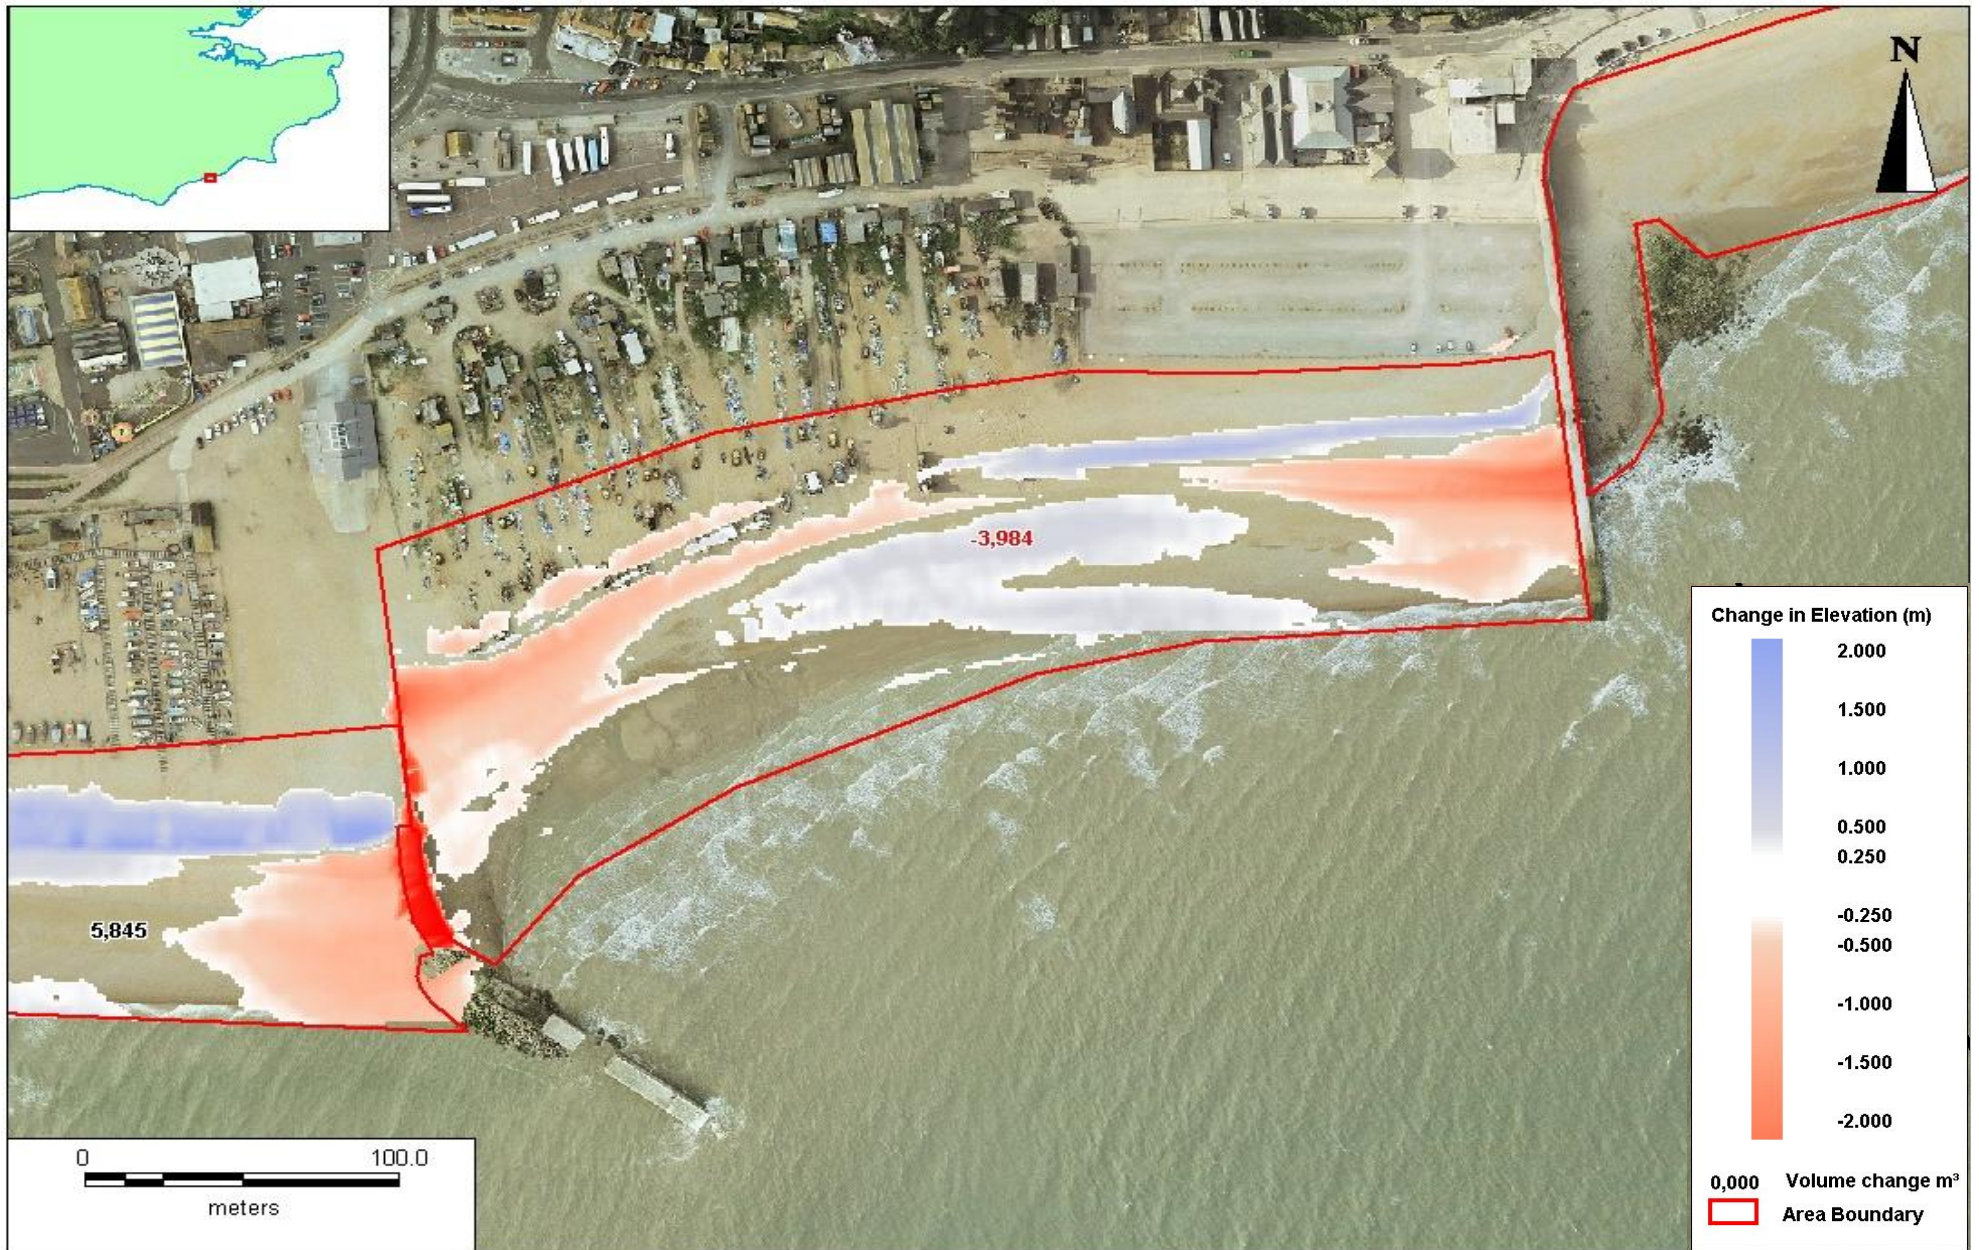
Beach Management Plan Site – Difference Model June 2009-February 2010 (prior to beach regrading): Hastings Harbour
