# Regional Beach Management Plan 2015: Eastbourne to Rye

Report – ENVIMSE100035/R-01

Final Report, February 2017

### Eastbourne to Rye Main Report

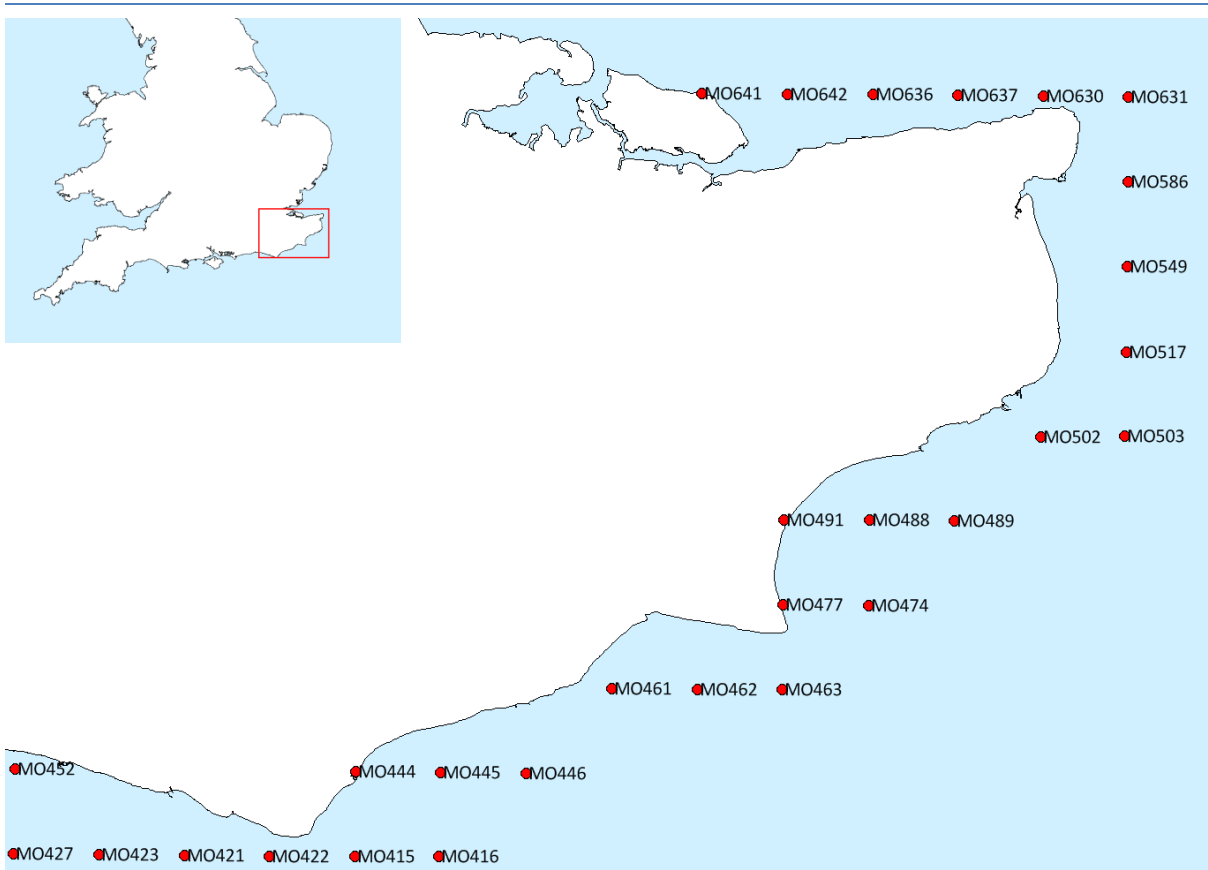
FIGURE 3-5 LOCATION OF MET OFFICE HINDCAST POINTS

Using thirty-three years of Met Office Hindcast data for 52 nearshore locations at ~5km intervals (Figure 3-5) the Joint Return Probability for Beach Management study (Mason, 2014), calculated extreme return periods for each of these points.

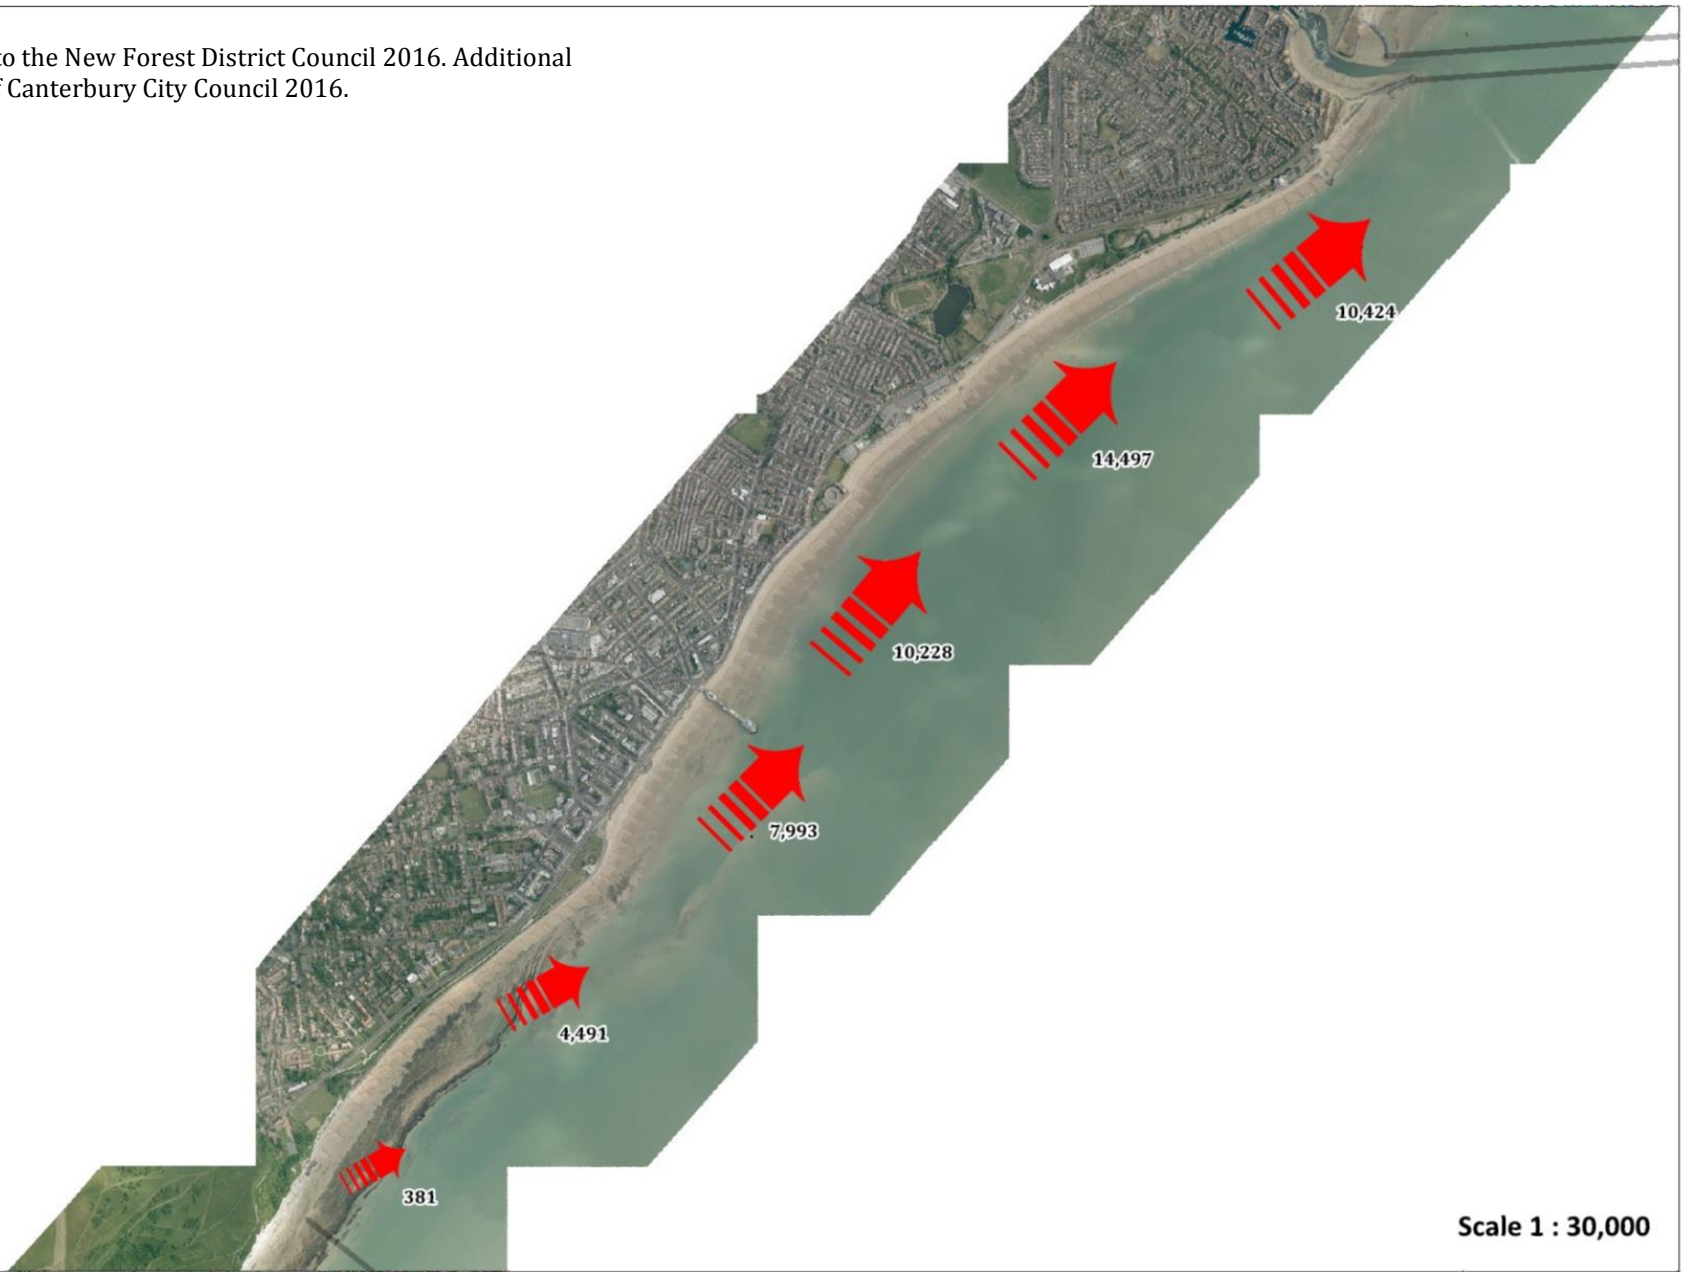
FIGURE 5-3 SEDIMENT BUDGET - EASTBOURNE

Scale 1 : 30,000

The following figures illustrate the changes in more detail. When interpreting the results it should be emphasised that these are average annual values and the observed rates can be considerably higher (or lower) in any given year. These fluctuations are taken into consideration in Chapter 7.

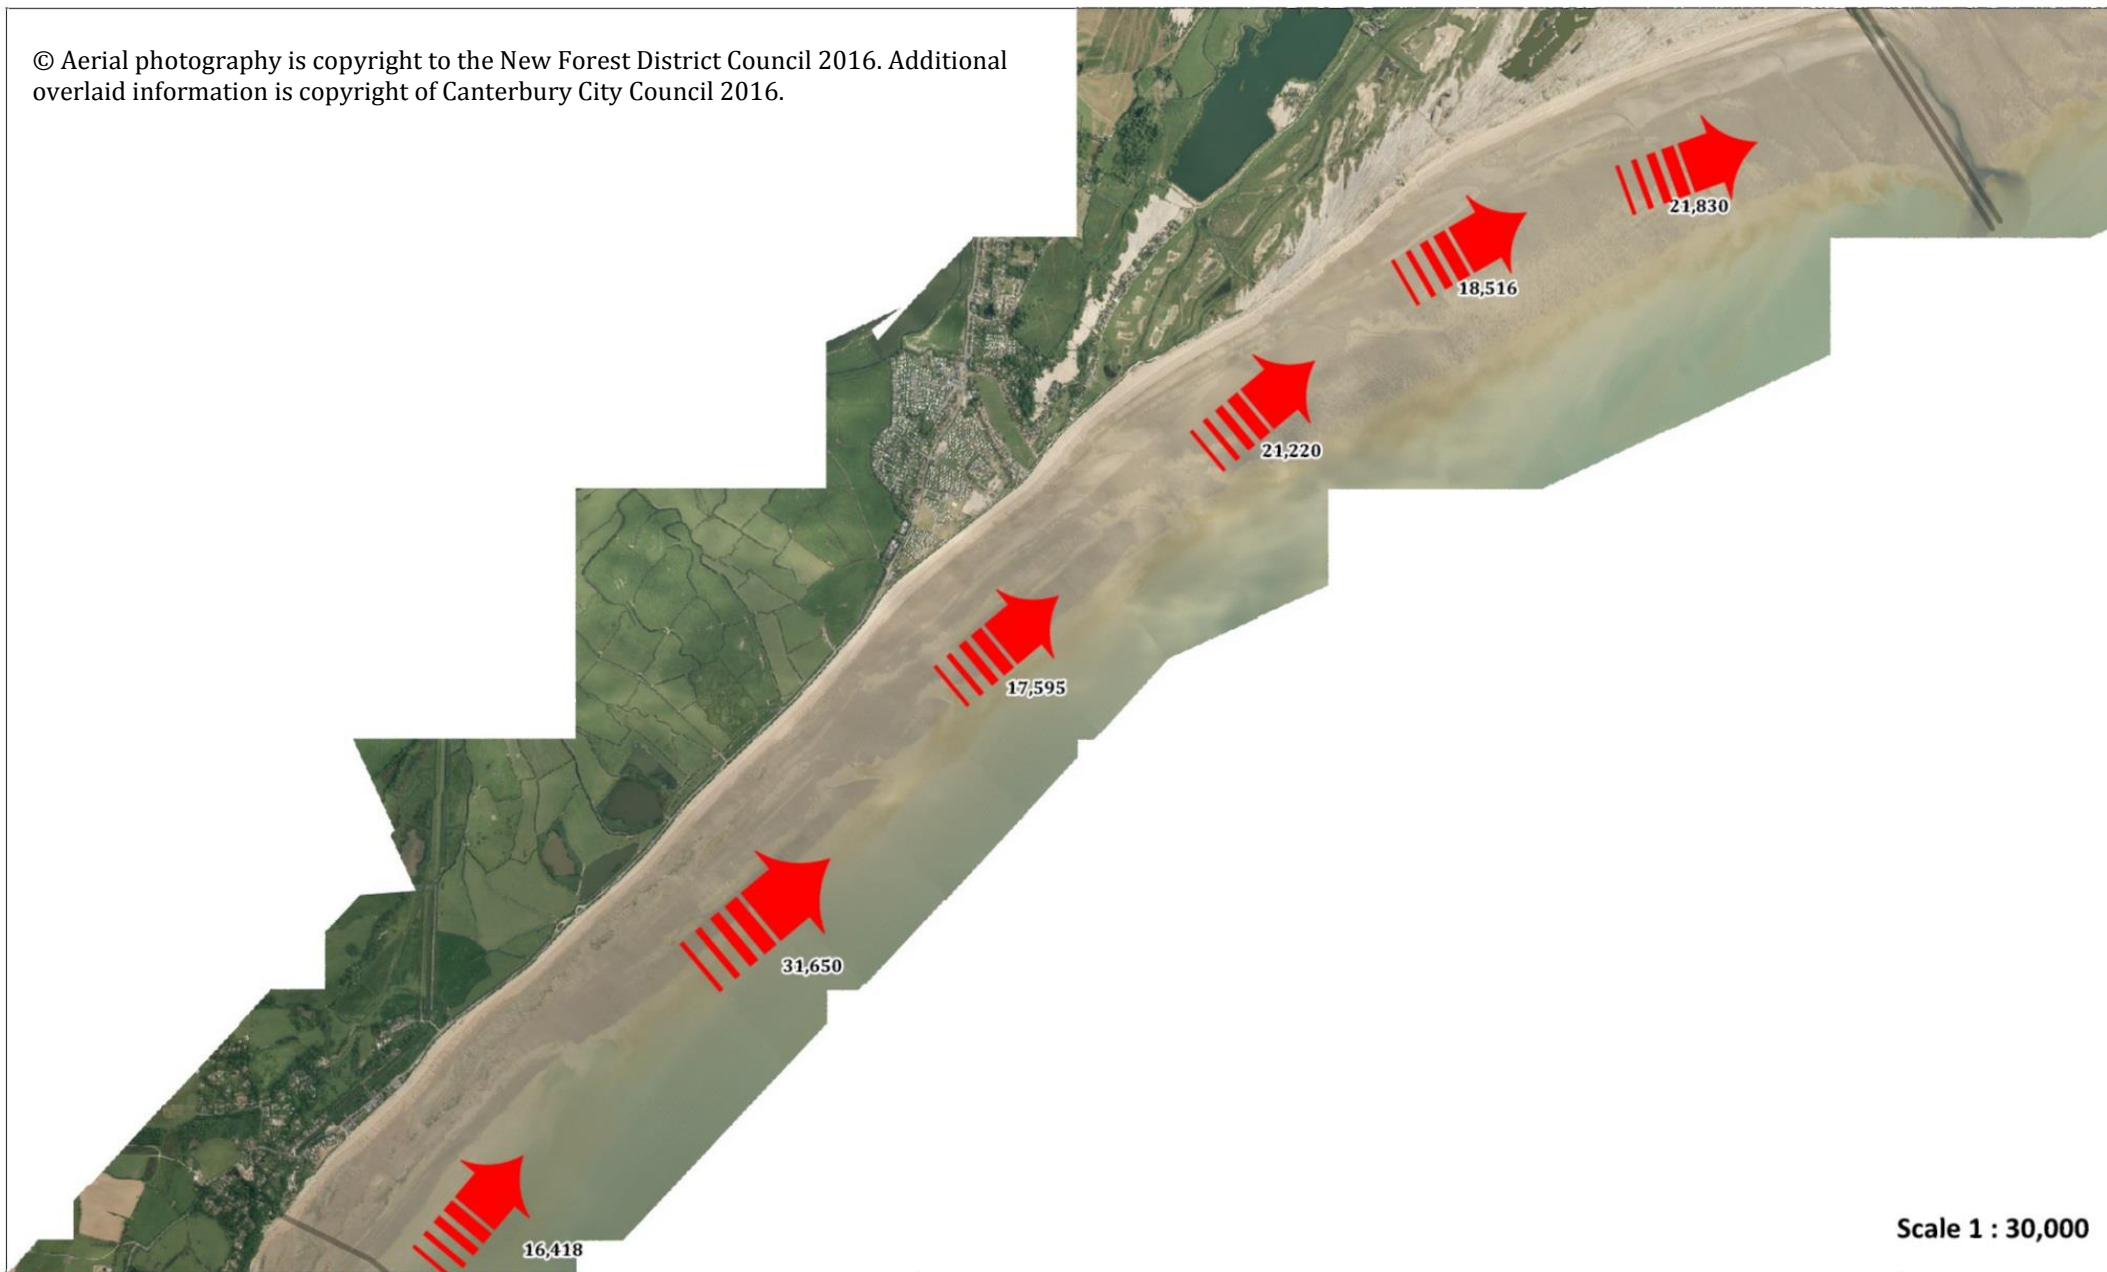
FIGURE 5-8 SEDIMENT BUDGET - WINCHELSEA

Estimated annual sediment transport in cubic meters.

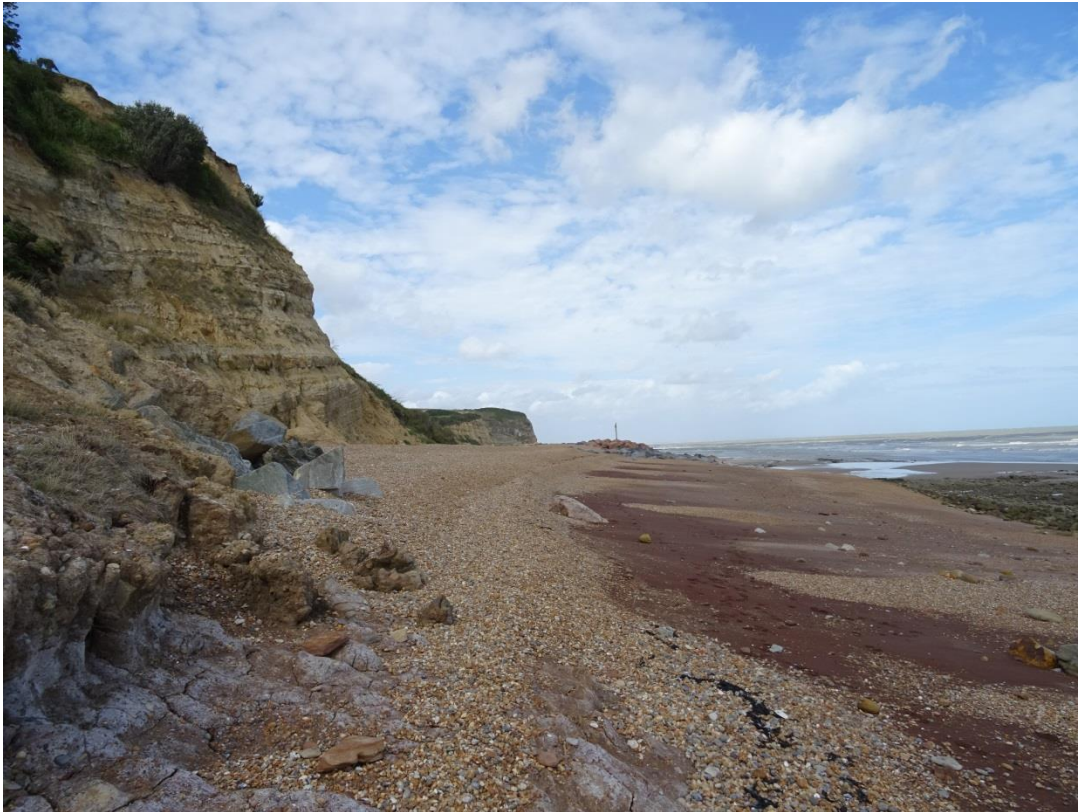
FIGURE 5-20 SHINGLE DEPOSITS AND ERODING CLIFFS AT FAIRLIGHT COVE

A reasonably large volume of shingle is now present at the eastern end of Fairlight cove. Although cliff erosion has taken place, with cliff tops receding by up to 3m a year in places, the sand and mudstone contains next to no gravel size material and so it is not expected that this contributes much quantity of shingle.

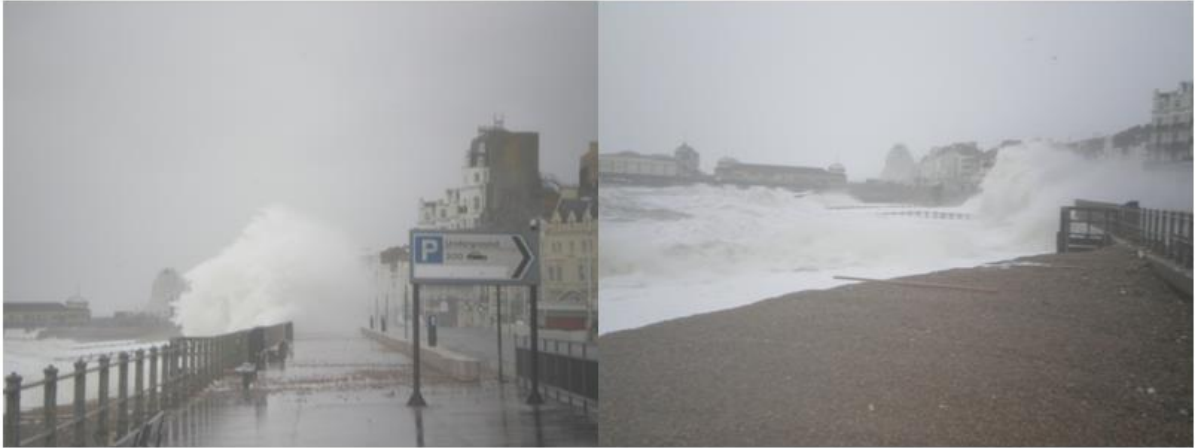
FIGURE 6-2-7 SEVERE OVERTOPPING AT HASTINGS AS A CONSEQUENCE OF LOW BEACH LEVELS (2009)

1. Photographic evidence of large overtopping events and retrospective comparison with predicted overtopping. There were several instances where this was possible, examples shown below.

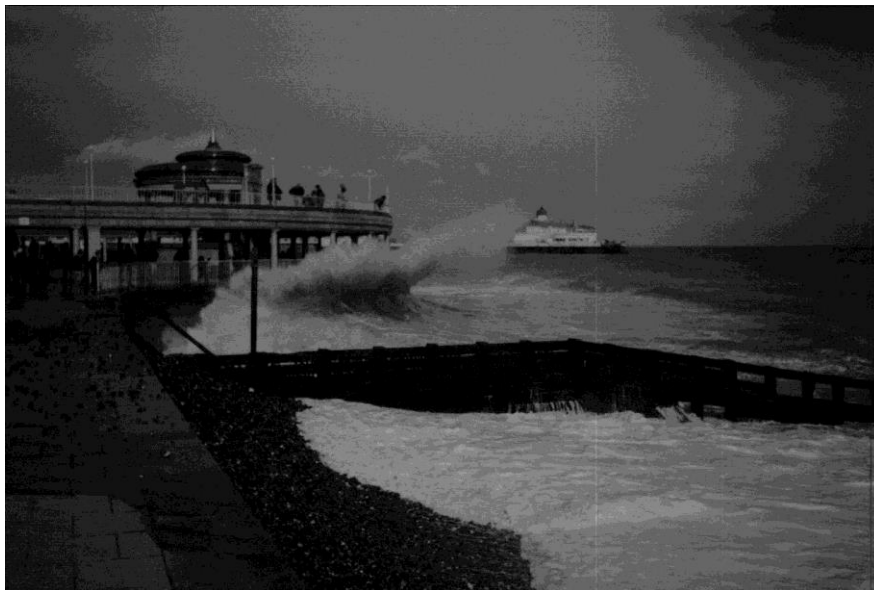
FIGURE 6-2-8 OVERTOPPING AT EASTBOURNE IN THE 1990S (BEACH LEVELS LOWER THAN PRESENT DAY)

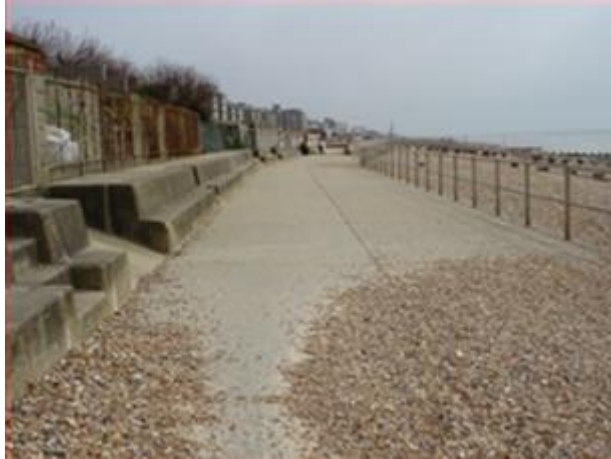
FIGURE 6-2-9 SHINGLE WASHED ON TO THE PROMENADE AT BEXHILL (2015)

2. Anecdotal evidence in the form of information that is not well documented or photographed. The prime example of this is shingle on the promenade, which is indicative of small scale overtopping (e.g. Figure 6-2-9). Where management authorities have to periodically clear this it is evident that the defence is subject to minor overtopping on a regular basis. Results can be queried to ensure these events are predicted

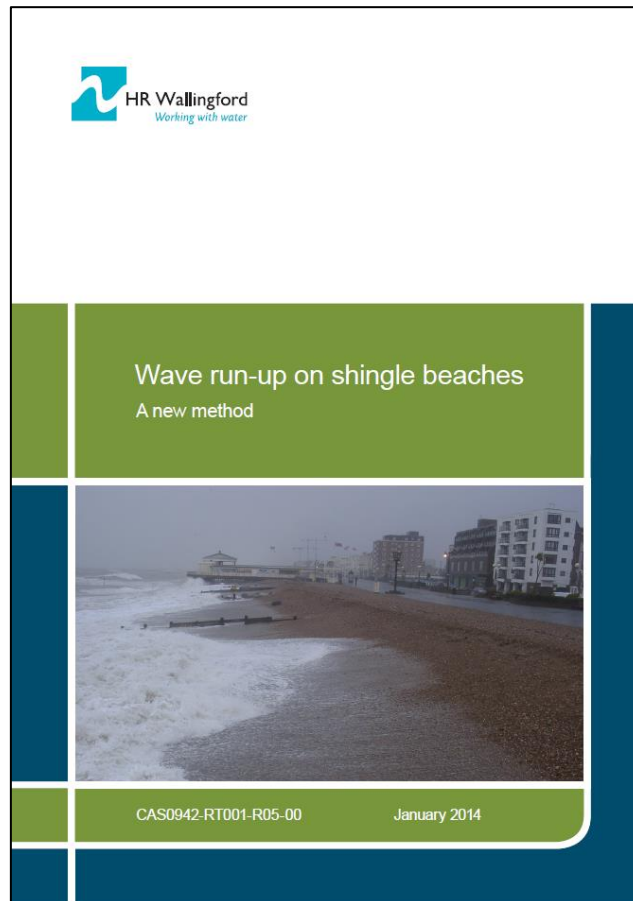
FIGURE 6-2-11 SUB-PROJECT RESEARCH AND DEVELOPMENT OF IMPROVED RUN-UP FORMULA.

- 
4. The improved formula presented in Wave run-up on shingle beaches: a new method (HRW, 2014) was used in areas that were prone to green water overtopping (No structure and run-up exceeds crest). By running calculations for a number of swell components results could be verified as reasonable and ensure that an underestimate had not been made.

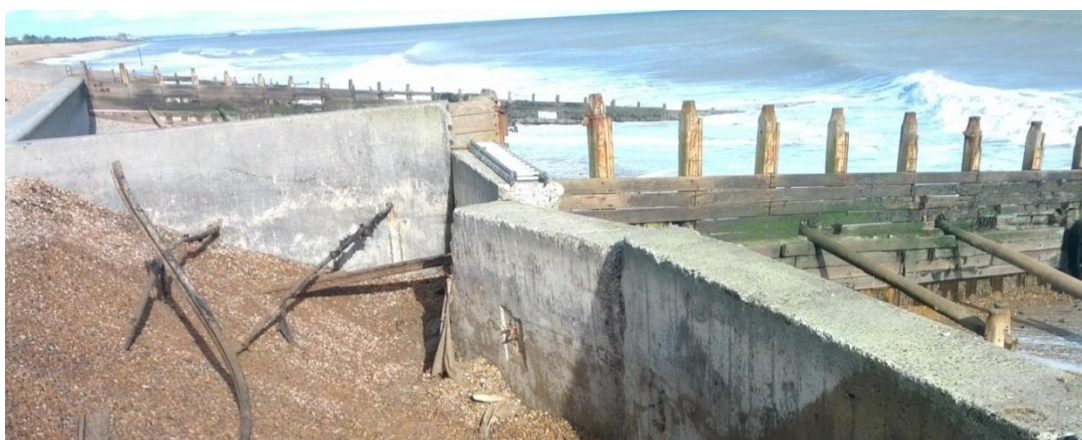
FIGURE 6-2-12 DILAPIDATED GROYNES LOW BEACH AND SEAWALL FAILURE AT KINGSDOWN

As beach levels continue to drop there is an additional threat of undermining of the seawall foundations. This can cause the structure to collapse and/or a draining of the fill material from behind the seawall that reduces the structural integrity (Figures 6-2-12 and 6-2-13). A beach also provides a lot of support and weighting in front of the structure, without which toppling or sliding of seawall sections can occur (Figure 6-2-14).

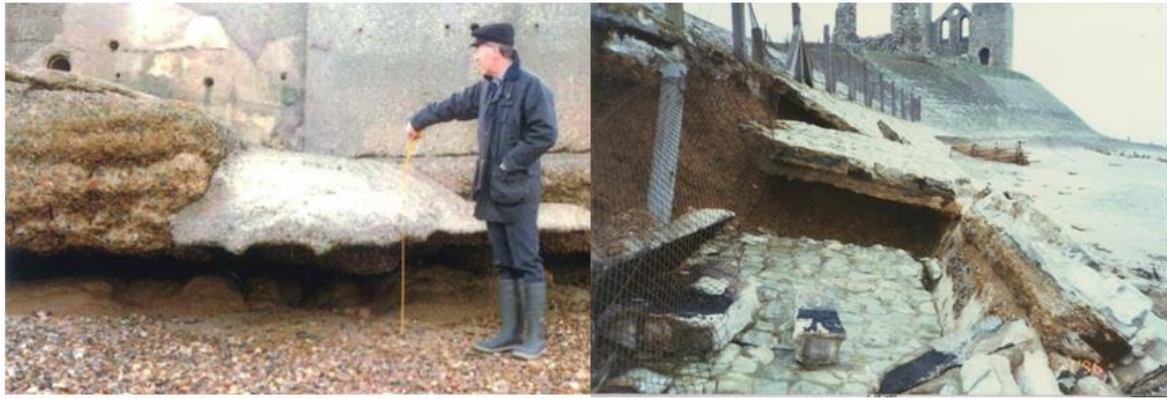
FIGURE 6-2-13 EXAMPLES OF UNDERMINING AT TANKERTON (LEFT) AND RECVLVER (RIGHT)

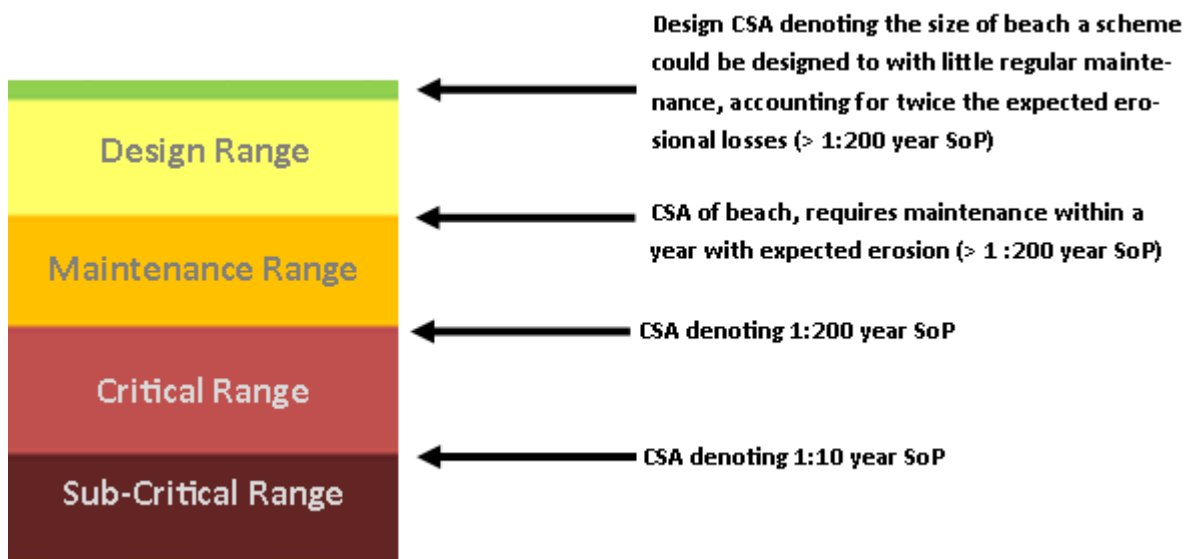
FIGURE 7-1 DESIGN, MAINTENANCE, CRITICAL AND SUB CRITICAL RANGES BASED ON TRIGGER LEVELS

It is important to note that CSAs within the Design Range (Yellow) and Maintenance Range (Orange) are above the 1:200 standard of protection. These areas give a factor of safety to allow time for coastal managers to intervene before the beach conditions drops below the required level of protection (Figure 7-1).

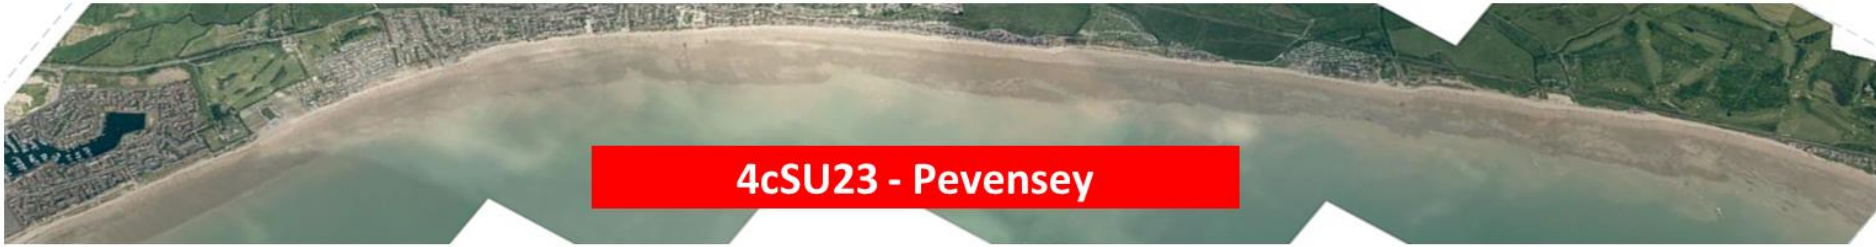
FIGURE 7-4 PEVENSEY BAY PCDL DESIGN LEVELS (BEACH CROSS SECTIONAL AREA (M2) VS PROFILE LOCATION)

Pevensey is currently managed by Pevensey Coastal Defence Limited (PCDL) on a 25 year management contract on behalf of the Environment Agency. The design levels from the PCDL/Environment Agency contract are shown in Figure 7-4. The PCDL designs are based on a combination of factors including maintaining a design berm width and having a large enough design to maintain updrift beaches, which require more detailed calculations than are conducted as part of this BMP.

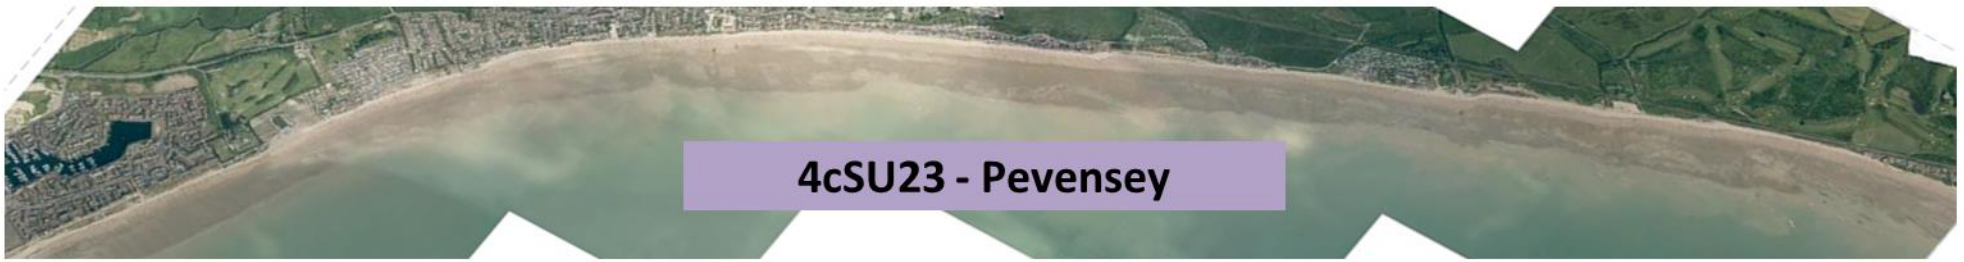
FIGURE 7-5 OBSERVED CSA CHANGES IN PEVENSEY BAY (4cSU23) WITHIN THE CONTEXT OF BEACH TRIGGER LEVELS

The design values based upon overtopping calculations, calculated for this BMP, are shown in Figure 7-5. The individual overtopping charts for each defence section are provided in Appendix G.

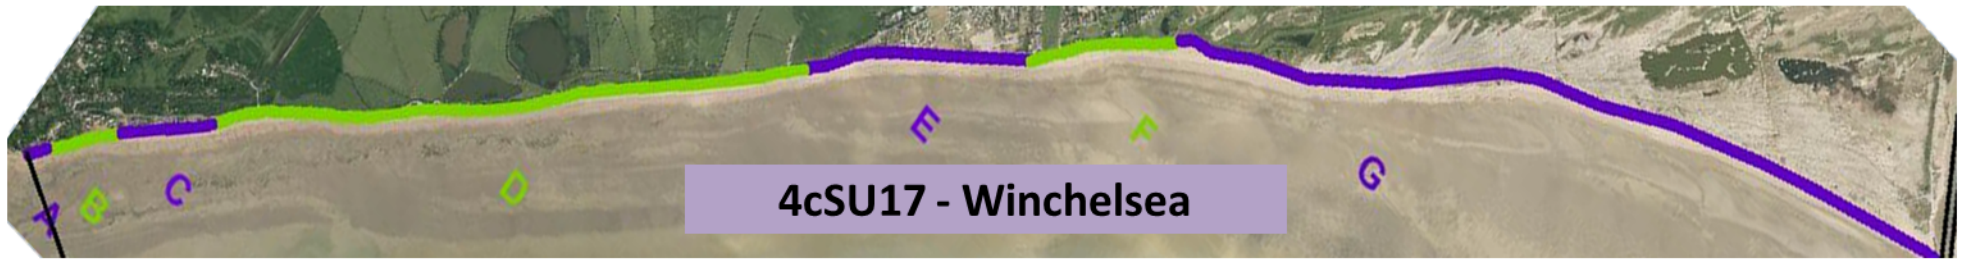
FIGURE 7-9 OBSERVED CSA CHANGES IN WINCHELSEA (4cSU17) WITHIN THE CONTEXT OF BEACH TRIGGER LEVELS

Regular beach recycling to Section A compensates for the material lost via longshore drift to Sections further east. Pett Levels, lies behind Section A which includes less than 100 properties. Further east of this section the beaches increase in volume and are above the design levels and backed by agricultural and therefore the risk of failure is low but the potential impact of flooding is high. The individual overtopping charts for each defence section are provided in Appendix G.

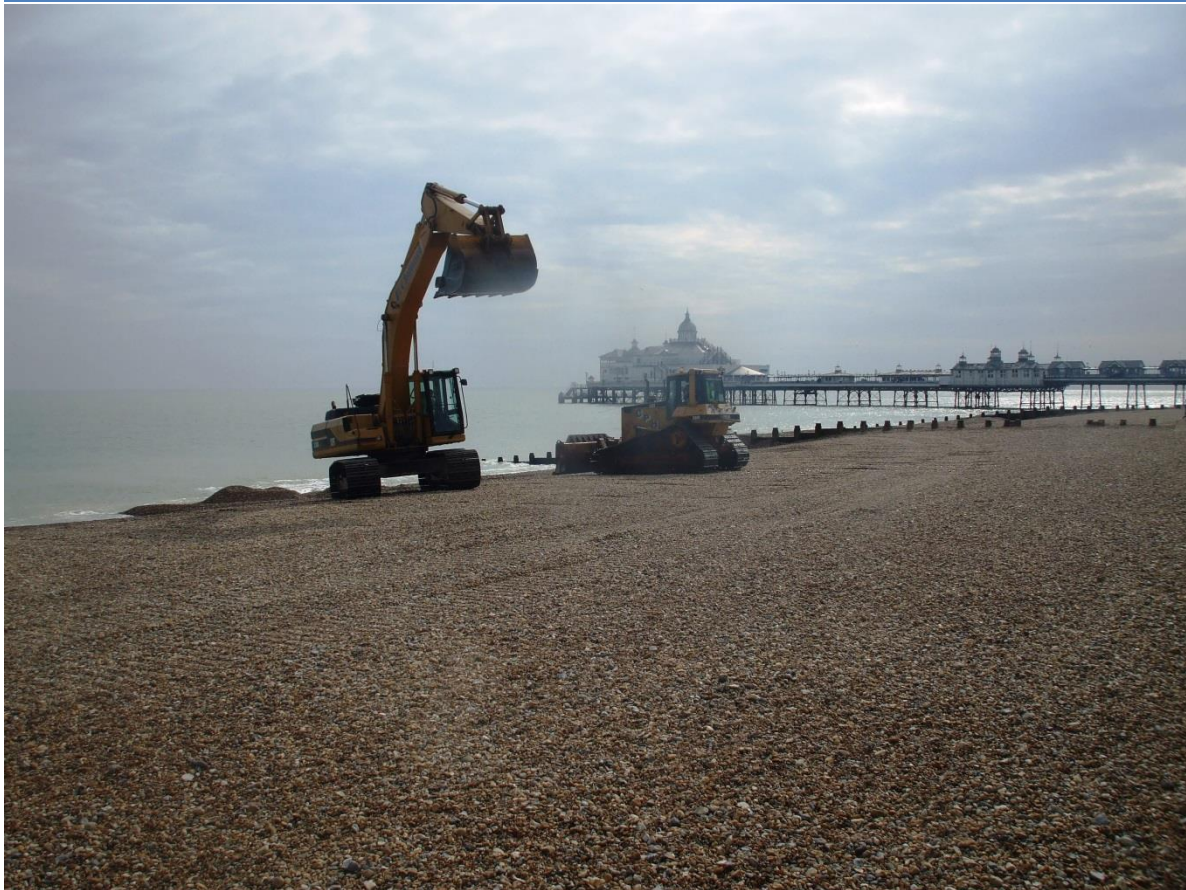
Sections C and D at the centre of Eastbourne are backed by a densely populated flood basin. Beach levels are within the maintenance and design range. Material is currently recycled or recharged here on an annual basis in order to provide protection against overtopping and flooding.

FIGURE 8-1 RECYCLING WORKS AT EASTBOURNE PIER, 2012

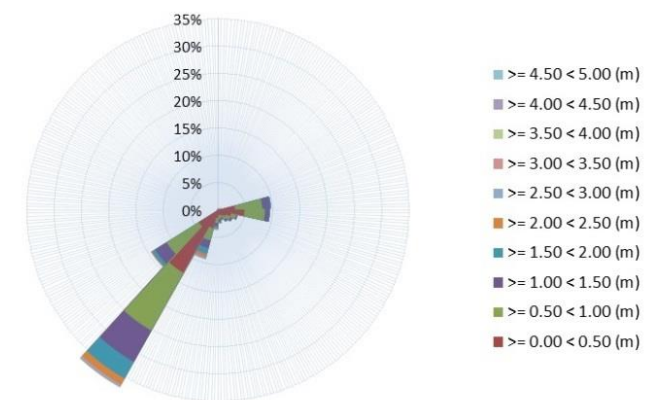
**Wave Rose for Pevensey Bay indicative of direction, frequency & magnitude of waves, April 2014 - April 2015**

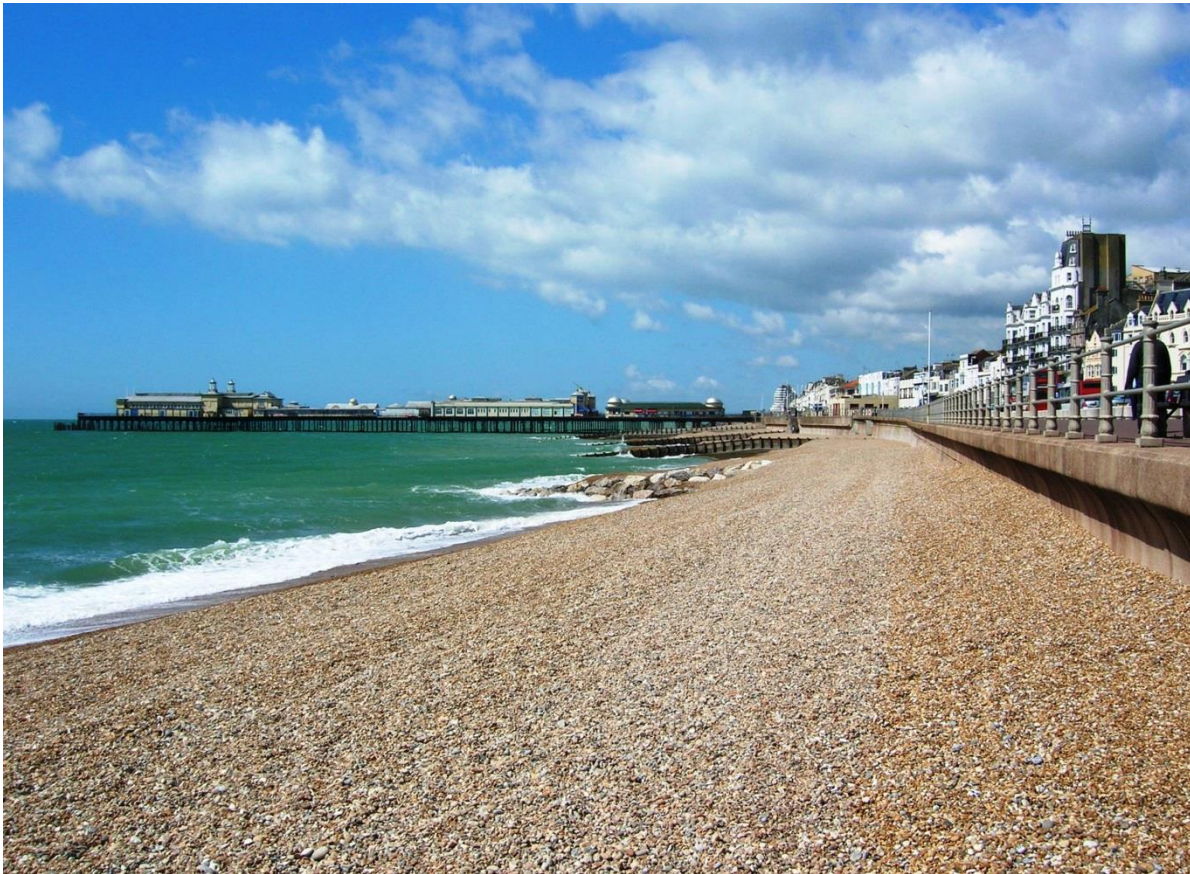
Where the coastline changes in orientation at Carlisle Parade, beach levels are low, increasing the risk of overtopping and sea wall failure. The shingle beach crest is often very narrow and the CSA of Profile 4c01375 is in the critical range. Continued erosion would expose the sea wall to wave impact damage.

FIGURE 8-5 LOW BEACH LEVELS AT CARLISLE PARADE, HASTINGS, 2012

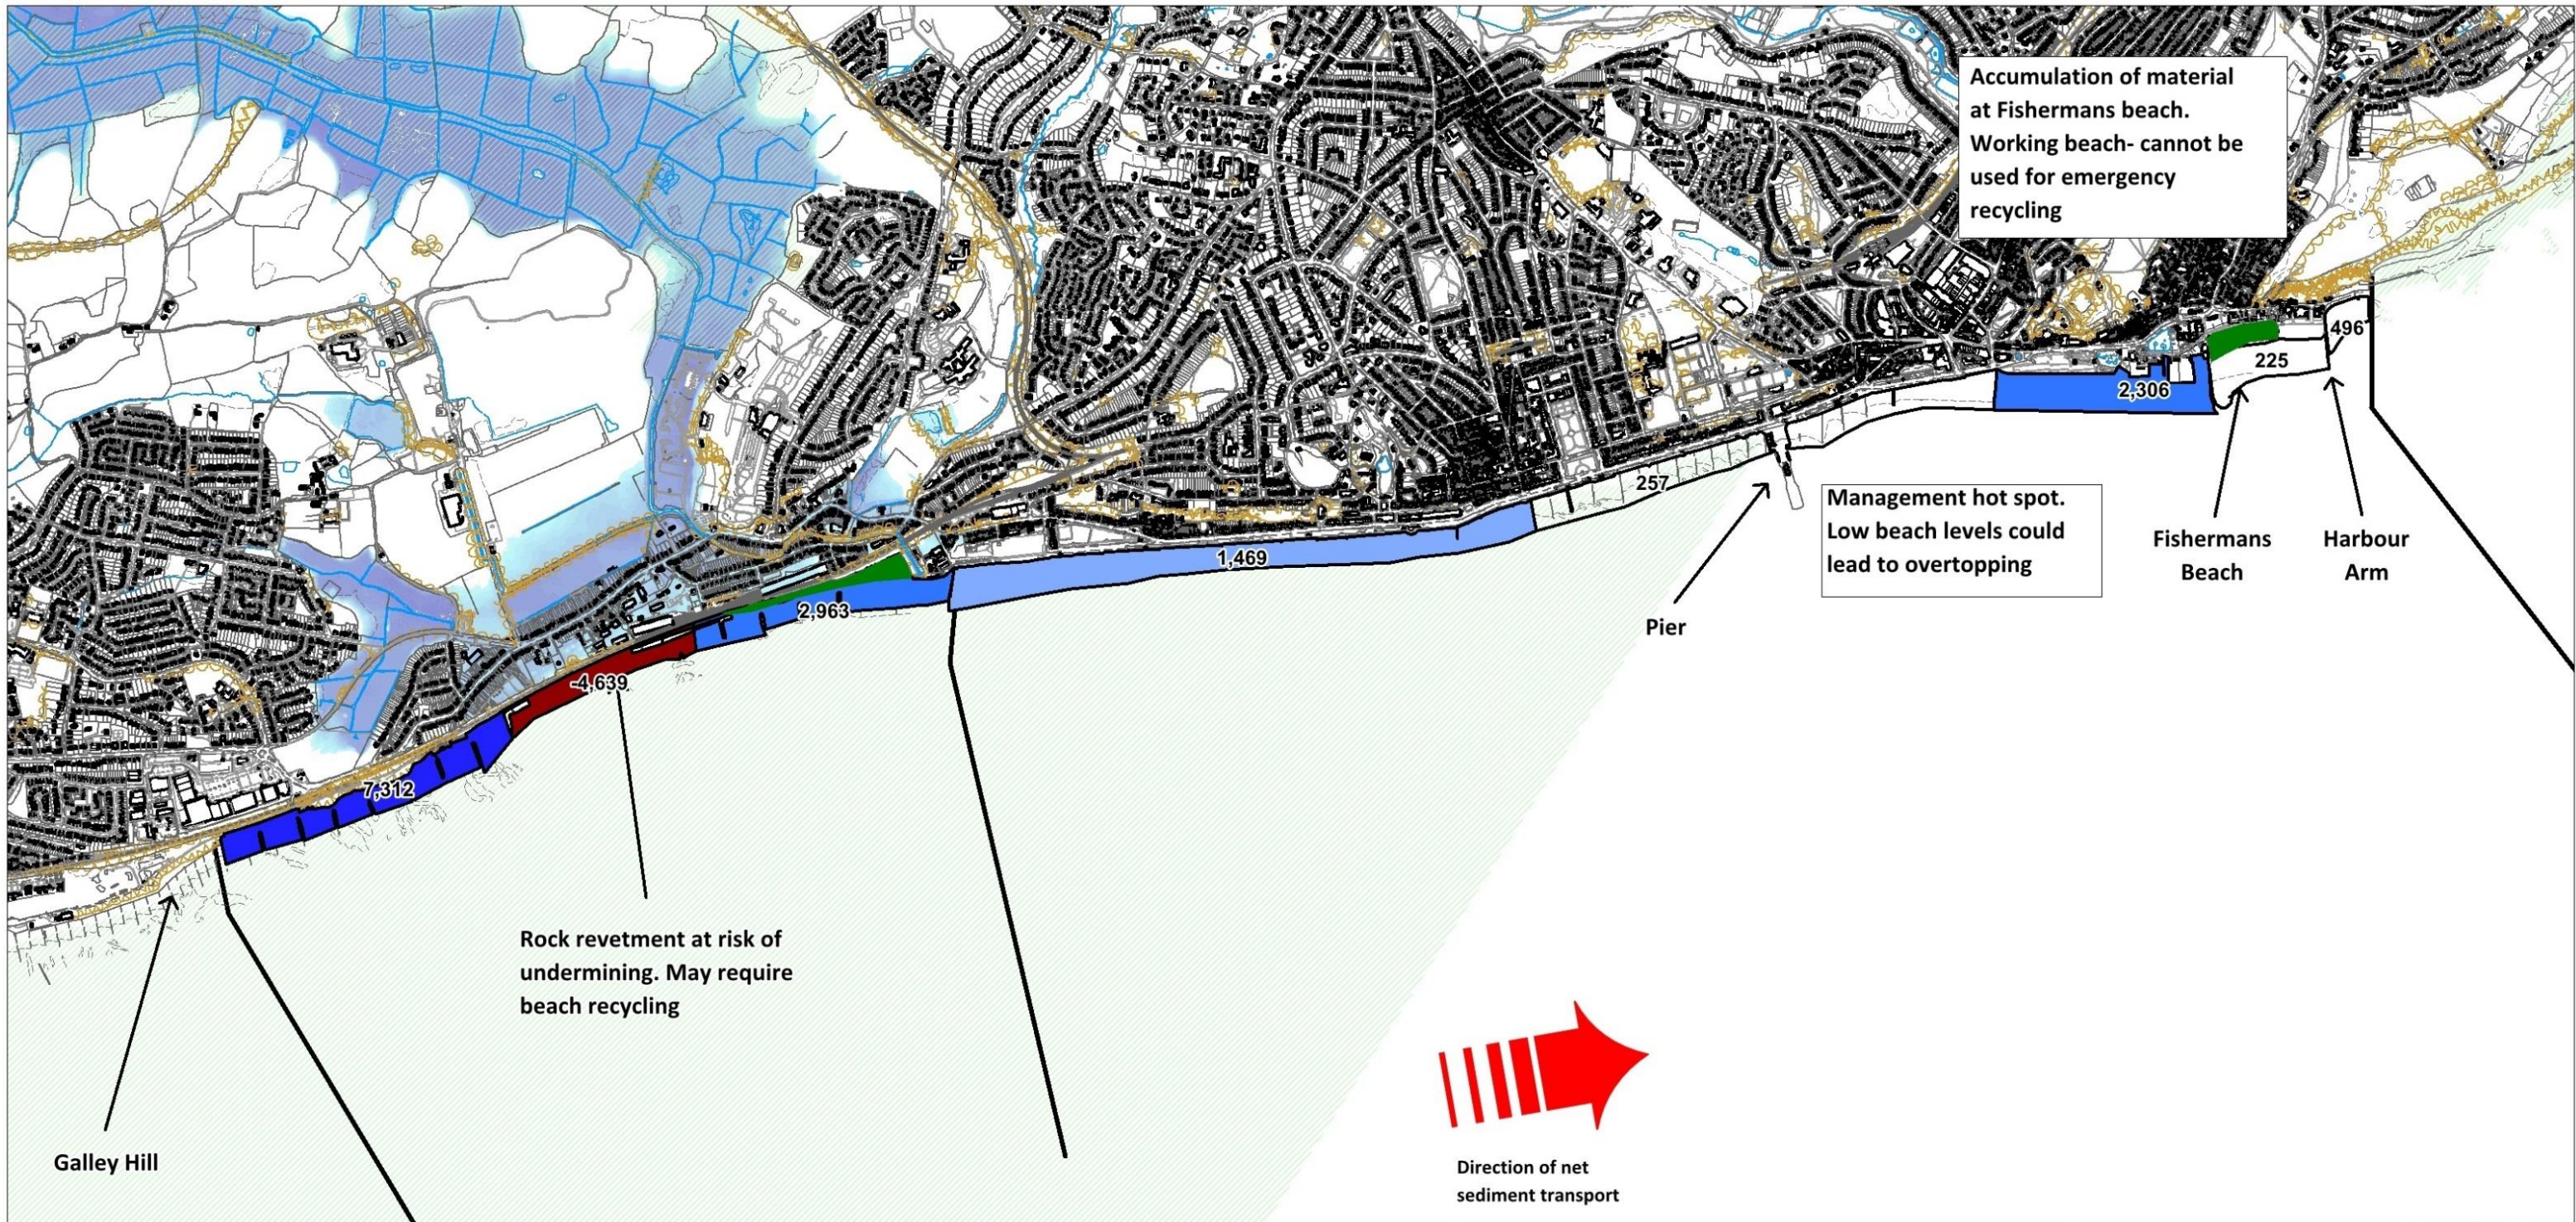
In the event of an emergency, it is recommended that material is extracted from the beach fronting the amusements as this acts as a sediment store and beach levels are well above design levels. Material should be placed along weaker sections of the frontage, in particular at Carlisle Parade.

**FIGURE 8-6 SUMMARY OF SEDIMENT TRANSPORT RATES, ENVIRONMENTAL RESTRICTIONS, AREAS OF CONCERN AND RECOMMENDED MANAGEMENT ALONG THE BULVERHYTHE TO HASTINGS FRONTAGE**

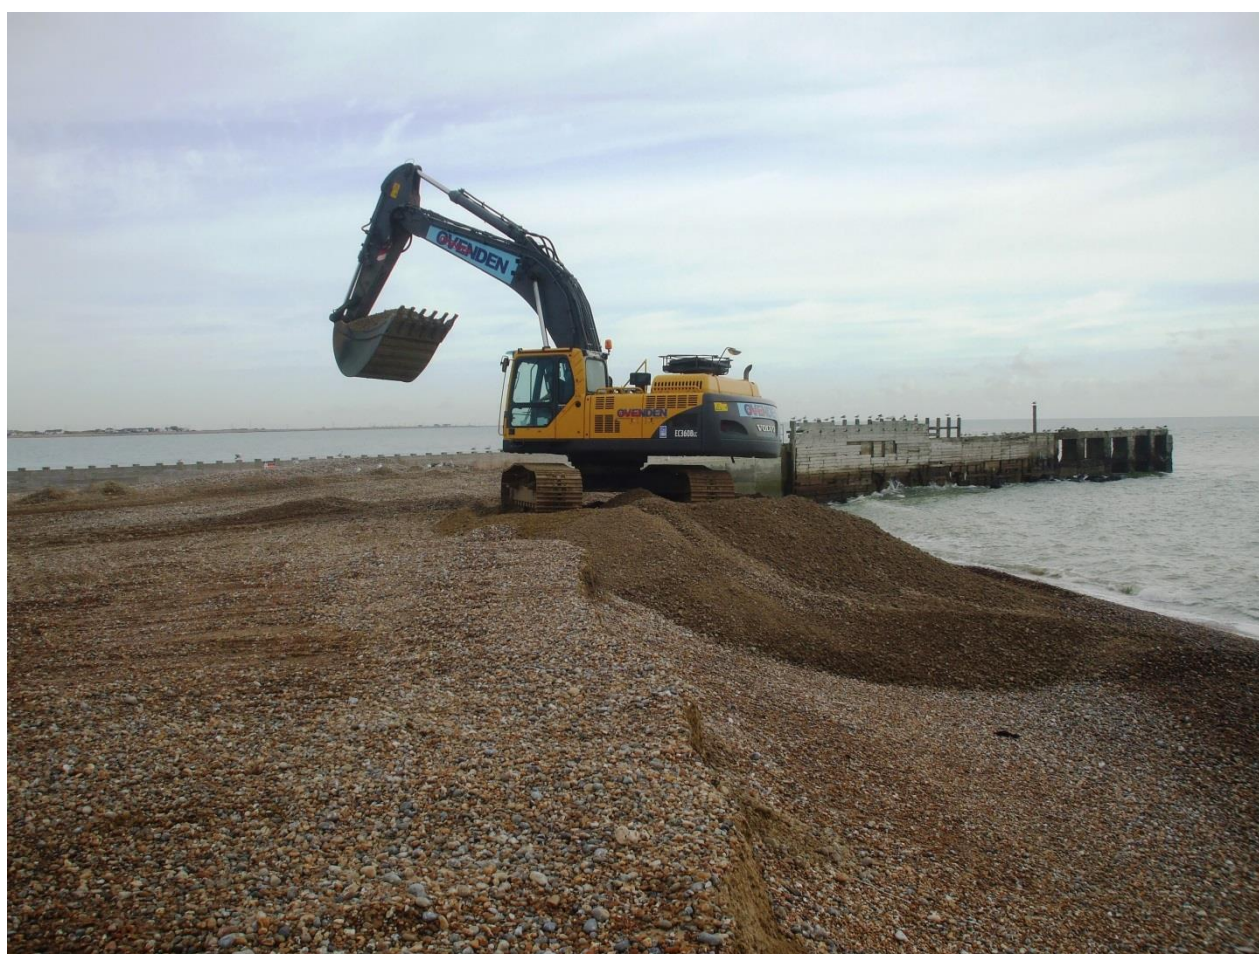
Nook point acts as a sediment sink for the Winchelsea frontage. Material can be taken from a 50m stretch, from the main crest of the beach back to the first line of vegetated material. Any shingle that has established vegetation cannot be used for recycling. Between 15,000-30,000m<sup>3</sup> of material is taken in March annually.

FIGURE 8-8 EXTRACTION OF BEACH MATERIAL AT NOOK POINT, WINCHELSEA, 2012

The beach levels should continue to be monitored as part of the RCMP. Extraction of material at Nook Point should continue to replenish the depleted beach at Cliff End (Pett Level Beach) as and when required. Any material not recycled quickly becomes vegetated and is then unavailable for recycling due to environmental restrictions.

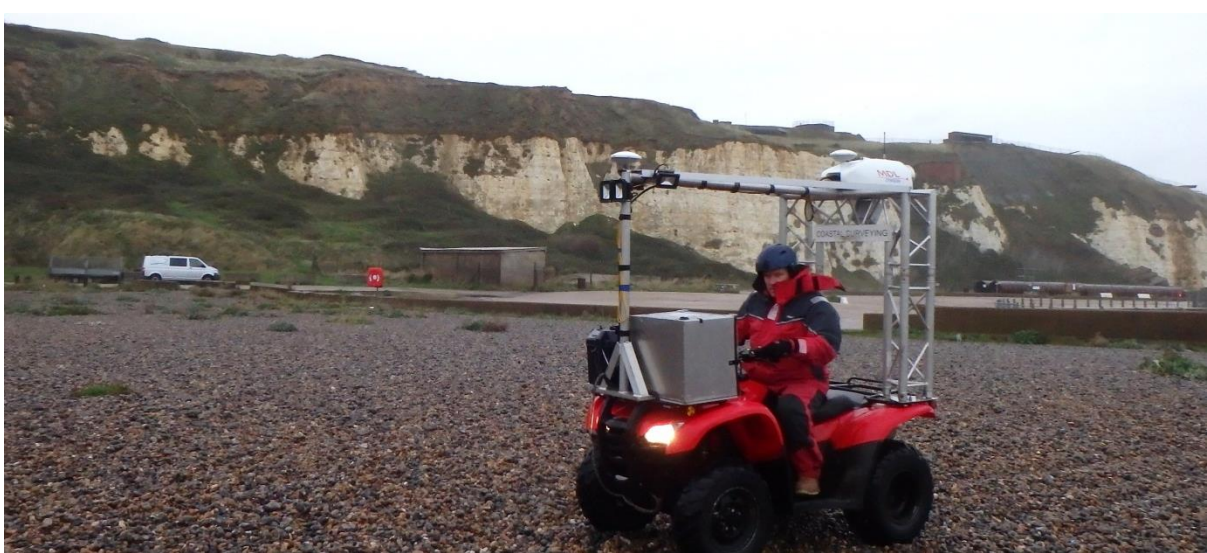
For the majority of this coastline a mobile laser scanner is mounted onto an ATV and driven along the beach to create a dense 3D point cloud. Beach levels can be extracted from this laser scan along predetermined beach profiles and across the beach face to create a 3D model of the beach. GPS equipment is also mounted on an ATV to code the substrate of the beach (Figure 9-1).

FIGURE 9-1 MOBILE LASER SCAN MOUNTED ON AN ATV – HASTINGS (2012)
